# **Rail Accident Report**

Class investigation into landslips affecting Network Rail infrastructure between June 2012 and February 2013

> Report 08/2014 April 2014

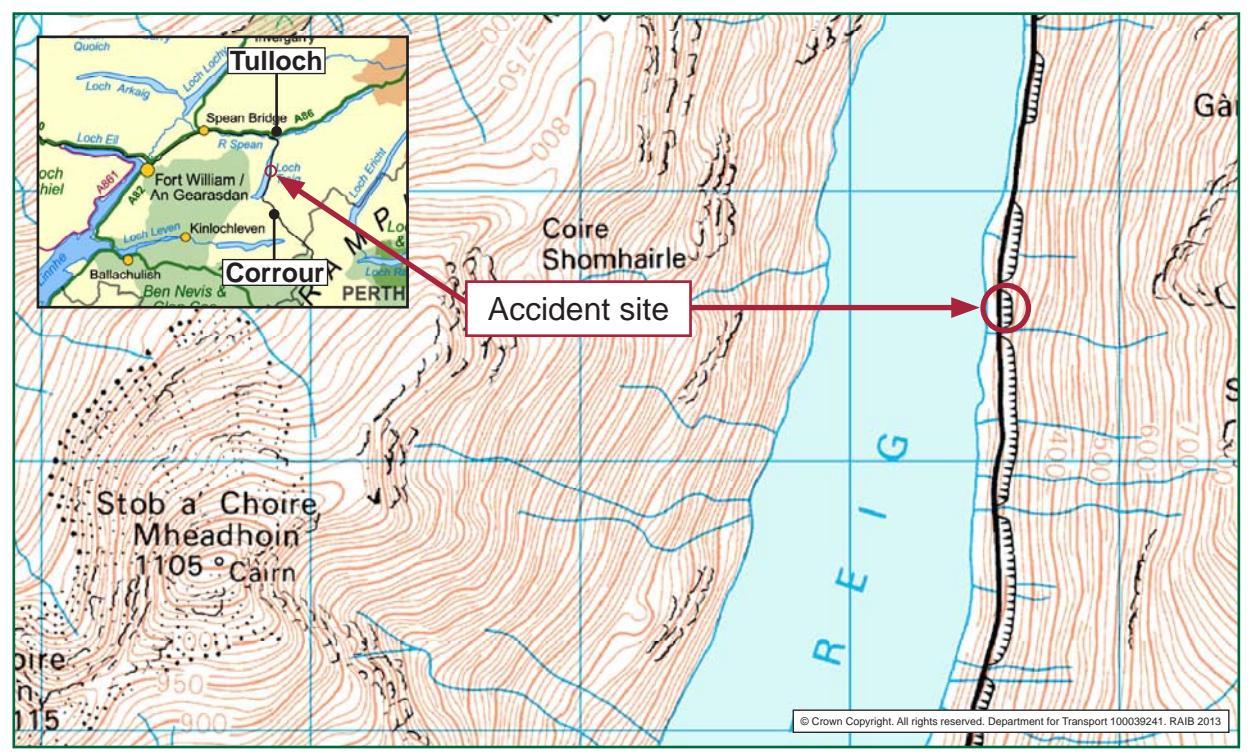
Figure 2: Loch Treig: accident location

9 At approximately 19:05 hours on Thursday 28 June 2012 a locomotive and five wagons were derailed when a freight train running on the West Highland line between Corrour and Tulloch hit a landslip alongside Loch Treig (figure 2). There were no injuries but three of the derailed wagons overturned and the locomotive ran part way down the *natural slope* leading to the loch (figures 3 and 4).

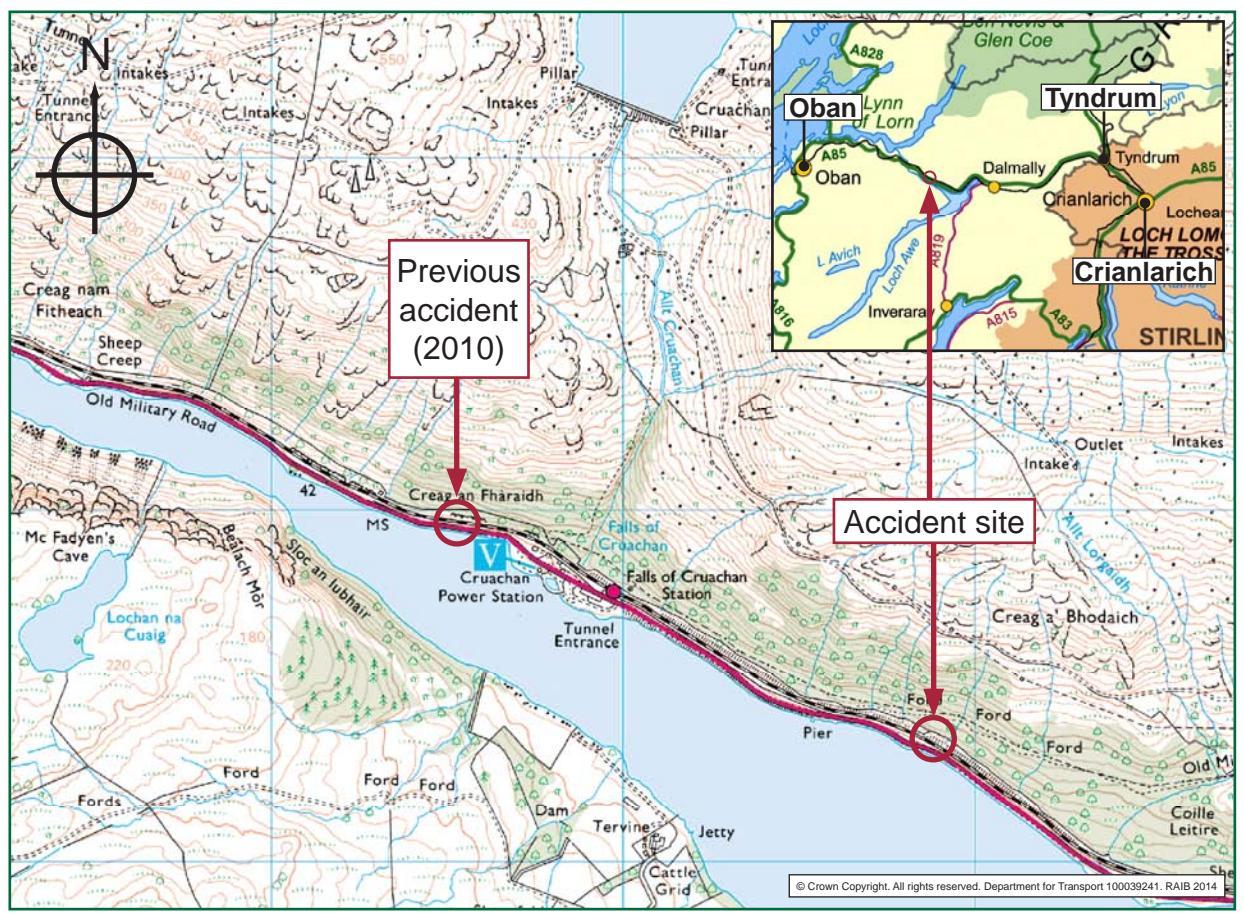
Figure 7: Falls of Cruachan: accident location

- 23 At 13:35 hrs on Wednesday 18 July 2012, the 12:56 hrs Oban to Glasgow First ScotRail passenger service, reporting number 1Y24, struck landslip debris near Falls of Cruachan but did not derail (figure 7). There were no reported injuries but the train suffered minor damage. If the train had been derailed by the landslip debris, it is possible that it would have fallen down an adjacent slope (paragraph 26).

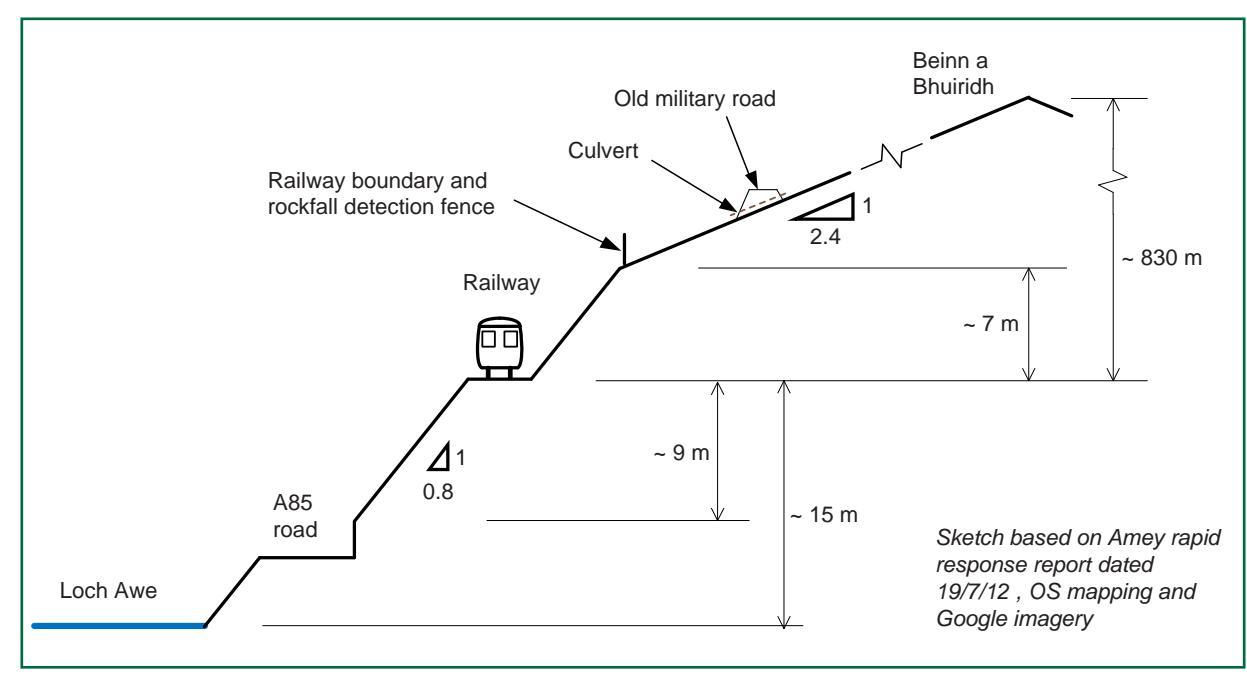
Figure 10: Falls of Cruachan: slope geometry (cross-section)

- At this location, the railway comprises a single line running through the Pass of Brander on a ledge some 15 to 20 metres above Loch Awe. The north side of the railway comprises a rock *cutting* about seven metres high with a slope of about 1 in 0.8 with a fence at the top of the cutting marking the railway boundary. Beyond the fence, a natural hill slope rises at a slope of about 1 in 2.4 towards the summit of Beinn a Bhuiridh about 830 metres above the railway. On the south side of the railway, the ground slopes downwards at about 1 in 0.8 for a vertical height of about nine metres to the top of a retaining wall which runs alongside the A85 trunk road (figure 10).

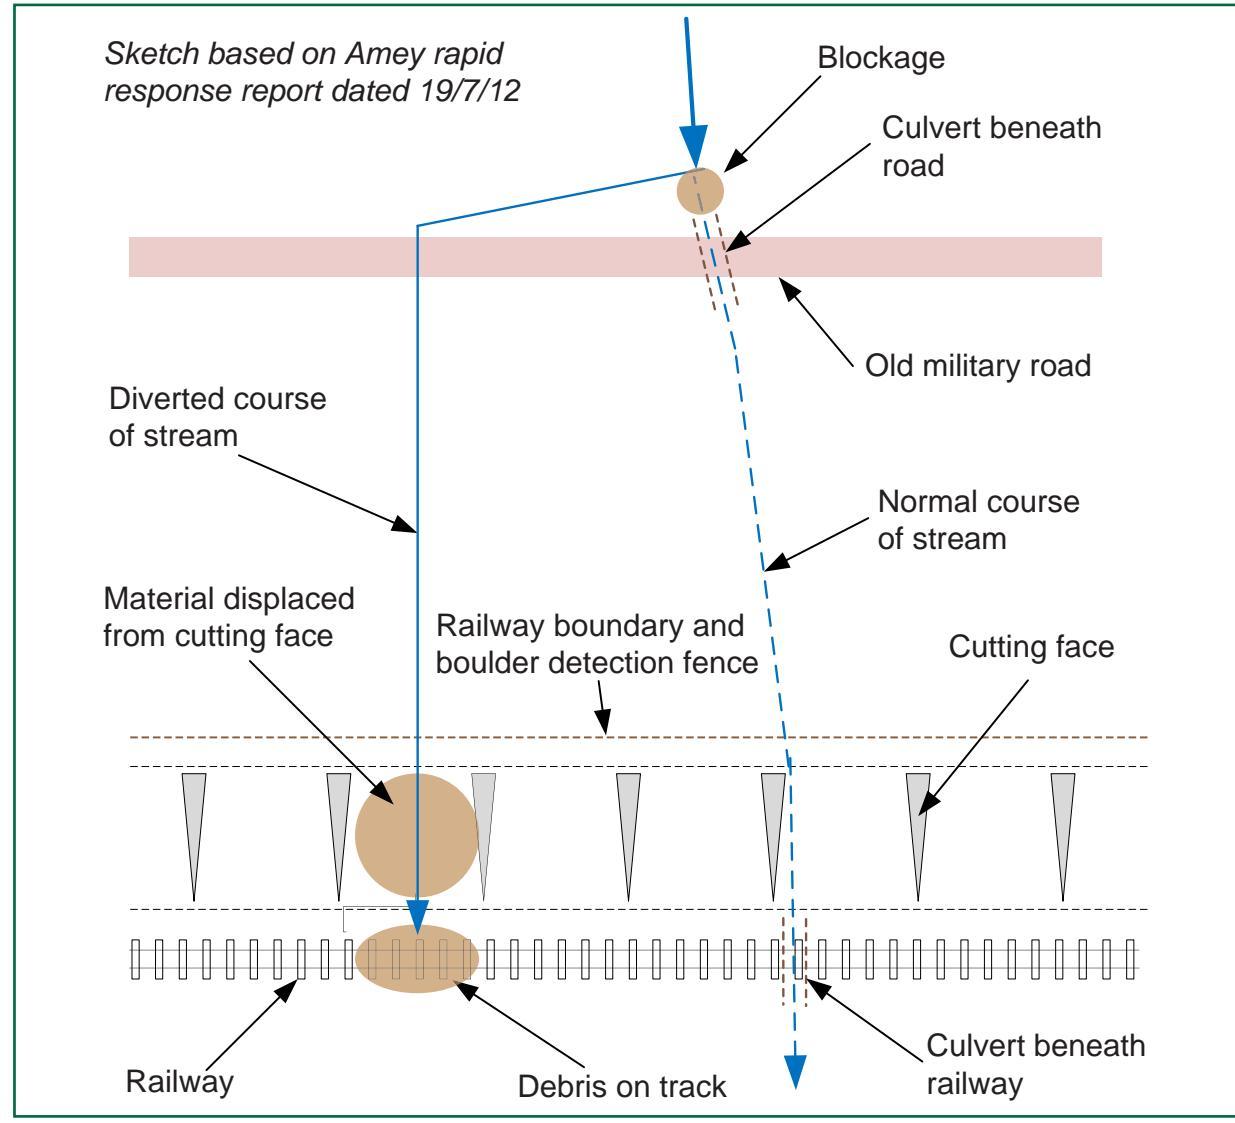
Figure 11: Falls of Cruachan: sketch plan

- 27 A post-incident inspection of the site undertaken by Amey staff on behalf of Network Rail<sup>8</sup> showed that the landslip had been triggered by a flow of water which had been diverted from its normal course by a blocked culvert about 60 metres upslope of the north side of railway (figure 11). The flow had therefore entered the cutting at a location where there was no channel to control the flow of water and the uncontrolled flow was sufficient to dislodge soil and boulders from the cutting face (figure 12).

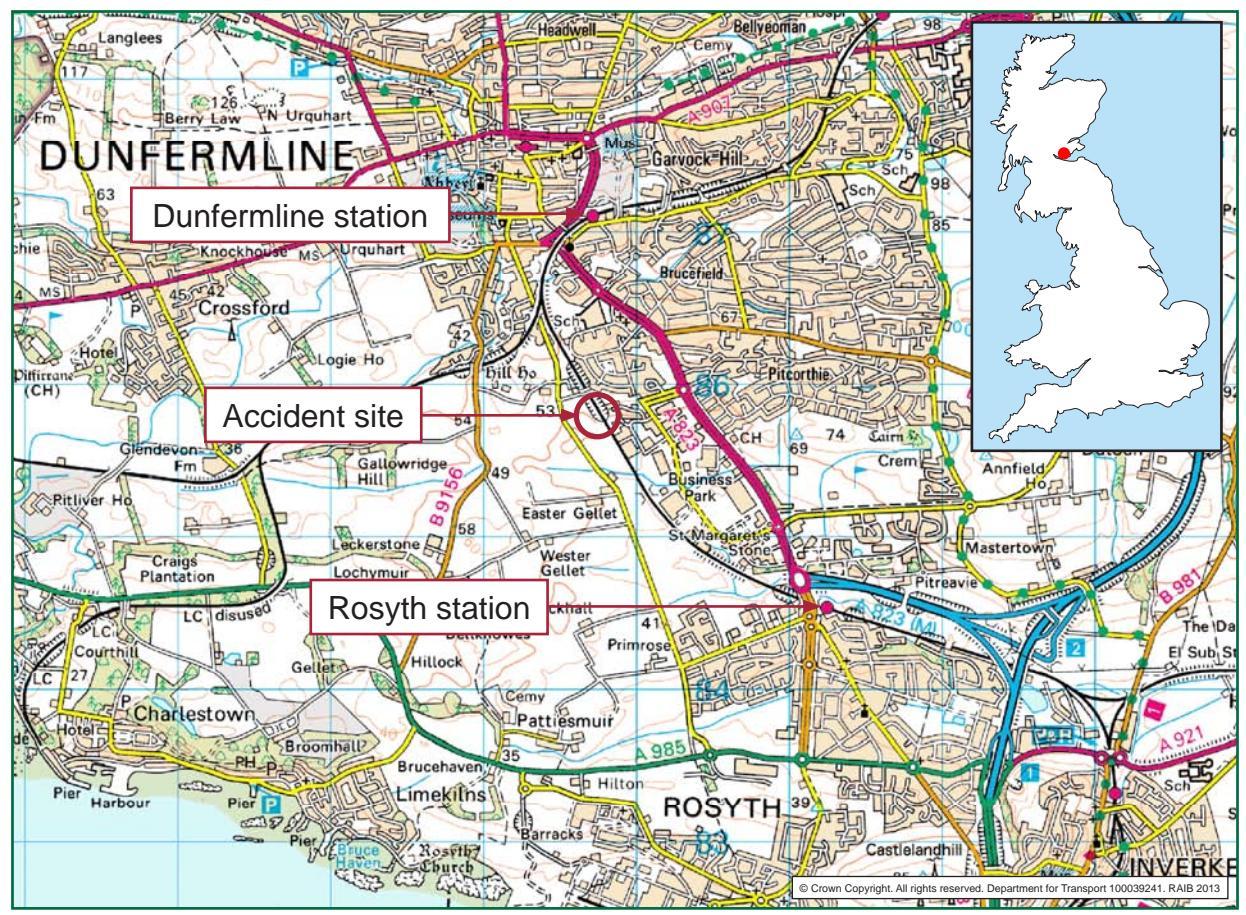
Figure 13: Rosyth: accident location

- 37 At about 16:10 hrs on Wednesday 18 July 2012, the 14:17 hrs First ScotRail service from Newcraighall to Edinburgh, reporting number 2K05, was derailed when it struck landslip debris between Rosyth and Dumfermline (figure 13). There were no injuries. The track and train suffered minor damage.

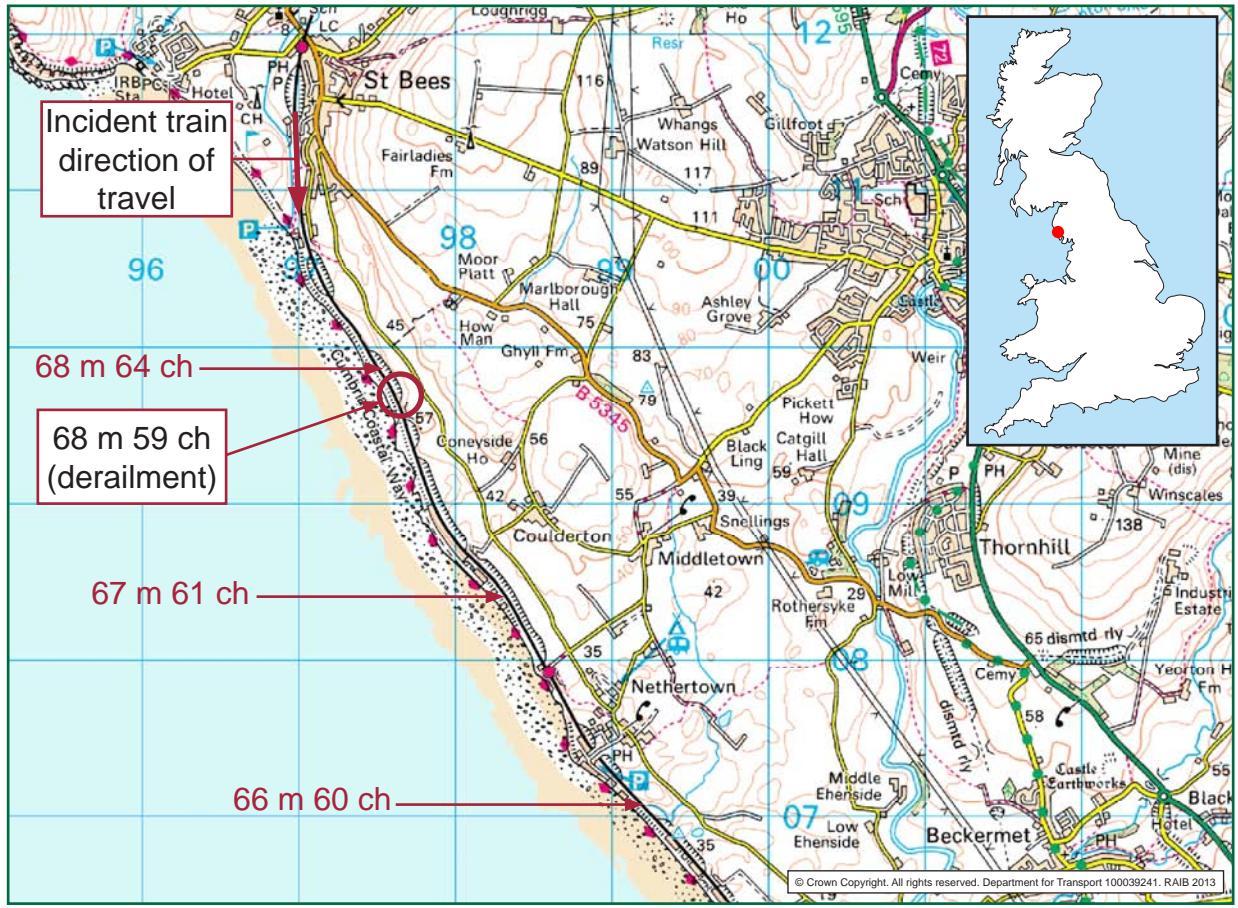
Figure 17: St Bees: accident location

- 48 At approximately 06:43 hours on Thursday 30 August 2012 the leading bogie of a passenger train derailed when it hit a landslip between St Bees and Nethertown on the Cumbrian coast (figure 17). There were no reported injuries and only relatively minor damage to the train. If the train had derailed to a greater extent, it is possible that it would have fallen down an adjacent slope (paragraph 50).

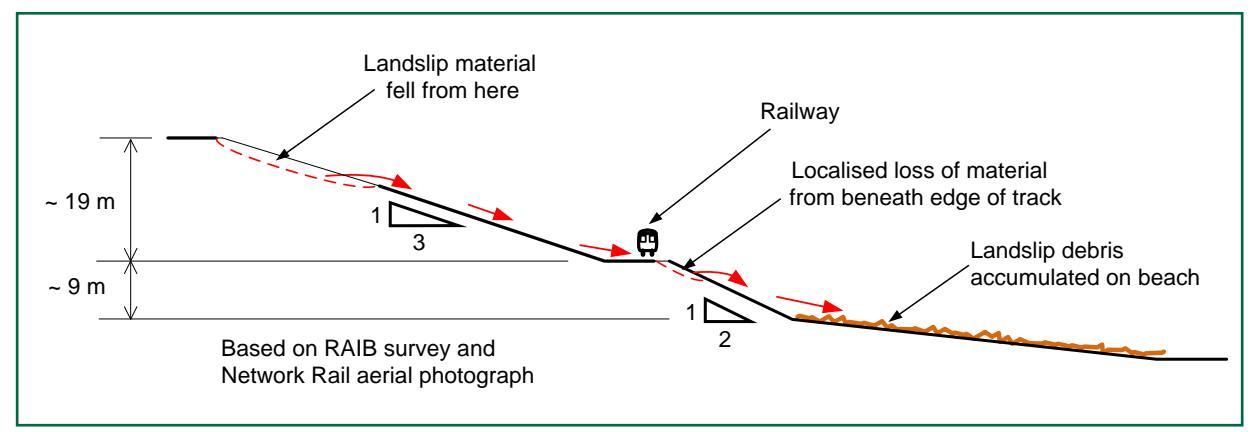
Figure 21: St Bees: slope geometry (cross-section)

- 50 The accident occurred in an area where the railway has a maximum permissible speed of 60 mph (96 km/h) and comprises a single line running on a ledge cut into the sea cliffs which rise about 19 metres above the railway at a slope of approximately 1 in 3. This slope continues at a steeper angle of about 1 in 2 to the toe of the cliff about 9 metres below the railway (figure 21). The land at the top of the cliff is grassed, relatively level and used for grazing farm animals. At both 68 miles 64 chains and 68 miles 59 chains, the debris on the line was the consequence of landslips which had occurred in the cliff slopes above the railway.

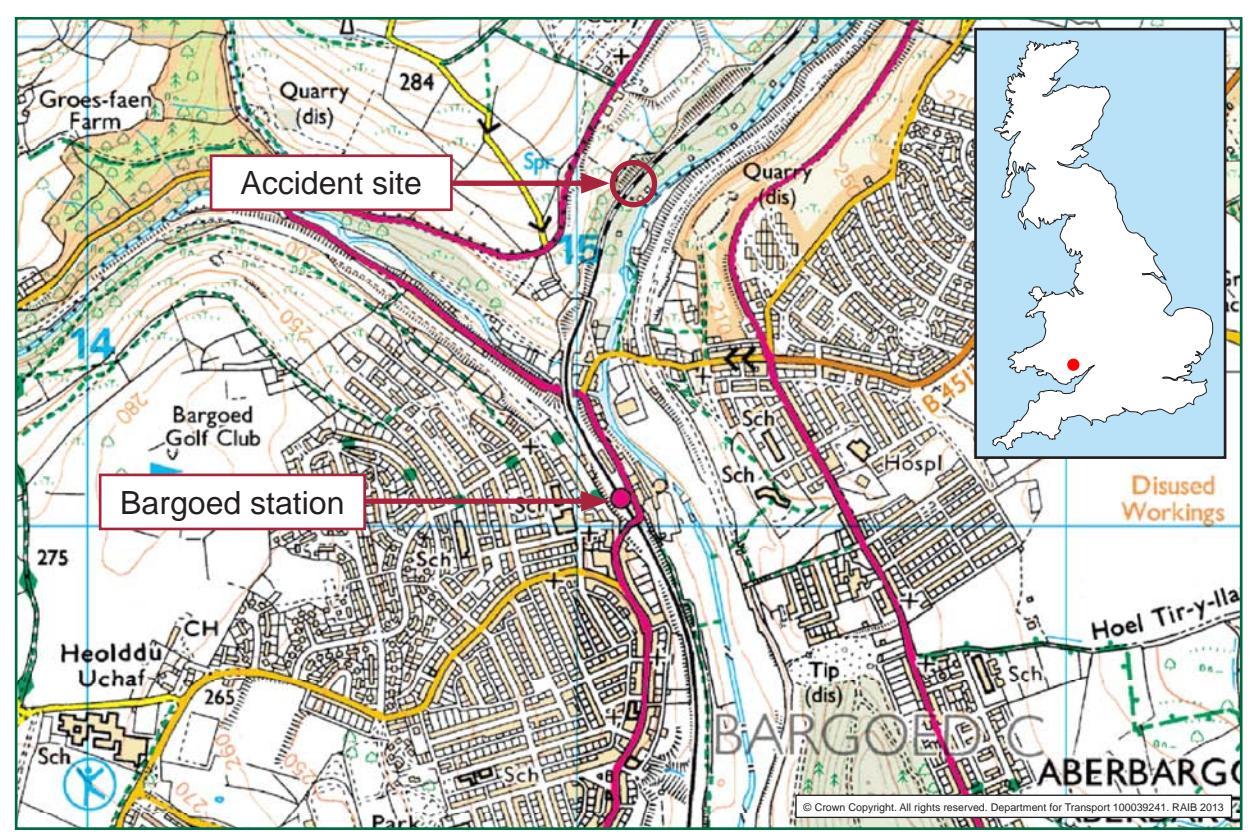
Figure 25: Bargoed: accident location

61 At approximately 06:20 hrs on Wednesday 30 January 2013, the 06:10 hrs Arriva Trains Wales service from Rhymney to Barry Island struck a tree which had been displaced onto the track by a landslip on the approach to Bargoed station (figure 25). The leading bogie derailed, the train suffered minor damage and a passenger was taken to hospital suffering from shock (figure 26).

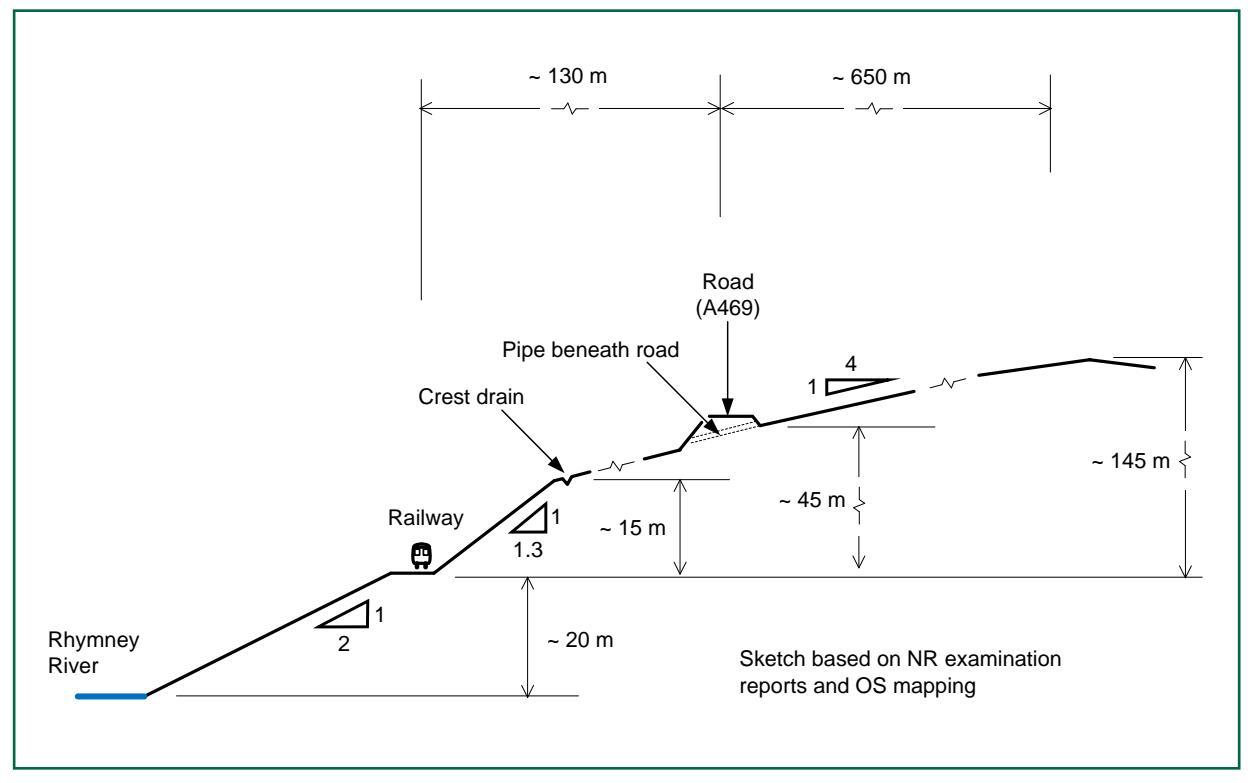
Figure 27: Bargoed: slope geometry (cross-section)

- 63 The landslip occurred at 18 miles 38.5 chains<sup>11</sup> alongside a section of single track railway running on a ledge cut into a hillside above the Rhymney River. Construction of the railway created a cutting face approximately 15 metres high and with a slope of 1 in 1.3 on the west side of the railway. Above this, the natural hillside rises a further 30 metres at a slope of about 1 in 4 to a road. The natural hillside continues to rise a further 140 metres above the road to a ridge. Below the railway, the natural hillside slopes at about 1 in 2 down to the Rhymney River which is about 20 metres below the railway (figure 27).

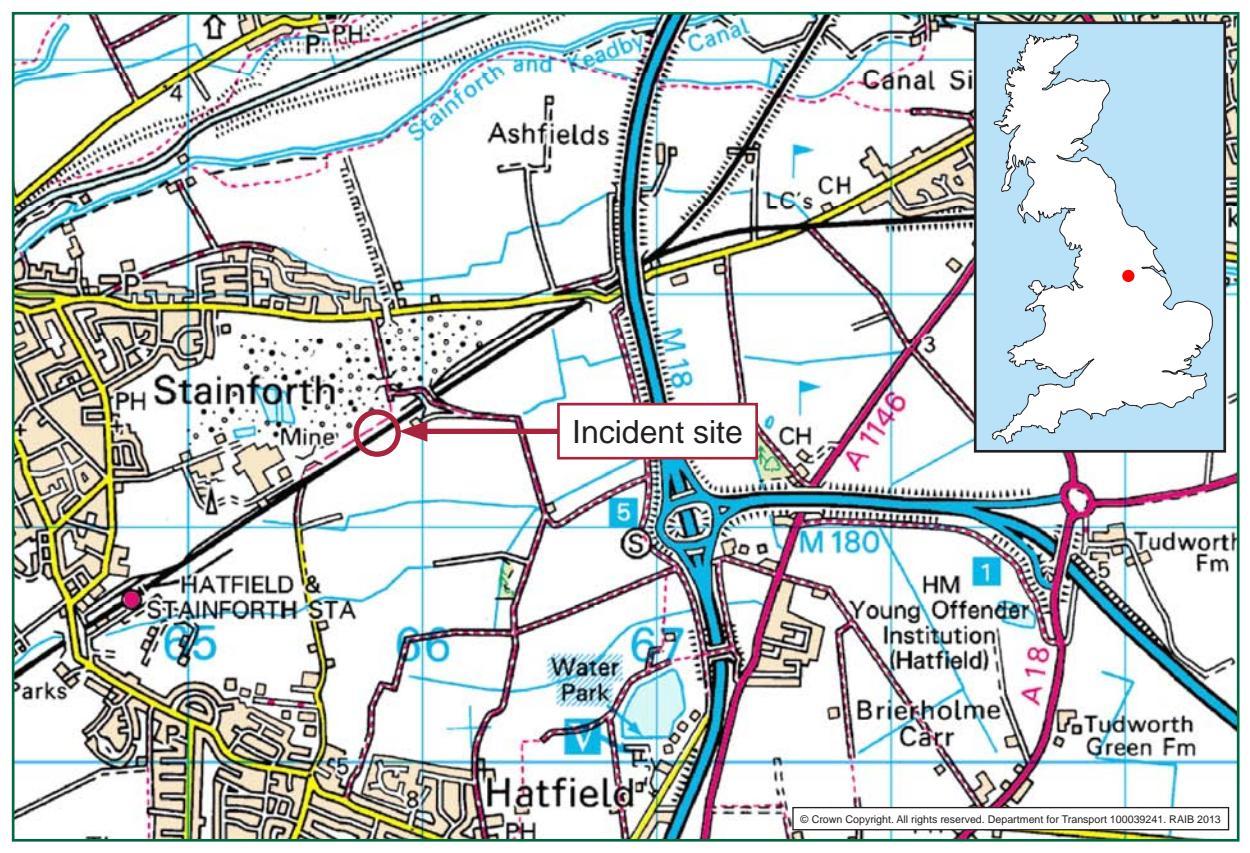
Figure 29: Hatfield Colliery: incident location

76 On 9 February 2013 a train driver noticed a track defect when passing Hatfield Colliery, near Stainforth, South Yorkshire at 7 miles 25 chains<sup>13</sup> on the four track section of railway between Doncaster and Scunthorpe (figure 29). At this location, the maximum permissible speed is 40 mph (64 km/h) on the outermost lines and 60 mph (96 km/h) on the central pair of tracks. Network Rail staff attended site when the driver reported the defect and implemented progressively lower speed restrictions as on-going track movements became apparent (figure 30). Due to these movements, three of the lines were closed to traffic on 11 February and the fourth line was closed on 12 February.

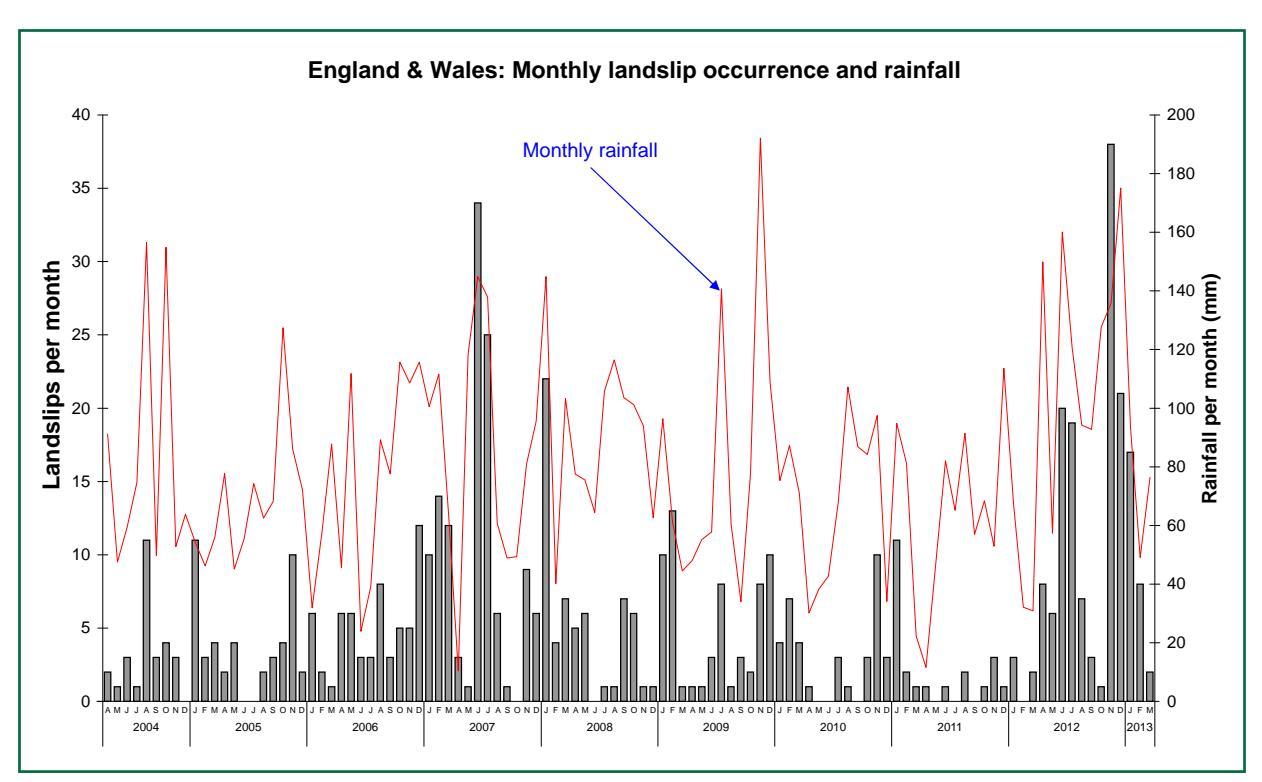
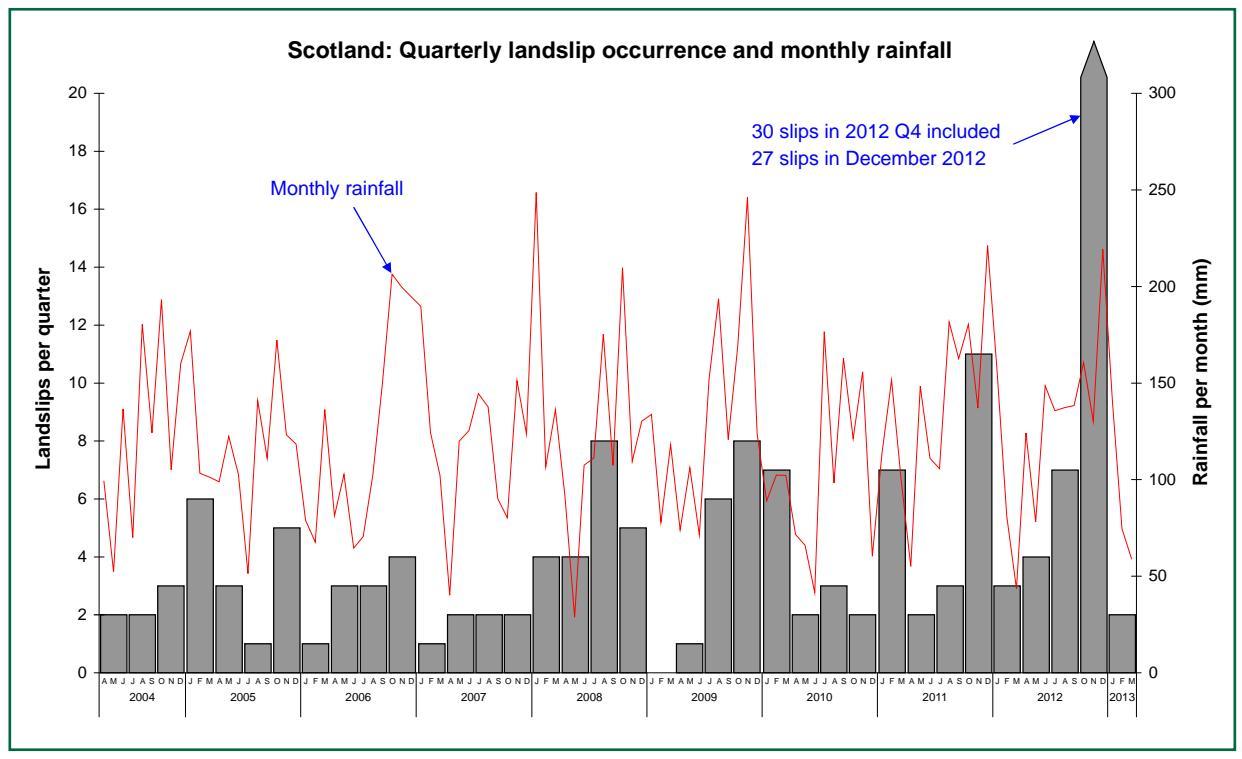
Figure 33: Rainfall and earthwork events on Network Rail infrastructure in England & Wales

- water can increase the likelihood of a landslip by making parts of a slope heavier than in dry conditions.
- 86 The importance of rainfall is evidenced by the relationships between earthwork failures and rainfall shown in figures 33 and 34. Earthwork failure data is shown on a monthly basis for England and Wales (figure 33) and on a quarterly basis for Scotland where the length of railway is less and fewer failures occur (figure 34). Rainfall data is presented on a monthly basis on both figures and so does not include the following influences on landslips:
