Rail Accident Report

Accidents involving a wheelchair rolling onto the track at Southend Central, 28 August 2013; and a pushchair rolling onto the track at Whyteleafe, 18 September 2013

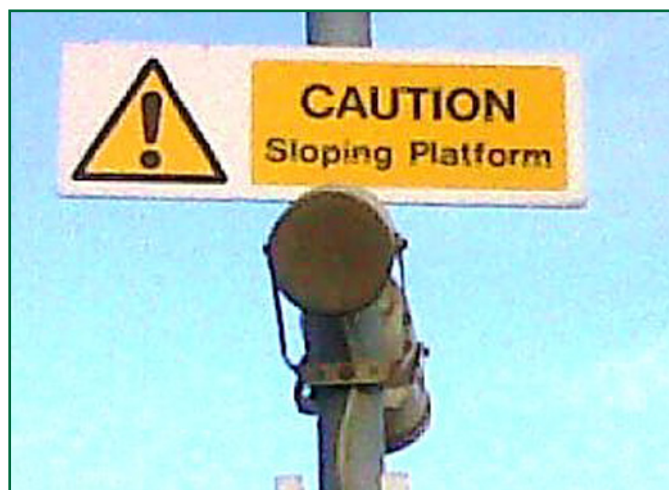
Figure 13: Signage installed at Barrhead station (image courtesy of First ScotRail)

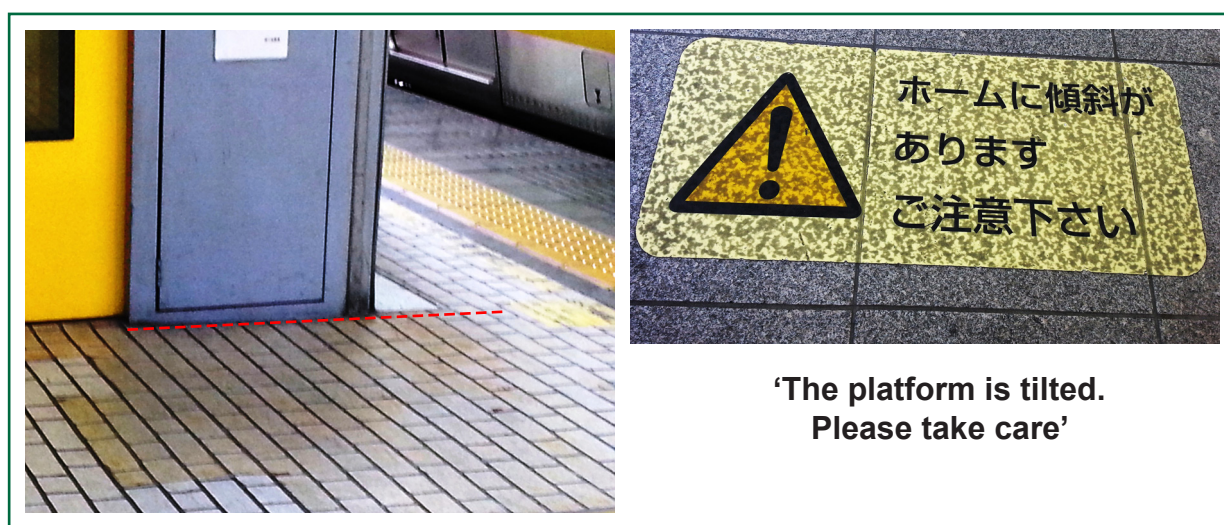
Figure 15: Platform transfers installed at Shinagawa Station, Tokyo, Japan (images courtesy of Professor N.Tyler. University College London)

- d. committed to undertaking a review of international best practice in the management of hazards at stations such as slopes towards the track and gaps between trains and platforms (figures 15 and 16).

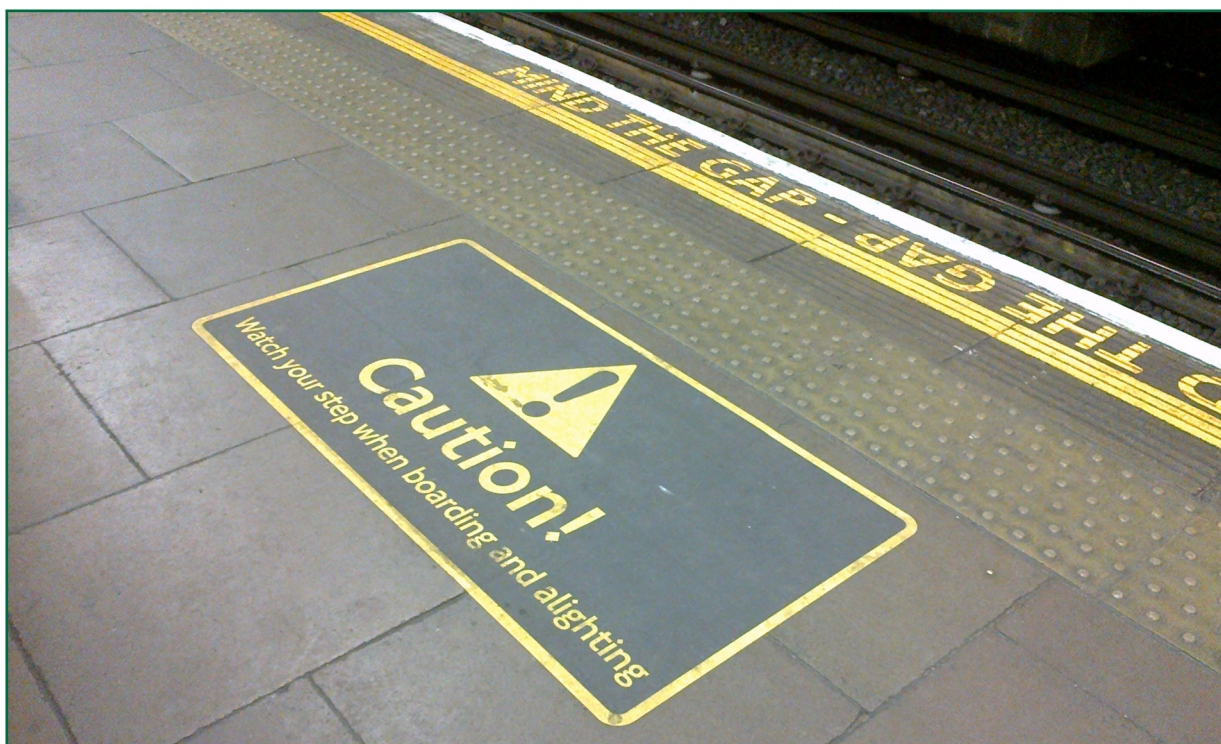
Figure 16: Transfer used on the London Underground

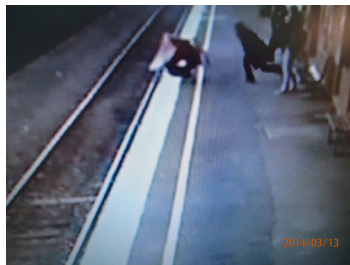
Other worldwide incidents	
<u>Ashburton station.</u> <u>Melbourne.</u> <u>Australia (Connex.</u> <u>Melbourne (now</u> <u>Metro trains) 2009</u>	<p>A near miss occurred after a pram holding a 6-month old baby rolled onto the tracks and into the path of an oncoming train as it entered the platform at Ashburton railway station.</p>

<p>The baby's mother had been distracted while she was standing on the platform, and was looking away as the pram rolled off the platform. The baby suffered minor cuts and bruises. It was reported that a previous identical accident had prompted the train operator to review the design of platforms in the Melbourne area, but the standards only require new platforms to slope away from the railway track.</p>
<u>Tooronga station.</u> <u>Melbourne 2010</u>	<p>A pram rolled off the platform and into the path of an approaching train at Tooronga station. No further details were supplied.</p>

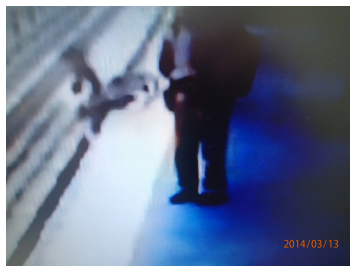
<u>Fairfield station.</u> <u>Melbourne 2012</u>	<p>A mother standing next to her baby's pram on the platform became distracted. As she looked elsewhere the pram slowly rolled away on the platform and fell onto the railway track. As the pram fell, the mother noticed and ran across the platform and jumped onto the tracks. The pram and baby were recovered. Station officials confirmed that the baby was rescued uninjured before the next train arrived. It was reported that the incident was one of three identical incidents involving prams rolling off platforms in the Melbourne area in 2011.</p>
<u>56th Street station</u> <u>Philadelphia. USA</u> <u>2013</u>	<p>A mother became distracted and unaware of her pushchair and child rolling forward onto the track. The mother and other passengers jumped down to rescue the child.</p>

<p>The train operator stated that the mother had become distracted and had not applied the brake. The platform is slanted slightly for drainage purposes causing the pushchair to roll forward. The child was taken to Philadelphia hospital with head injuries.</p>

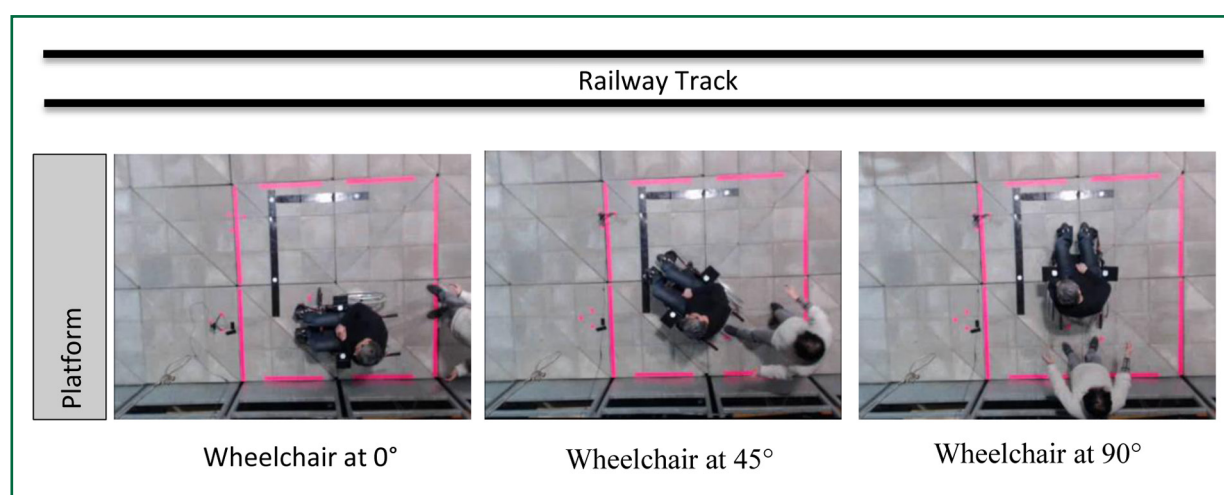
The PAMELA platform was set-up with a 2.4m x 2.4m area on a slope. Two slope gradients were investigated: 2° (1:28 or 3.5%) and 5° (1:11 or 9%). The initial position of the wheelchair was adjusted so that its orientation relative to the edge of the slope was in one of three positions (figure F1):

1. Wheelchair at 0° with casters at 90°.
2. Wheelchair at 45° with casters at 90°.
3. Wheelchair at 90° with casters at 90°.

Figure F1: Wheelchair positions relative to the slope which runs downhill towards the top of the picture. The term '0°' refers to chair and/or wheels being side-on to the slope, while the term '90°' refers to the chair and/or its wheels facing down the slope.)
