DUTCH
SAFETY BOARD

Train derailment Hilversum

January 15th 2014

The Hague, December 2014

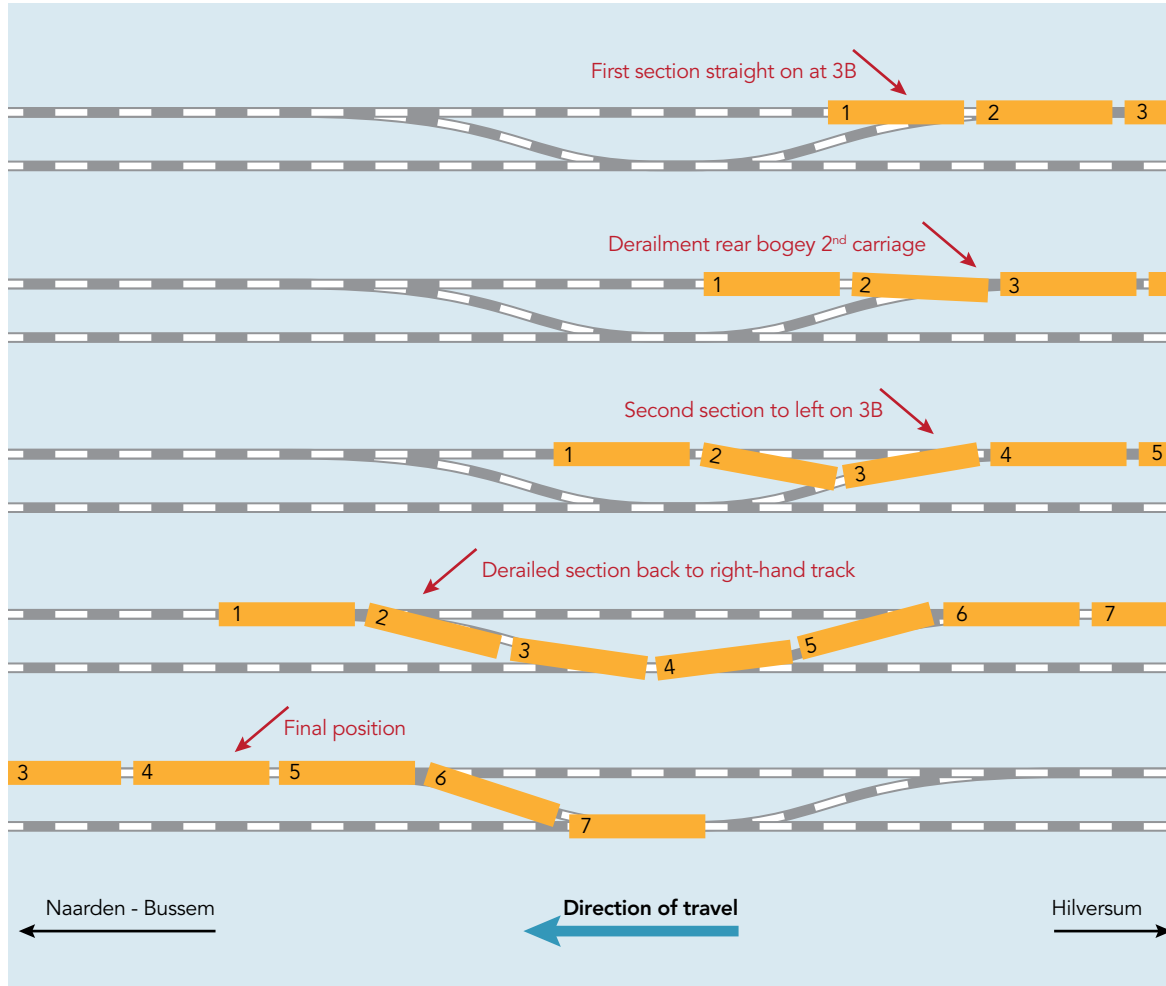
Figure 2: Top view of the course of movement of the carriages during the derailment.

whereby the carriages were directed from the left-hand track back onto the right-hand track, via crossover switch 1A/B. In the final position, the front five carriages were on the right-hand track; the sixth carriage was on crossover switch 1A/B and the seventh carriage was still on the left-hand track (see the bottom illustration in figure 2).

The illustrated course of movement was derived from video images recorded by cameras at the level crossing, and from the consequential damage to the infrastructure and the rolling stock. In the final position, only the front bogie of the second carriage ended up 'alongside the rails' (see figure 3), but the damage to the wheel sets, rails and sleepers clearly showed that four other bogies temporarily had been derailed as well.

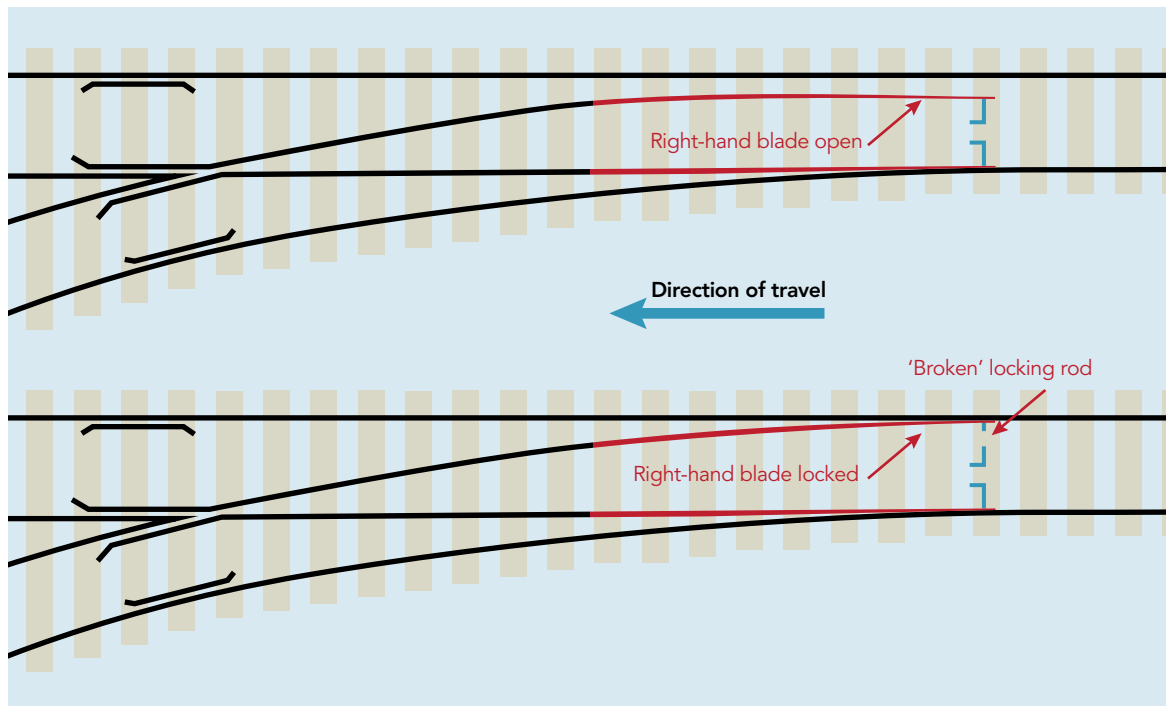
As a consequence, the front section of the right-hand switch blade worked loose and – under the influence of the passing train – this blade shifted from the open position to the locked position (see figure 5). From that moment, both blades were in the locked position. The wheel sets which subsequently reached the switch were as a consequence confronted with a narrowing of the track gauge, in the direction of travel. This is shown in the bottom illustration in figure 5. Both switch blades (shown in red) are in the locked position.

Because the distance between the switch blades became smaller in the direction of travel, the wheel sets were forced to derail.

Figure 5: Schematic representation of the cause of the derailment: due to the breaking of the right-hand locking rod, the right-hand switch blade was able to shift from open to locked position.

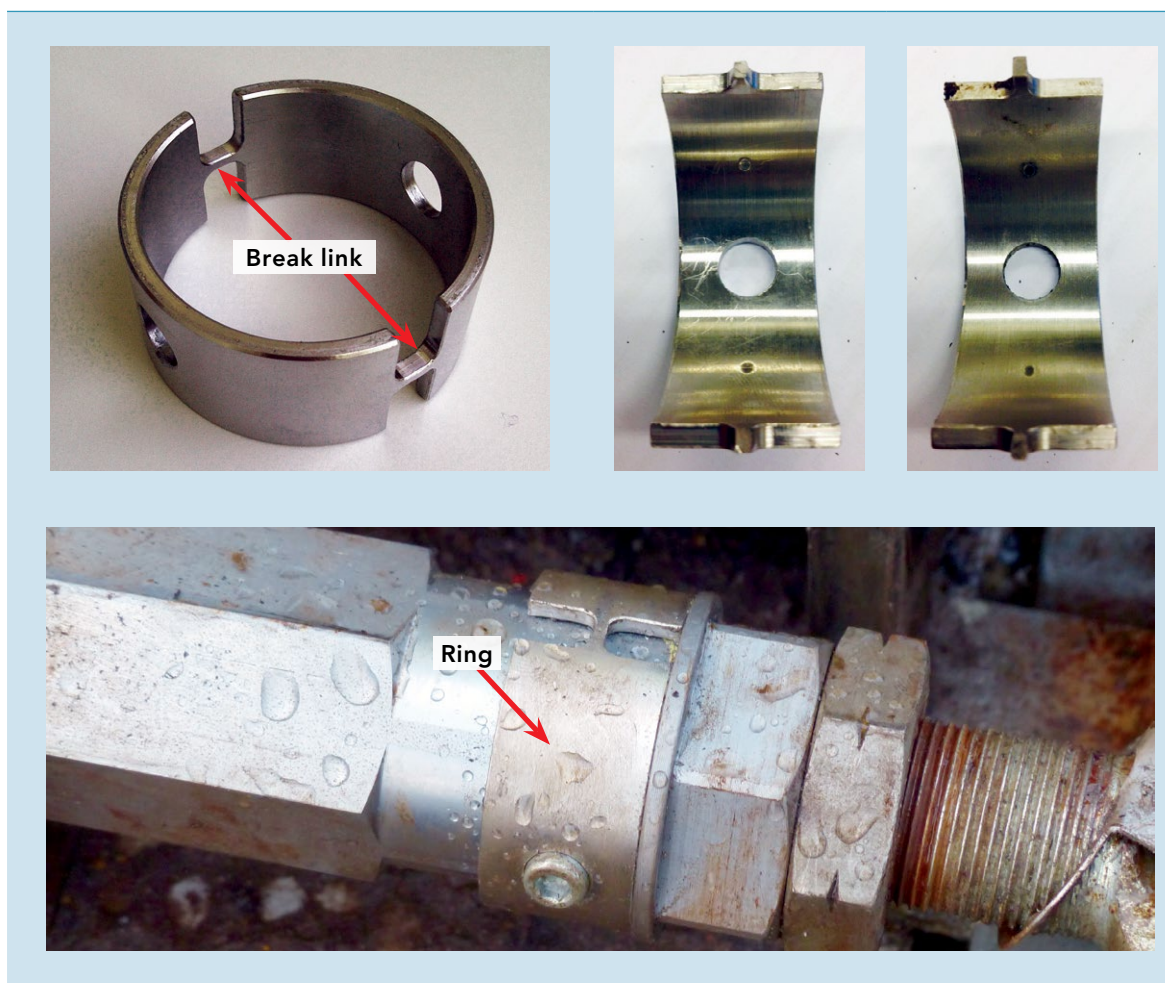
Figure 7: The upper left-hand photograph shows a new ring (with two break links); the upper right-hand photograph shows a broken ring. The lower photograph shows a ring in its installed situation. (Source: ProRail)

The ring found in the switch in Hilversum revealed a rough grinding spot near one break link and burrs near the other. These non-conformities influenced the fatigue strength of the ring. In addition to the dimensions and material characteristics, the fatigue strength is determined by the shape and condition (roughness) of the surface. In final finishing, machining burrs were not correctly removed from this ring: at one break link the burrs remained, while at the other link too much material had been ground away, leading to a

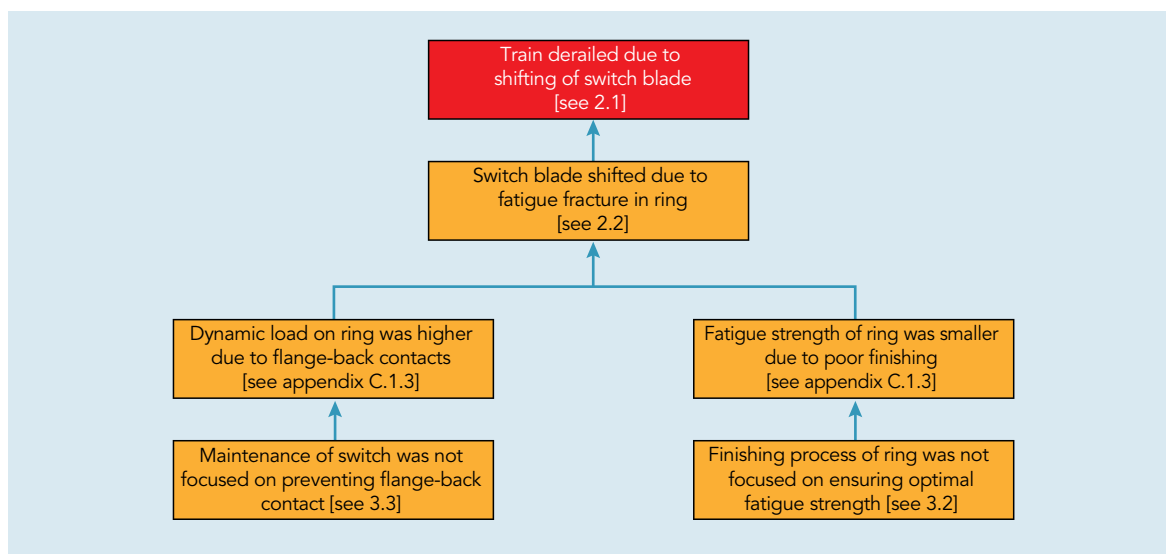
The maintenance carried out by the subcontractors was not sufficient to maintain the condition of switch 3B at the required level. The wear on the Ekos-V rollers and slide chairs was not dealt with in time. Flange-back contacts were observed, but no control measures were taken. During the most recent inspection of the point machine, only one of the two break links of the ring was inspected.

Figure 9: Diagrammatic representation of the direct causes of the derailment.

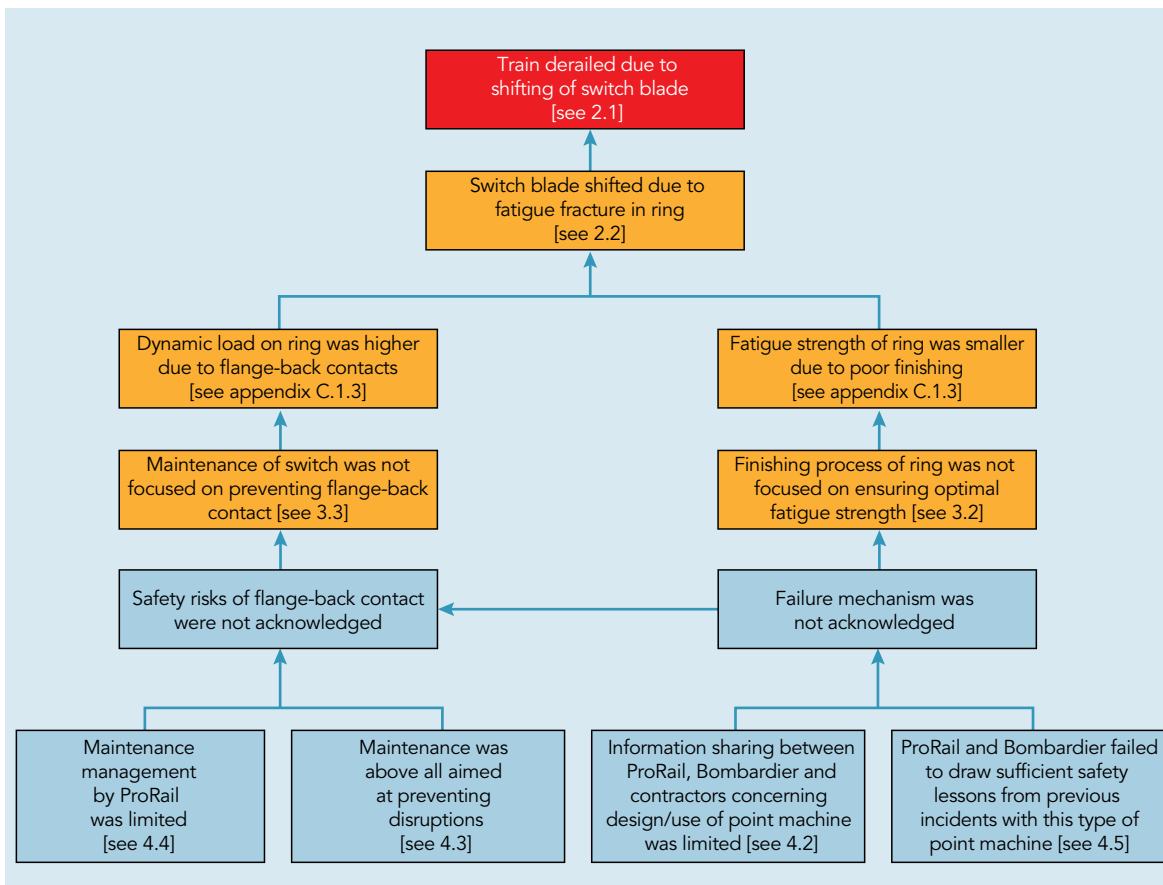
Figure 10: Diagrammatic representation of the failure mode, including underlying factors.

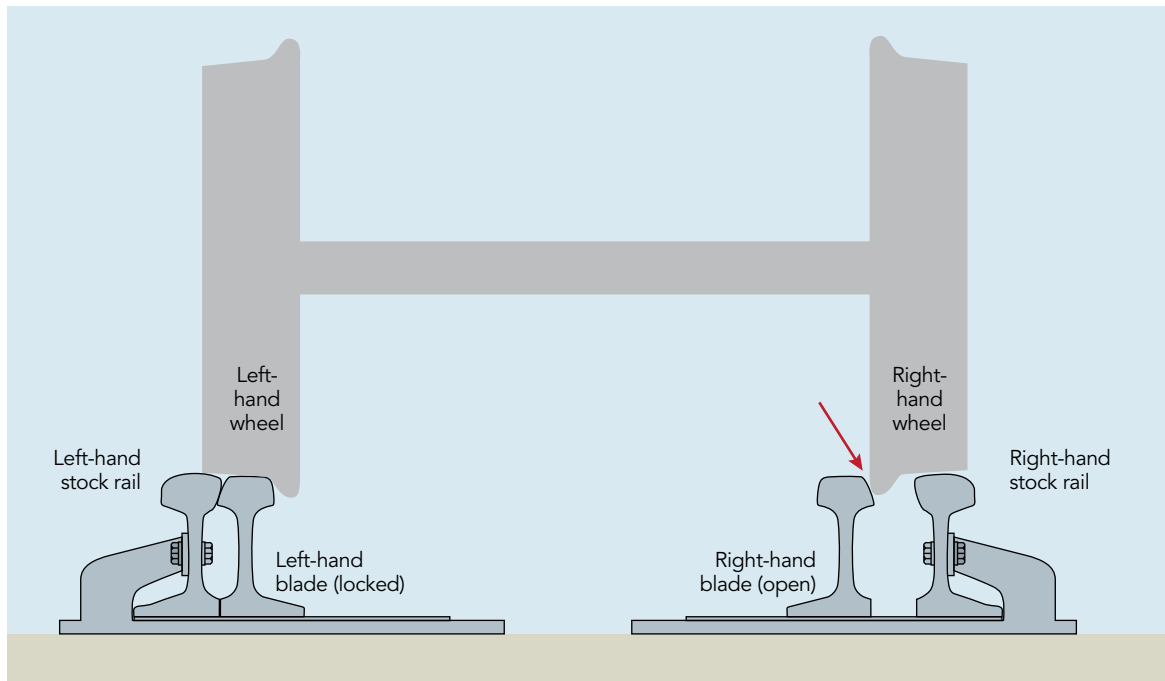
When an open switch blade is positioned too close to the stock rail, it is possible that the inside of the passing train wheels will come into contact with the outside of the switch blade. This situation (see figure 18) is referred to as 'hitting the open blade'.

Figure 18: Hitting the open switch blade.

Hitting an open blade generally occurs around the mid-section of the blade, if that section shifts not far enough when the blade is switched to the open position (meaning that it remains positioned too close to the stock rail). To counter this situation, broadly speaking the following three measures are possible: ensuring minimum friction when moving the blade (for example by lubricating the slide chairs or by using a so-called 'lubrication-free system'), increasing the stroke of the point machine and fitting a panel below the foot of the blade at the heel attachment. As previously mentioned, it is also possible to connect the switch blade to the switch mechanism not only at the toe but at several other points. This is known as multipoint operation.

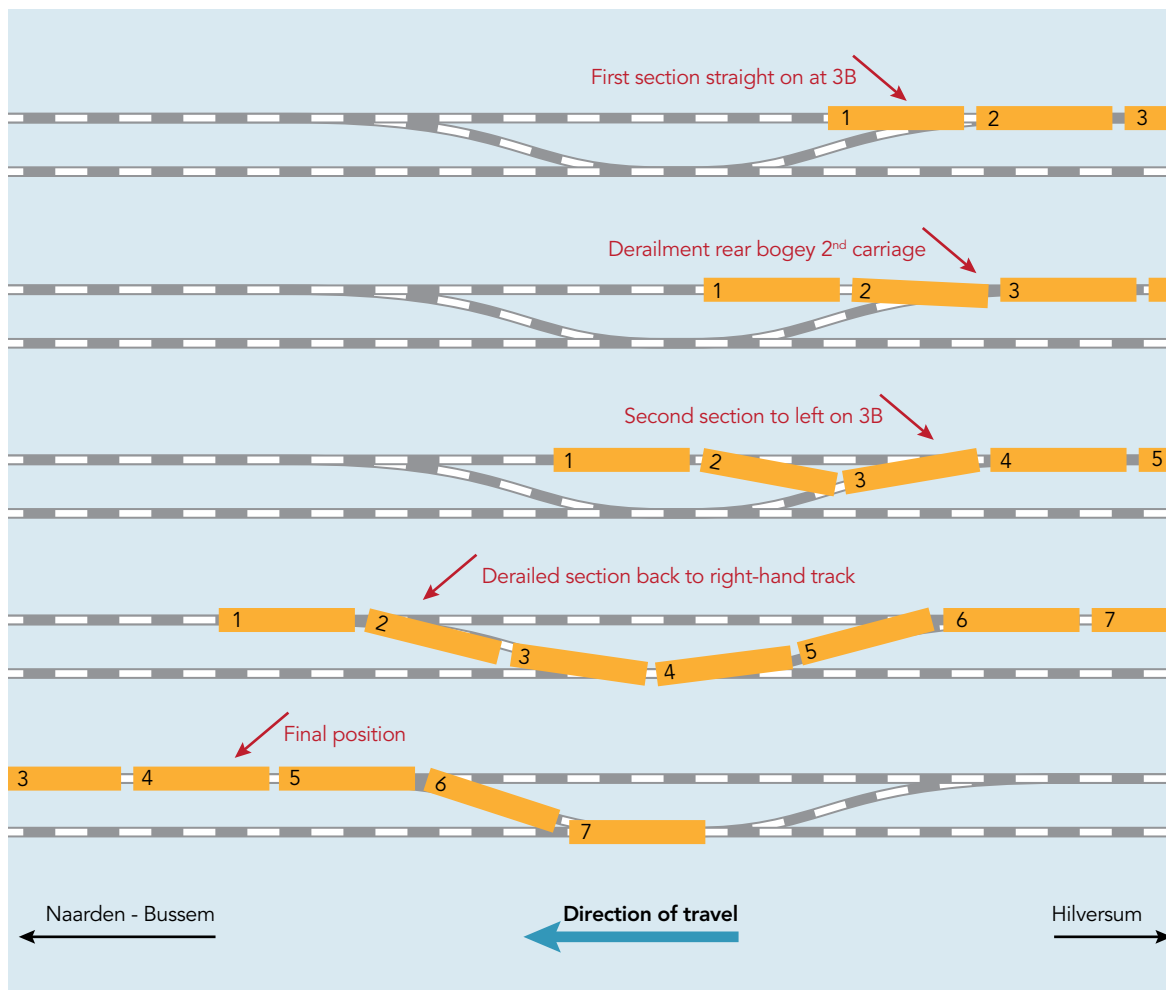
- In the upper drawing, the train approaches switch 3B.
- In the second drawing the train is in the position that the derailment starts: after the front three bogies have travelled straight on at switch 3B, the fourth bogie (below the rear section of the second carriage) derails.
- The third drawing shows that the derailed fourth bogie subsequently moves to the left and ends up on the left-hand track. The same then happens with the subsequent bogies.
- The fourth drawing shows that during the run-out movement (which lasts approximately two hundred metres), the bogies that are directed to the left-hand track return to the right-hand track via the second set of crossover switches (1-A/B).
- The bottom drawing shows the final position of the train.

Figure 24: The course of movement of the train from the start of the derailment until reaching the final position. (represented schematically)

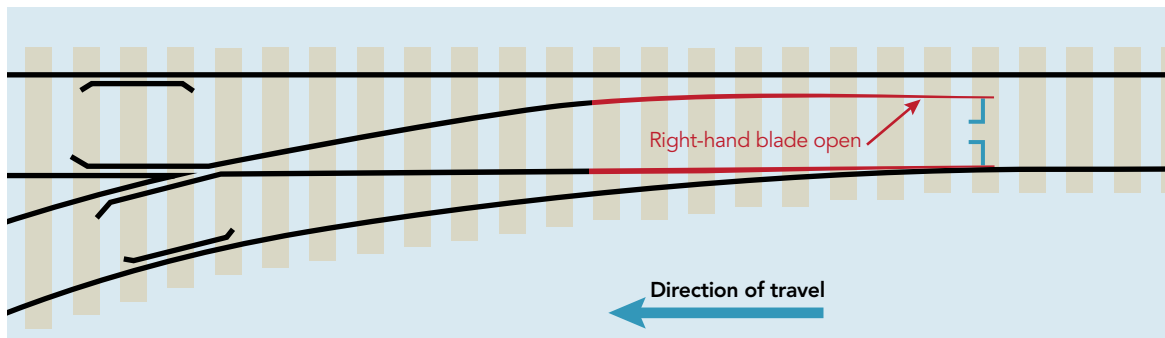
Prior to the derailment, switch 3B was in the position to direct the train along the straight track, with the left-hand switch blade in locked position and the right-hand switch blade in open position (see figure 26). Source: the train safety system. The derailment was initiated when the release mechanism of the locking rod of the open right-hand blade failed. The failure of the rod meant that the front section of that switch blade worked loose, as a result of which it was able to shift into the locked position under the influence of the passing train (see figure 27). From that moment onwards, both switch blades were in the locked position so that the wheel sets which subsequently arrived at the switch were confronted with a narrowing of the track gauge and were forced to derail.

Figure 26: Prior to the derailment, switch 3B was in the setting for travel straight on.

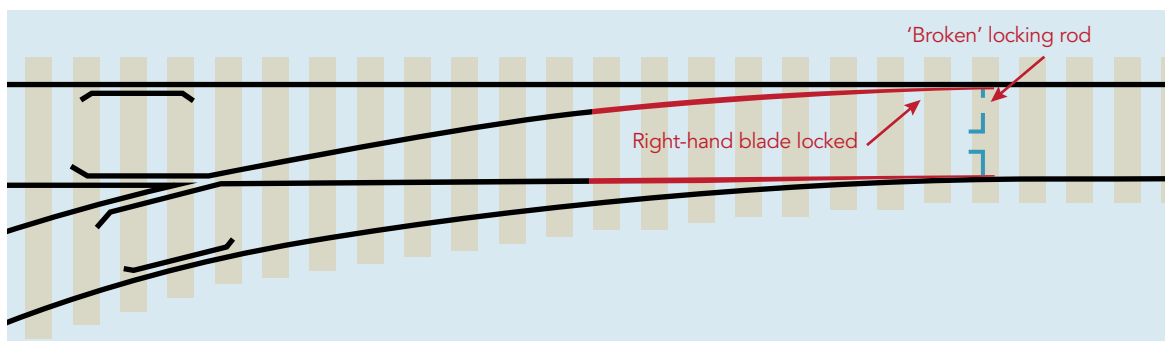
Figure 27: Due to the failure of the release mechanism, the right-hand switch blade was able to shift from open to locked position.

- Even after the derailment, the point machine was still in the setting for travel straight on. The right-hand switch blade, which should then be in the open position, however, turned out to be in the locked position after the derailment. This combination was possible because the locking rod for the right-hand switch blade was 'broken' due to the failure of the release mechanism. Source: investigation at the scene.

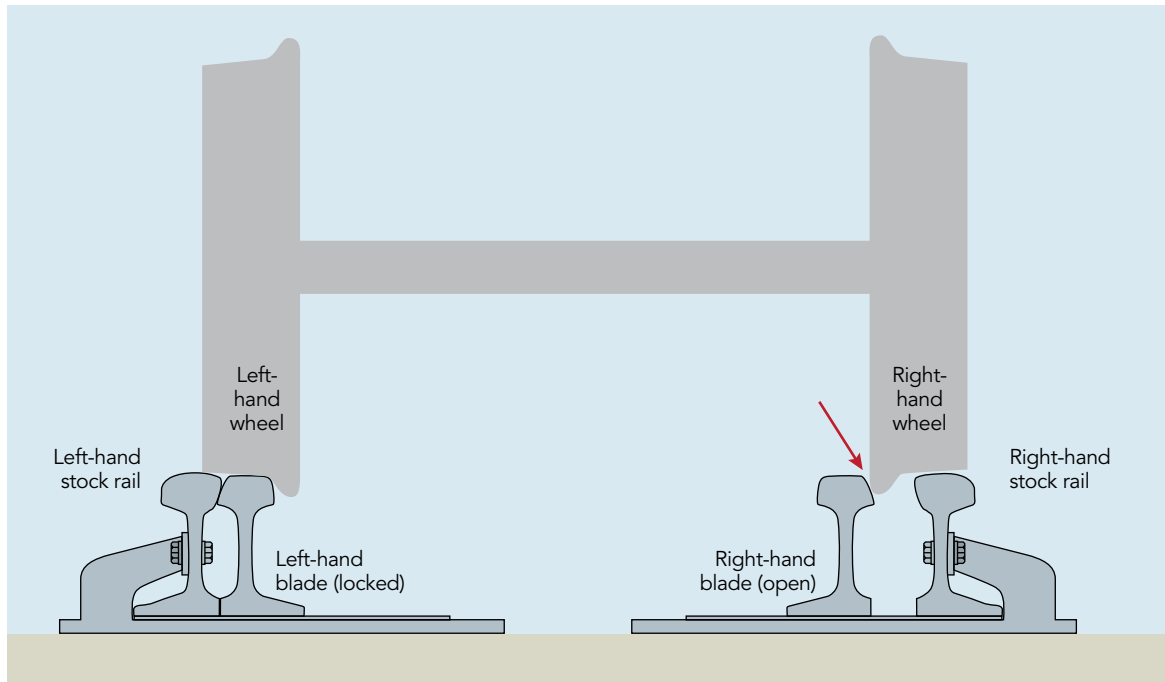
The flange-back contact marks reveal that the section in question of the switch blade, in the open position, was located so close to the stock rail that the inside edge of passing train wheels scraped along the open blade; so-called flange-back contact (see figure 31).

Figure 31: Flange-back contact marks occur when a switch blade in the open position is located so close to the stock rail that passing train wheels come into contact with it.

The size (depth) of the flange-back contact marks (1.3 mm) reveals ongoing flange-back contact. Whenever a switch blade is hit in this manner, it takes up an oscillating movement which results in dynamic forces in the locking rod. The more severe the flange-back contact, the more extreme the oscillating movement of the blade and the dynamic load on the locking rod will be. Given the above, the flange-back contact was accompanied by higher and more dynamic forces on the release mechanism (including the ring) than would occur during normal operation (without flange-back contact). Due to that increased load, the threshold load for fatigue effects was exceeded.

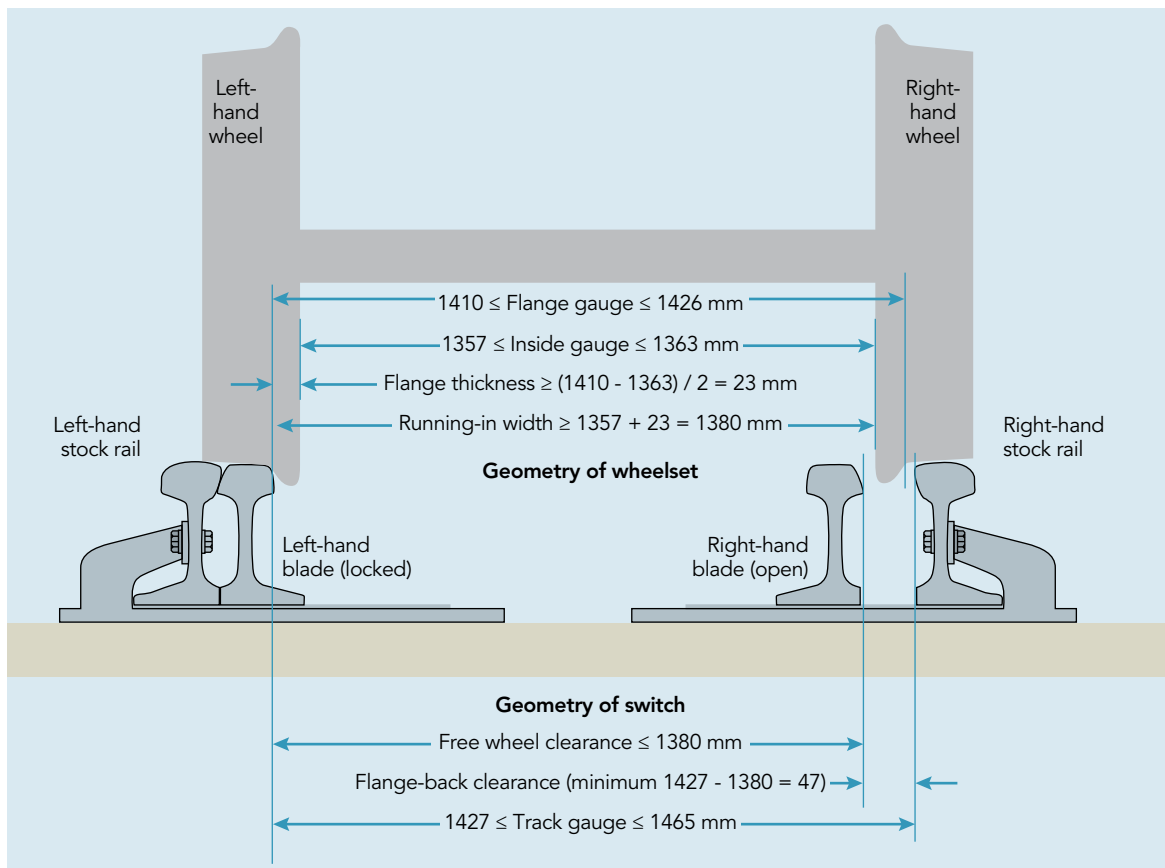
When a train passes a switch, the inside of a train wheel can normally speaking only come into contact with the back of an open blade, if the free wheel clearance of the switch exceeds the sum of the inside gauge and the flange thickness of the opposite wheel (see figure 33).

Figure 33: This illustration shows the relationship between the inside gauge and the flange thickness of a wheel set on the one hand and the free wheel clearance of a switch on the other hand.

According to TSI-INF, the free wheel clearance in a switch must be less than 1380 mm. Only when demonstrated that the switch (including point machine) can withstand blade hitting, this standard may be deviated from. This standard for the free wheel clearance is matched to the regulations for the geometry of wheel sets: the TSI-RS demands that on wheel sets, the inside gauge is more than 1357 mm and the flange thickness more than 23 mm (as a consequence of which the sum of the two distances is at least 1380 mm).

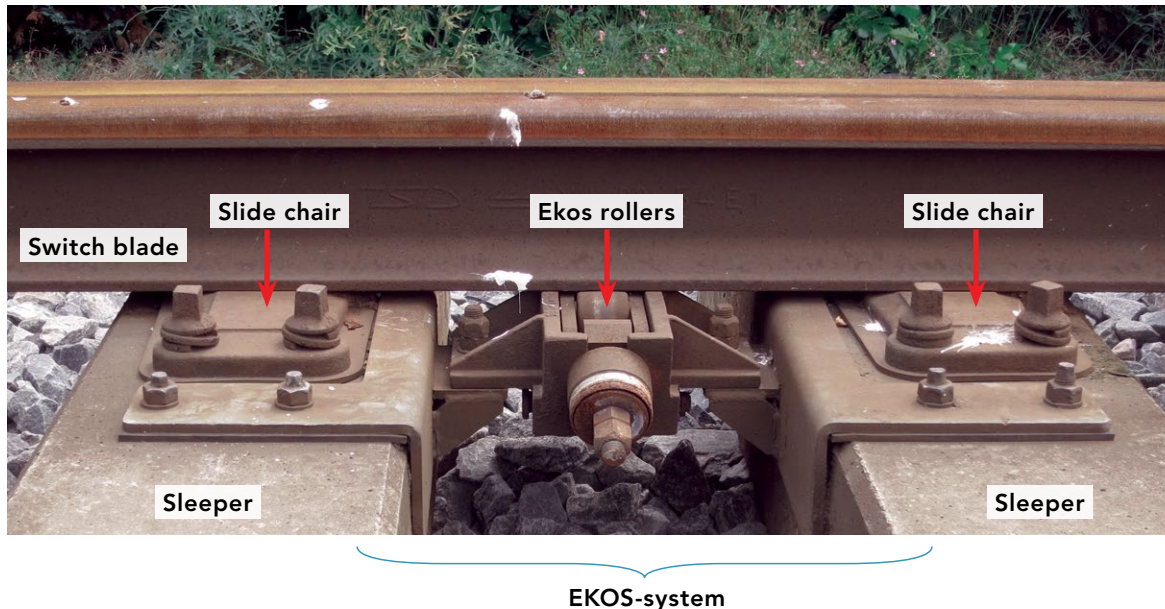
Figure 35: The photograph shows the Ekos-V system of switch 3B.

The Ekos-V system of the right-hand switch blade of switch 3B proved to be so badly worn that the rollers no longer protruded above the slide chairs [Source 1]. This situation must have continued for some time, because the slide chairs themselves also showed considerable wear (see the photographs in figure 36). The lower left-hand photograph shows the worn Ekos-V system. The lower middle photograph shows the underside of the right-hand switch blade; this photograph shows that the frame and the rollers of the Ekos-V system are stamped into the underside of the switch blade. The lower right-hand photograph shows one of the slide chairs; this photograph shows that – both below the switch blade and below the stock rail – the slide chair is severely worn. Due to the fact that the Ekos-V system no longer functioned, the mid-section of the right-hand switch blade, when moving to the open position, must have remained so close to the stock rail, that it could be run hit by the inside of the passing train wheels.

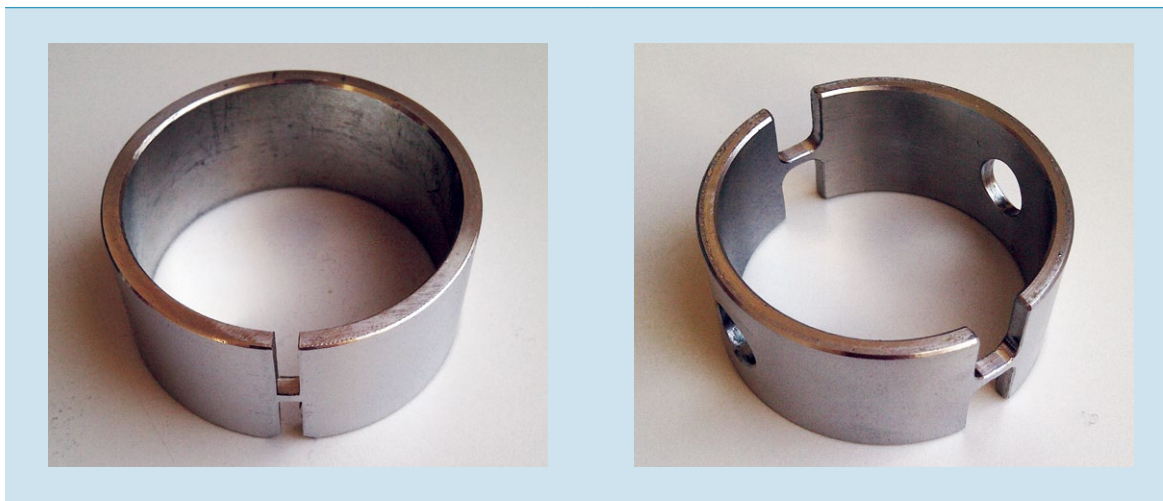
On the basis of the investigation results, Bombardier concluded at the time that the fractures had probably been caused by incorrect installation or maintenance of the locking rods. For that reason, the decision was made to adjust the design of the ring in such a way that the incorrect practice could no longer occur. To ensure that the breaking strength of the ring remained within the intended boundaries, the rings were designed with two break links instead of one. It was also decided to round the corners of the break links (which was not the case in the original design). The rounding of the corners was intended to make the rings less susceptible to fatigue. The photographs below show the original (left) and modified (right) ring design. On the instructions of ProRail, the modified ring design went through a series of fatigue tests at the time, and the results revealed no grounds for further alterations.³⁸

Figure 38: The left-hand photograph shows a ring of the original type (with a single break link and square corners); the right-hand photograph shows the modified version (with two break links and rounded corners). (Source: ProRail)

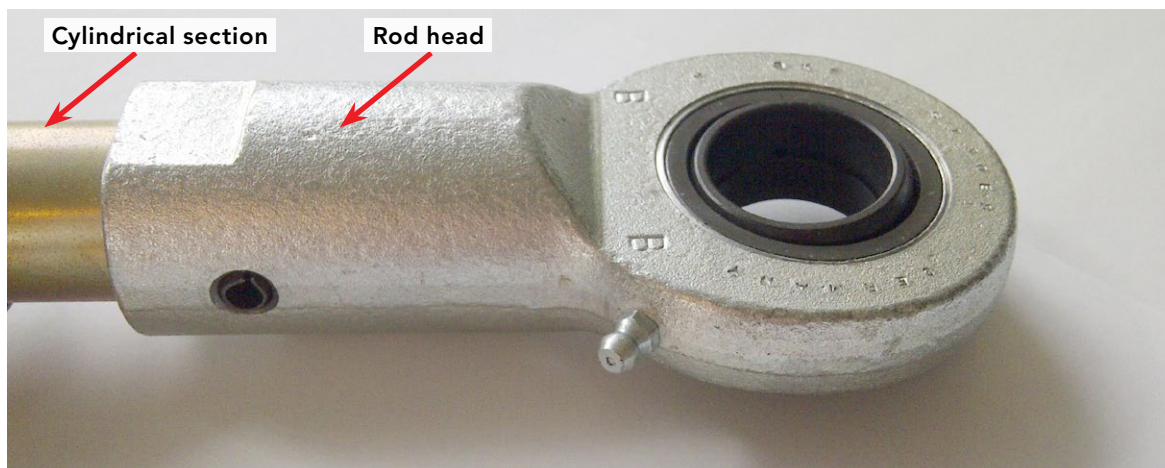
Figure 39: This photograph shows the original design of the rod head whereby the rod head was attached to the cylindrical section with a threaded connection. (Source: ProRail)

In the first incident, which occurred in April 2008 at switch 1373-A in Kijfhoek, the threaded connection demonstrated excessive wear and serious corrosion (see the left-hand photograph in figure 40). In the second incident, which occurred in August 2008 at switch 215 at Herfte junction, the threaded connection of the rod head had become loose (see right-hand photograph in figure 40). In both cases, the tension pin (intended to prevent unwanted twisting) had fractured.

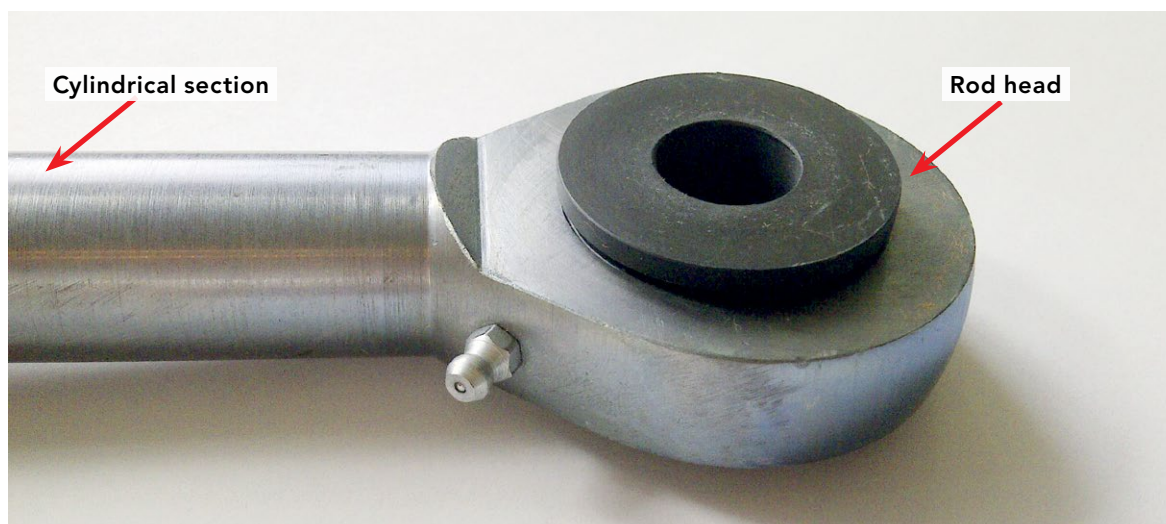
Figuur 41: This photograph shows the modified design of the rod head whereby the head and the cylindrical section are manufactured in single section.(Source: ProRail)

On the basis of these investigation results, Bombardier decided at the time to adjust the design of the rod heads in the sense that both components which were originally joined together by a threaded connection (and tension pin) were manufactured in single section. (see figure 41).
