Rail Accident Investigation Branch

Rail Accident Report

Wagon derailment at York station 18 January 2006

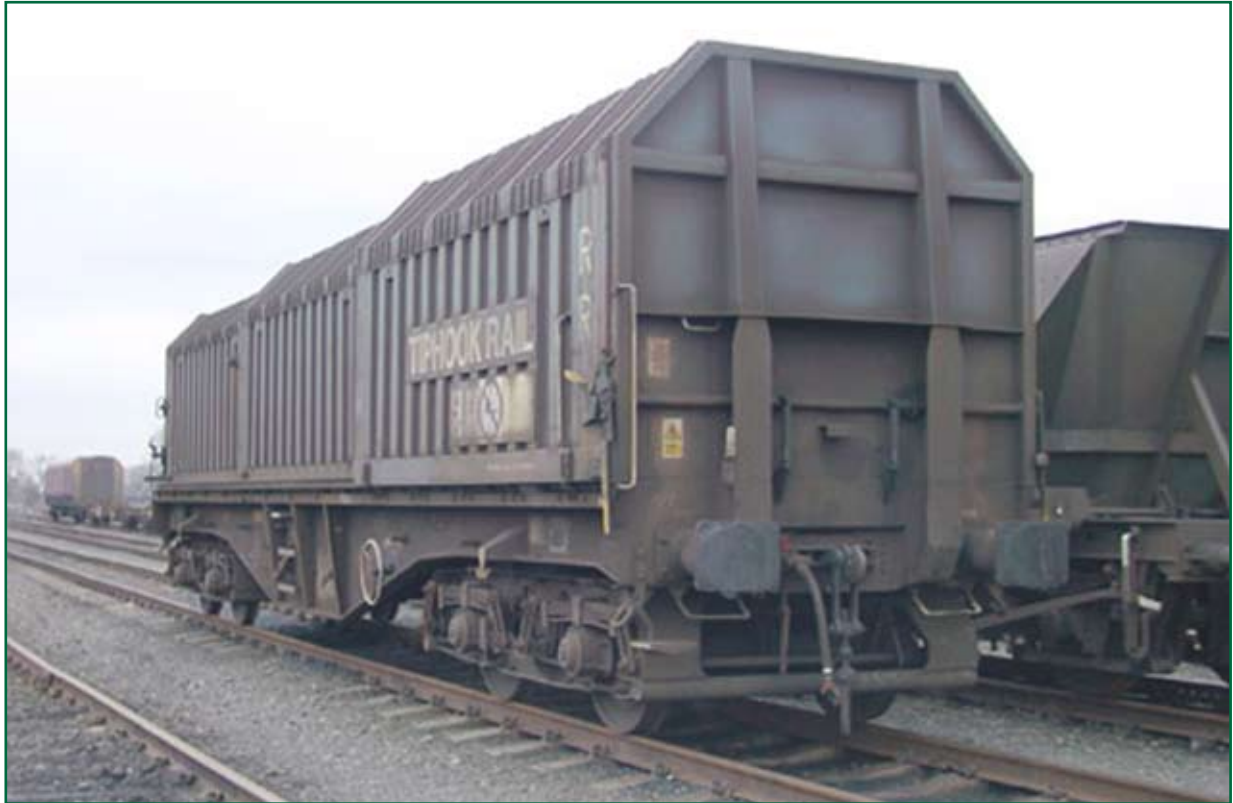
Figure 2: Wagon 7008990380

- 14 Wagon 7008990380, empty at the time of the incident, was the fifteenth wagon from the locomotive. A photograph of the wagon is shown in Figure 2.
- 15 The wagons were designed and certified for international traffic in accordance with the *Regolamento Internazionale Veicoli* (RIV) regulations of the *Union Internationale des Chemins de Fer* (UIC). The design of the wagons was scrutinised for compliance with UIC codes (standards) rather than Railway Group Standards. By this process, compliant wagons are considered to have satisfied the requirements of Railway Group Standard GM/RT2000, Engineering Acceptance, and are approved for use on Network Rail Infrastructure.
