Rail Accident Investigation Branch

Rail Accident Report

Collision at Badminton 31 October 2006

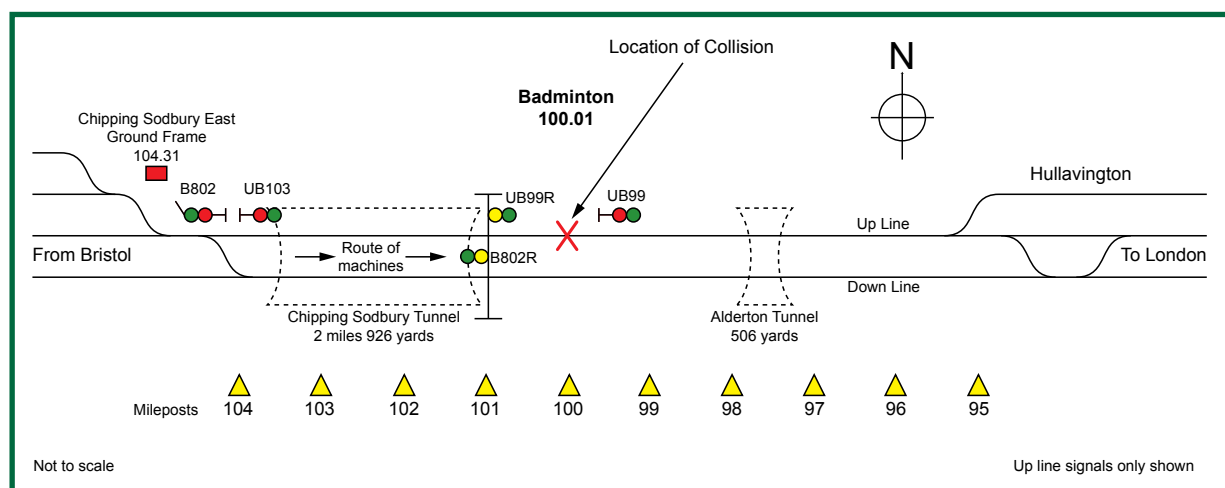
Figure 3: Schematic diagram

- 21 At this point the railway is double track, and in normal operation trains are permitted to run at up to 125 mph (200 km/h). The line from Chipping Sodbury (104 miles 31 chains) to Badminton (100 miles) is on a rising gradient of 1 in 300. Chipping Sodbury tunnel (which is 2 miles 926 yards (4.1 km) long) extends from 103 miles 48 chains to 101 miles 6 chains (Figure 3). The route is almost straight, with a slight left-hand curve approaching Badminton. Signalling on the line is by the *track circuit block* system, with two, three and four aspect colour light signals controlled from Bristol *panel signal box*. However, the signalling system was not being used to control the machines involved in the collision (paragraph 35).
