Rail Accident Report

**Dispatch of a train with an unsecured load,
Basford Hall Yard, Crewe
21 February 2006**

This report is published by the Rail Accident Investigation Branch, Department for Transport.

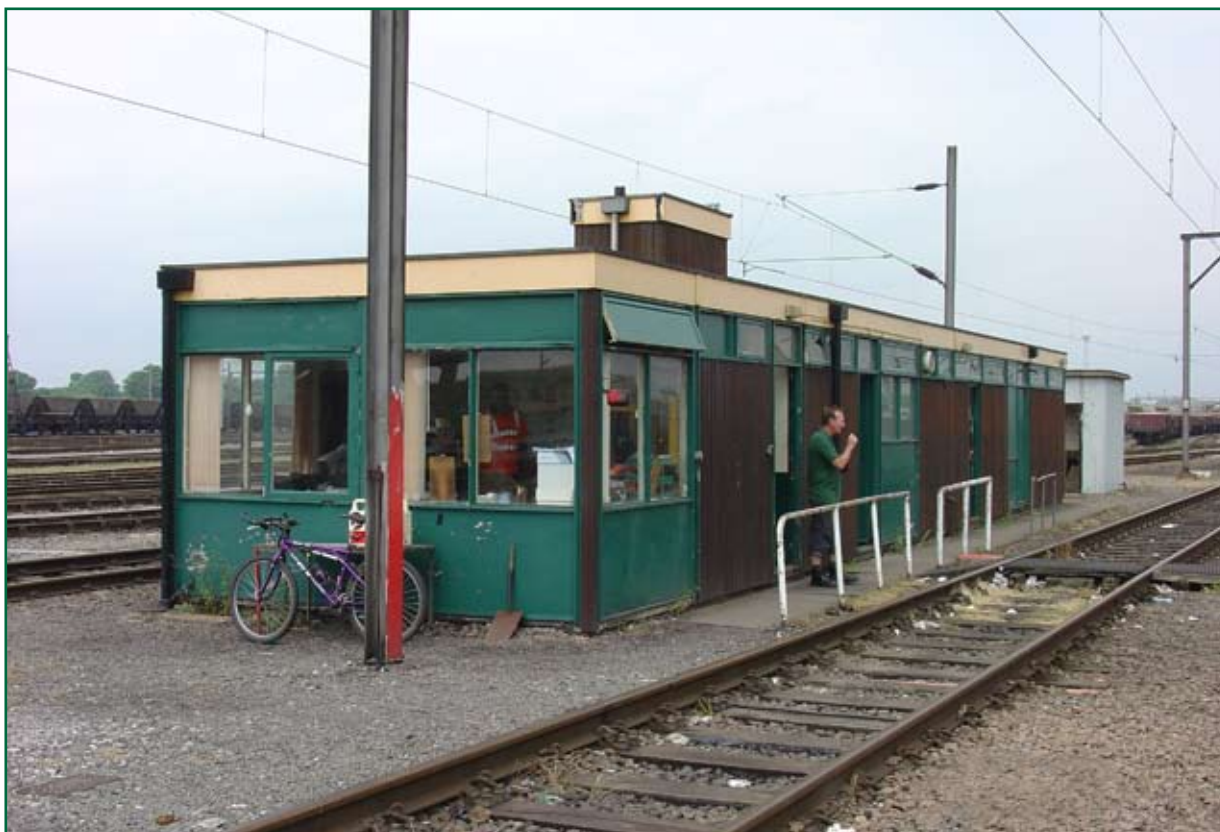
Figure 3: The middle cabin

- 17 Train 6D51 was *marshalled* and prepared in Basford Hall Yard, Crewe. This is a large marshalling yard 1.5 km south of Crewe station, Cheshire (see Figure 1).
- 18 This incident involved sidings MO9 to MO13. These are located towards the south end of the yard on the eastern side. The sidings were constructed in 2003 (see Figure 2).
- 19 Basford Hall Yard has two cabins for shunting staff. The north cabin is towards the north end of the yard; the middle cabin is towards the south end of the yard (see Figures 2 & 3).

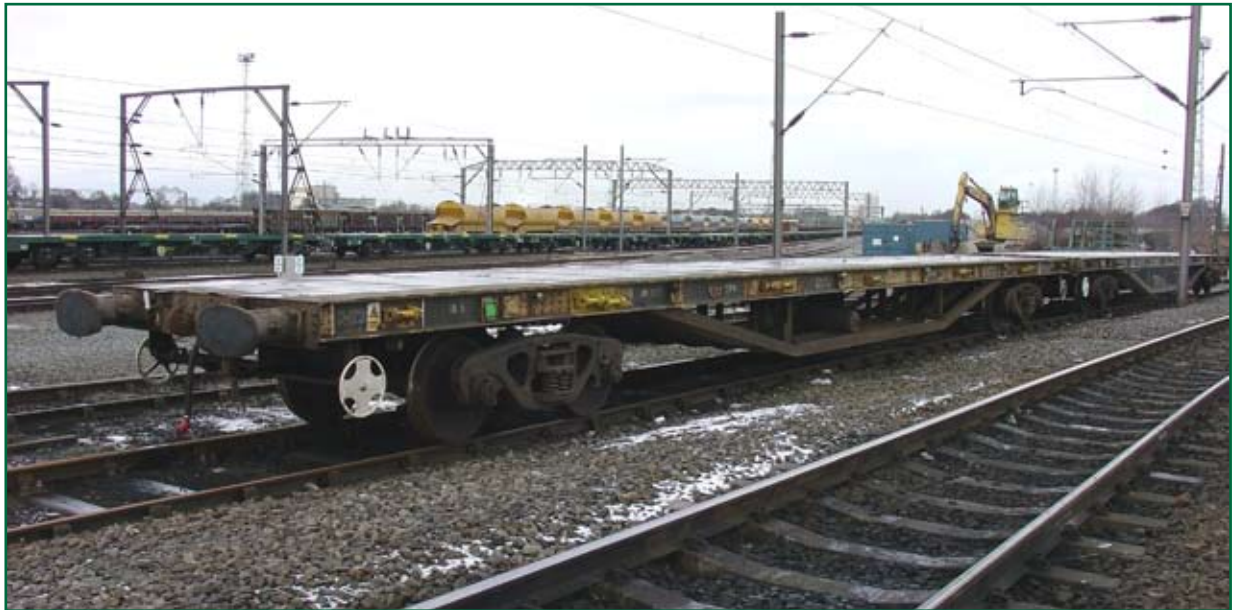
Figure 6: YSA or YWA wagon

- 5 On its journey from Crewe to Toton (near Nottingham) on 21 February 2006 train 6D51, hauled by two *class 67 locomotives*, incorrectly contained 14 *Salmon wagons* with unsecured loads of redundant *track panels*.

- 41 YSA and YWA ‘Salmon’ wagons are flat wagons with two bogies and without sides. They are 20 m in length.

- 87 Train 6D51 was viewed and photographed at Toton on 22 February 2006 in the condition it arrived from Basford Hall. Only one strap was in place over the track panels on one of the wagons. A number of other straps were found loose on the load. It was not possible to determine how many straps had been removed by TMA at Basford Hall, and how many fell from the wagons during the journey.

144 The loaded Salmon wagons had originated from two work sites. It was observed that wagons from both work sites had examples of poor loading including, two unsupported sleepers and one partially rotted sleeper end, any of which may have fallen from the train.
