Rail Accident Investigation Branch

# Rail Accident Report

## Passenger train derailments on the Ravenglass & Eskdale Railway 29 May & 5 July 2006

Report 07/2007  
March 2007

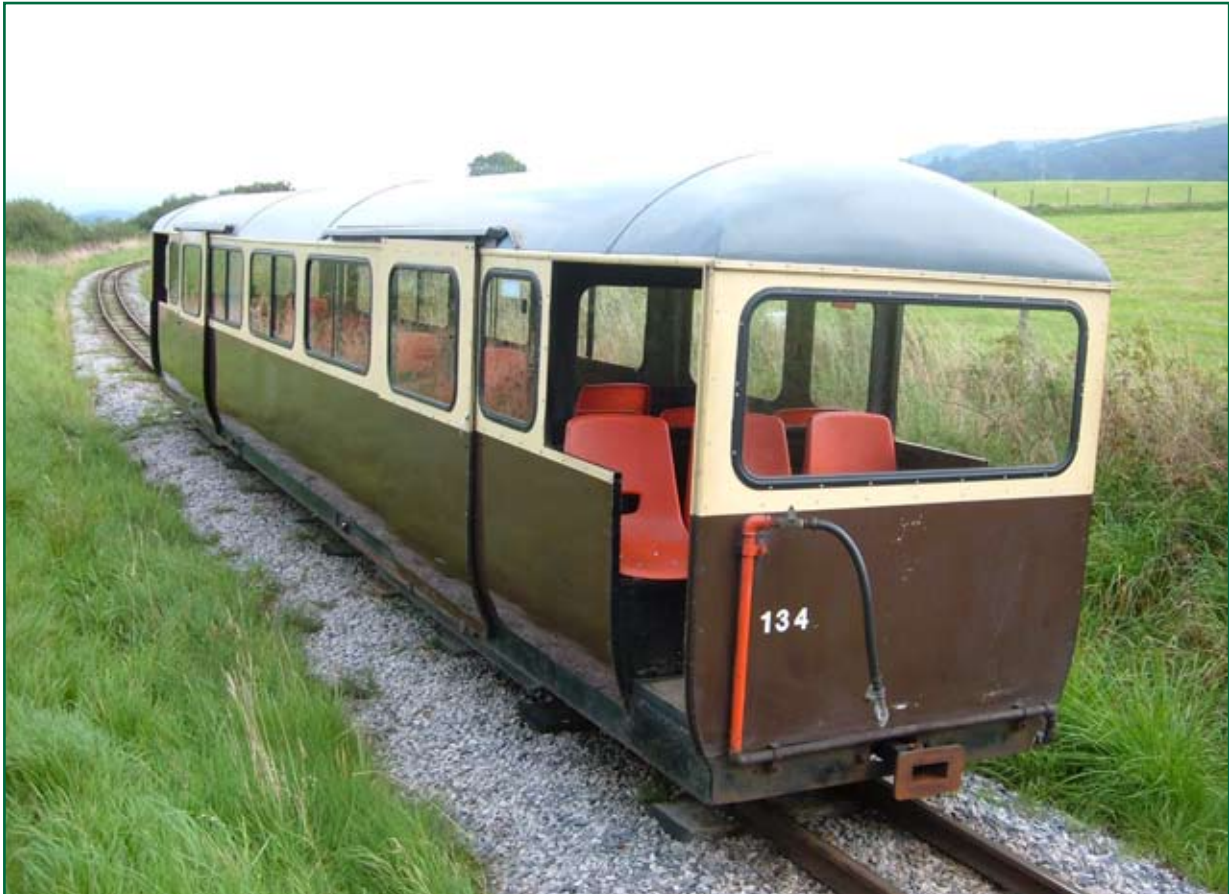
Figure 4: 'Maxi' Coach No. 134

- 34 The train entered the left hand curve at Spout House Farm, located between the stations at Beckfoot and Fisherground (Figure 1) at a speed of 12-13 mph (19-21 km/h). As coach 134 exited the curve, its leading bogie derailed to the right hand side of the track. The bogie's right hand side suspension then collapsed and the equalising beam and springs (Figure 6) on that side came adrift. Both wheelsets remained sufficiently guided by the bogie frame for the wheels to continue running on the sleepers with the vehicle body upright. The derailment site is shown in Figure 2.

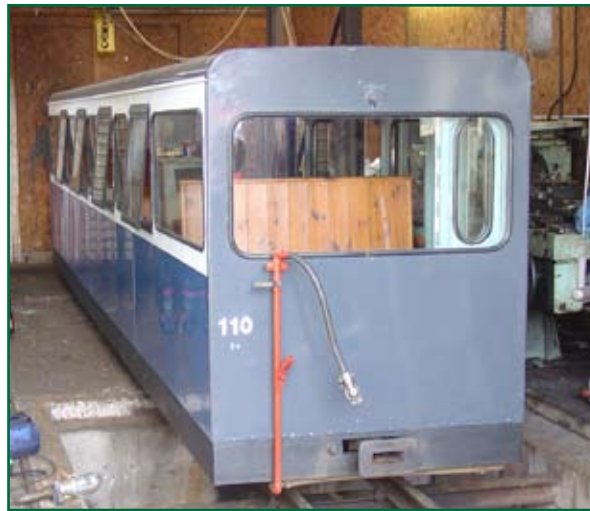
Figure 7: Saloon Coach No. 110

- 72 At around 10:45 hrs and at a location approximately 180 m from Miteside Halt, the leading wheelset of coach 110 derailed to the right hand side of the track. The derailment site is shown in Figure 3. Neither the driver nor the guard were aware of the derailment and the train continued towards Muncaster Mill in this condition. There were no passengers in coach 110.
