Rail Accident Investigation Branch

Rail Accident Report

**Derailment in Hooley Cutting, near Merstham,
Surrey
13 January 2007**

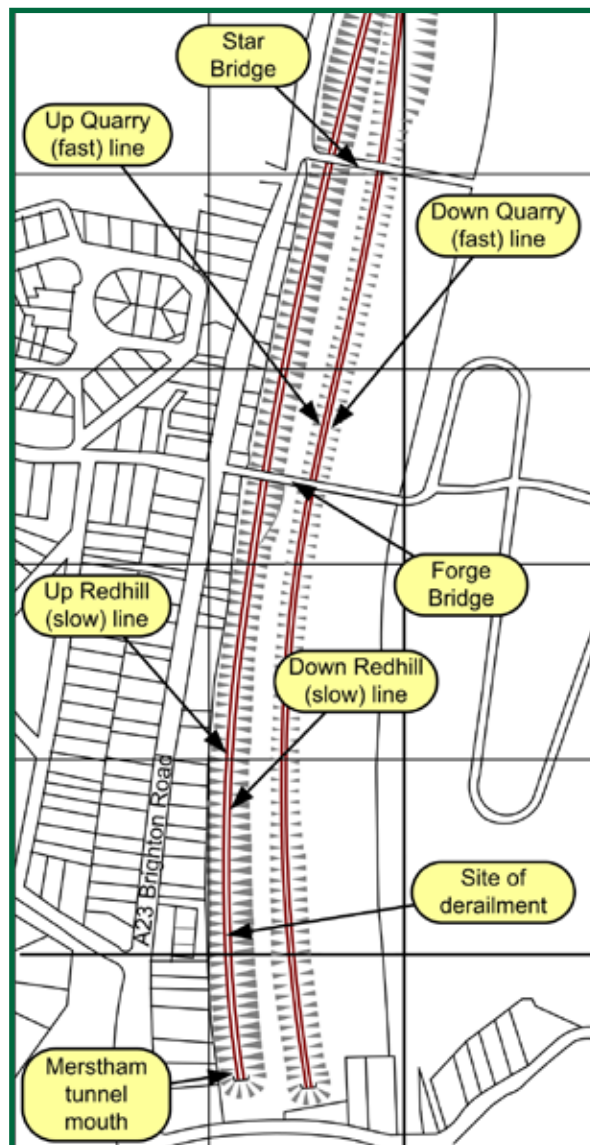
Figure 2: Drawing of railway lines in and around Hooley cutting

- 73 The area identified at highest risk lay between two road overbridges: Forge Bridge and Starr Bridge (Figure 2). Here a 500 mm reinforced concrete beam was installed at the top of the cutting. It was supported by a grid of concrete columns and beams supported by piles from the bottom and face of the cutting. A chain link catchment fence was installed at cess level along part of the route.

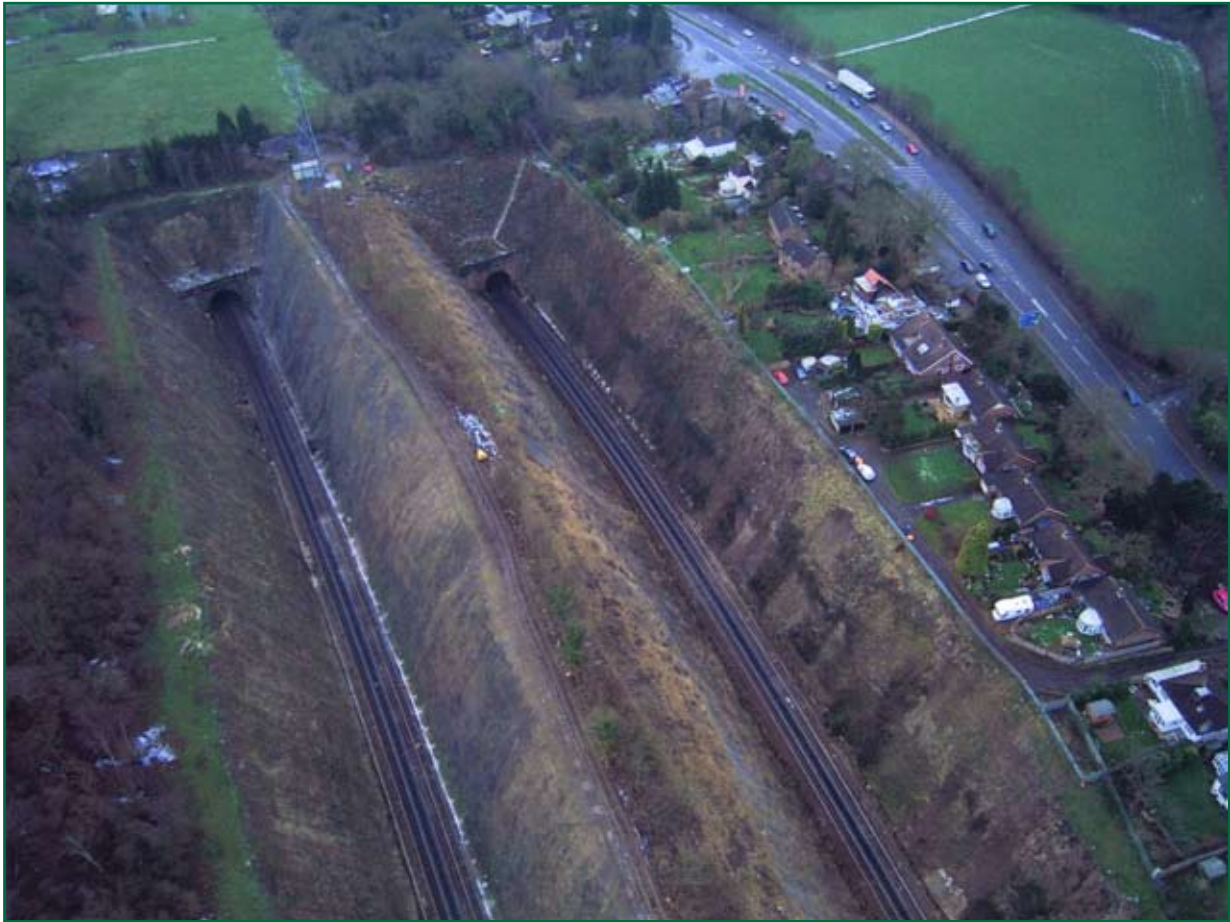
Figure 4: Aerial photograph of the two lines at Merstham in 2007. The Redhill slow lines are on the right and the Quarry fast lines on the left (courtesy of Network Rail)

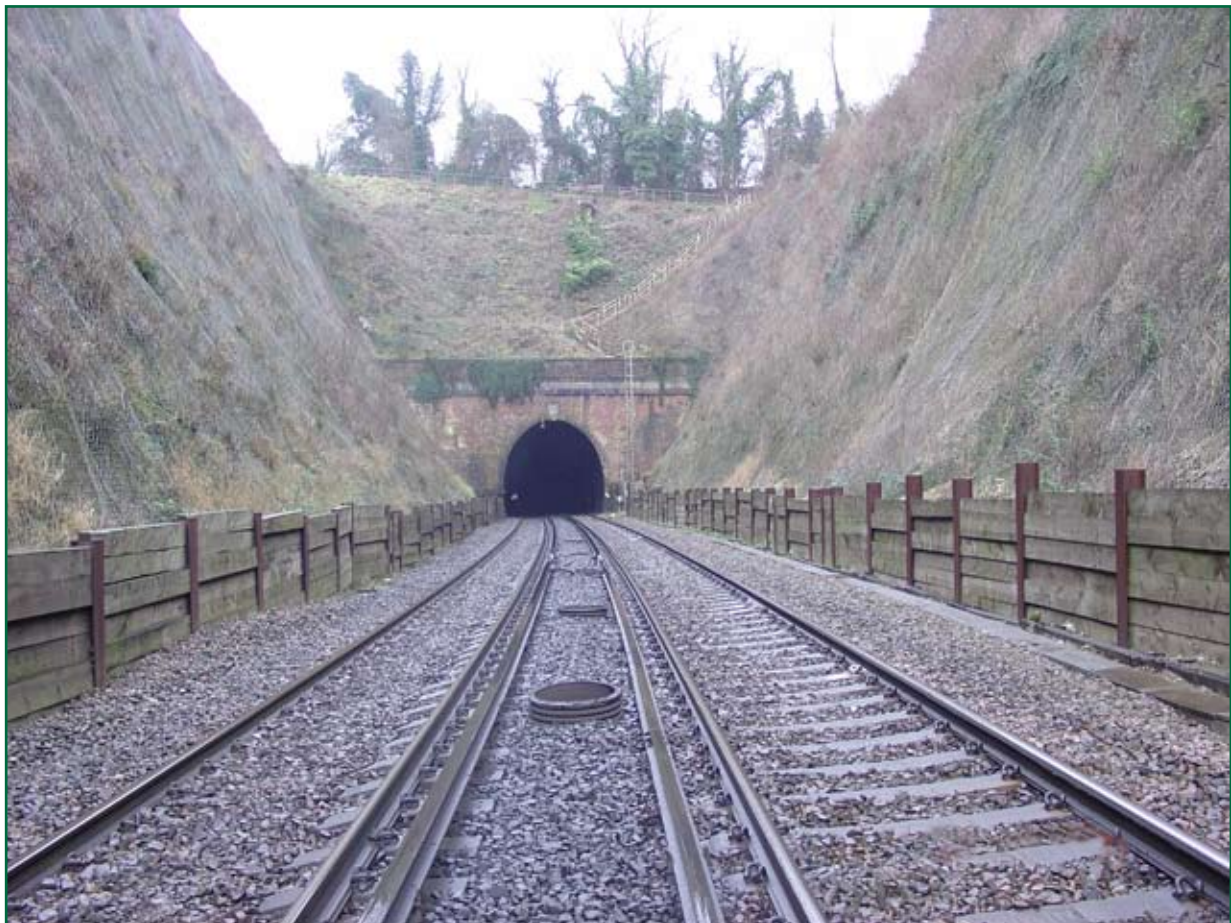
Figure 7: Hooley cutting viewed from the site of the derailment looking towards the tunnel mouth.

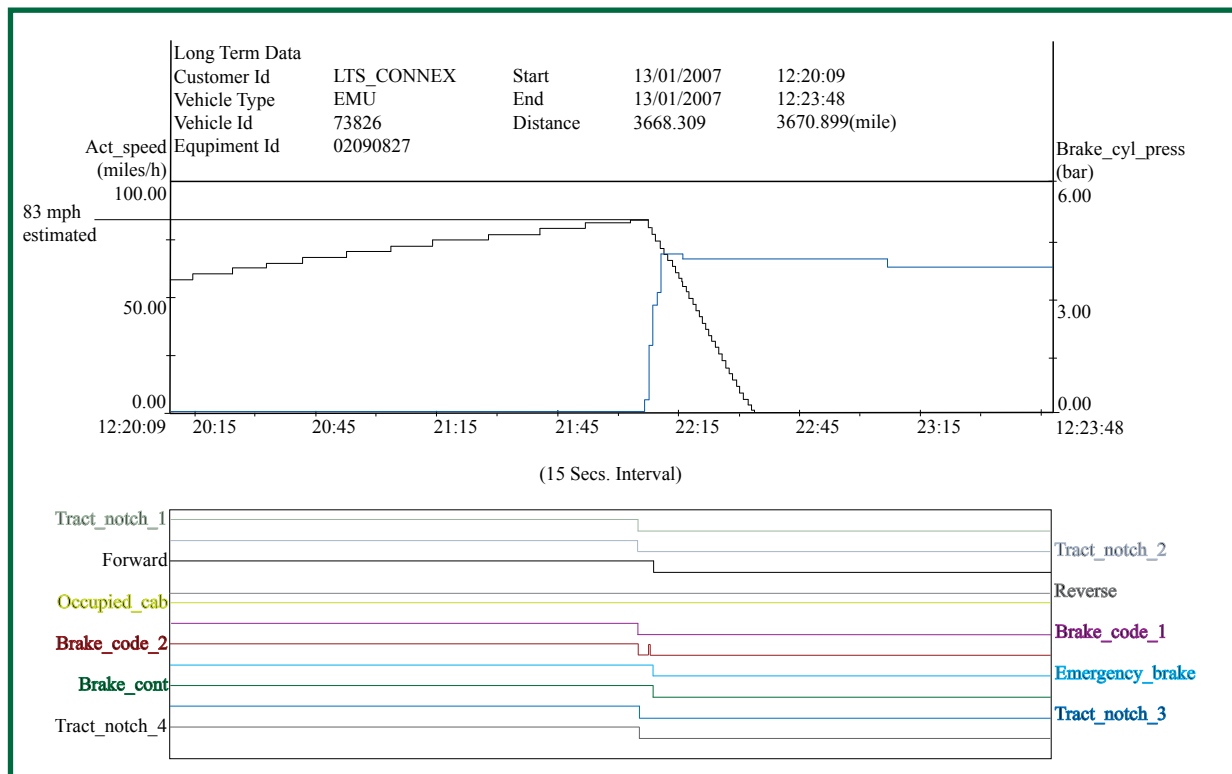
Figure 10: Output from the OTDR

- 32 The train was fitted with a Secheron *On-Train Data Recorder* (OTDR). This was downloaded at Selhurst depot and provided details of the train speed and the status of power and braking functions immediately before the collision (Figure 10).
