# Rail Accident Report

## **Derailment at Wigan North Western station 25 August 2009**

A derailment occurred on the night of 25/26 August 2009 at Wigan North Western station. A container train travelling from Glasgow to Manchester and Birmingham was slowing down to stop at Wigan when one of its wagons derailed. The wagon which derailed was an empty container wagon and its front bogie derailed at low speed whilst running round a sharp curve into the platform.

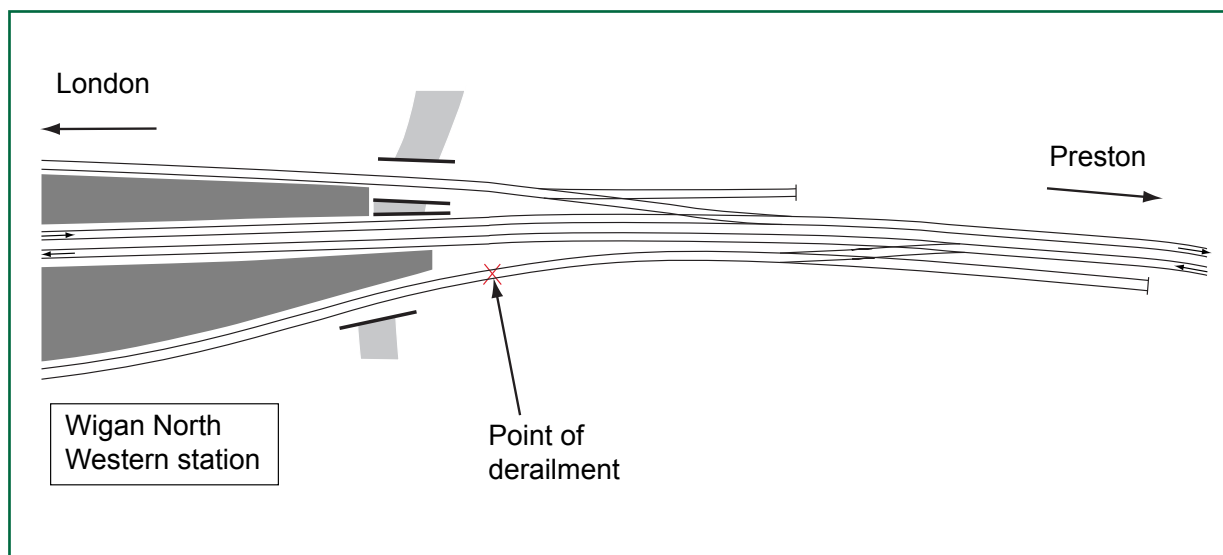
Figure 3: Plan of the site

- 6 The train was slowing down to stop and was travelling at 12 km/h (7.5 mph) at the time the derailment occurred on a left-hand curve on *plain line* to the north of the platform (figure 3). Slight damage was caused to the track and the derailed wagon. Some signalling cables were damaged in the derailment and the track through platform one was closed for 24 hours while repairs were undertaken.
