Rail Accident Report

Derailment of a Docklands Light Railway train near West India Quay station, London, 10 March 2009

This report is published by the Rail Accident Investigation Branch, Department for Transport.

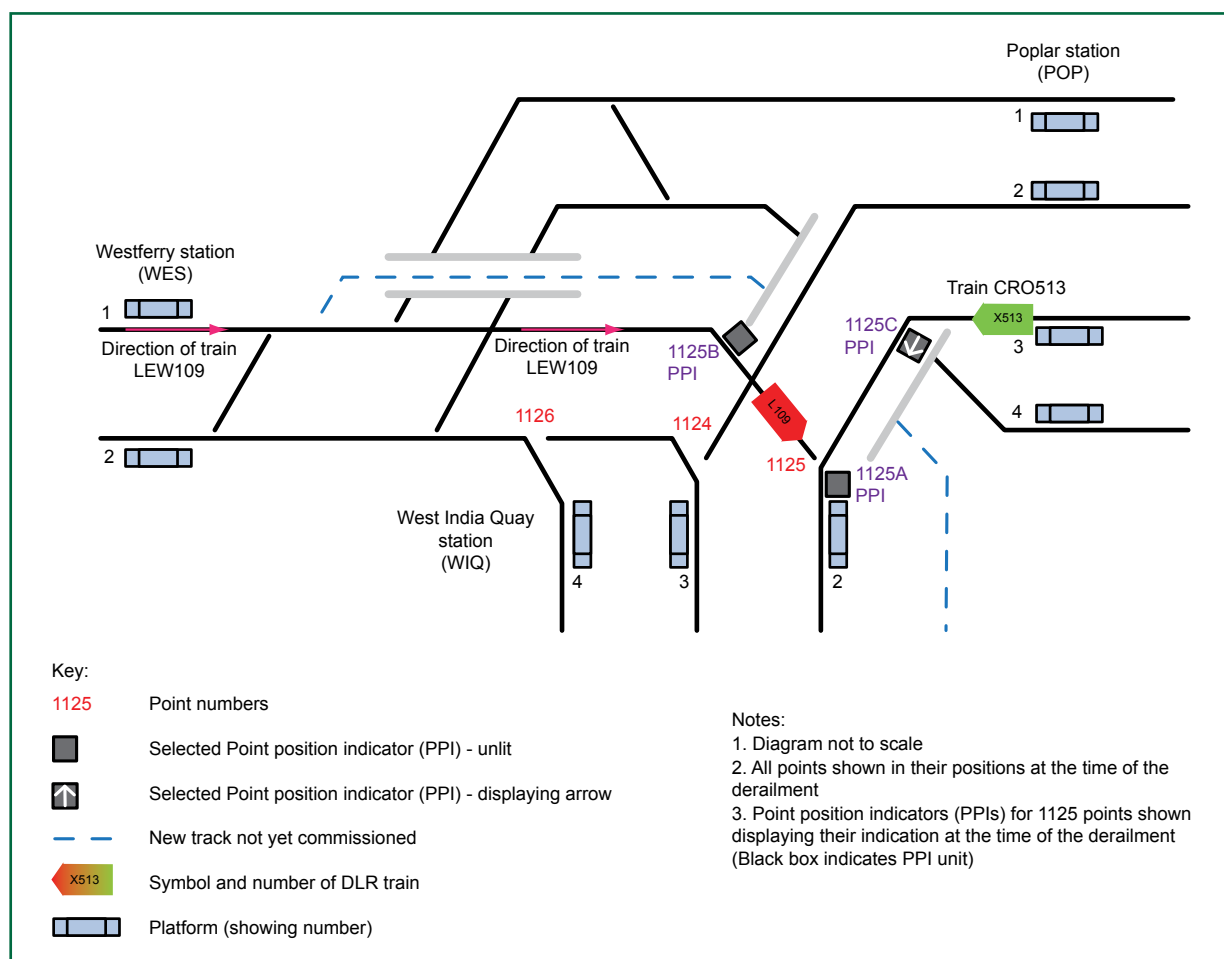
Figure 2: Diagram of the location of the derailment at North Quay Junction

- 12 At 10:02 hrs on 10 March 2009, the 09:50 hrs DLR service from Bank to Lewisham (train LEW109) became derailed by both axles of the leading *bogie* as it travelled through a set of trailing points that were not correctly set for the route of the train at North Quay junction, just north of West India Quay station.
- 13 The train had undergone an earlier automatic emergency brake application initiated by a failure of the signalling between Westferry and West India Quay stations, and was being driven by a passenger service agent in emergency shunt mode.
- 14 The train was travelling at approximately 10 km/h when it derailed on 1125 points at the junction. The front of the train came to rest 10.3 metres after derailing and approximately in line with the top of the end ramp of platform 2 at West India Quay station (figure 2).

- 26 The accident took place on 1125 points at North Quay junction, immediately north of West India Quay station (figure 2). At this location the track is level and constructed on a series of viaduct structures, approximately 9.5 metres above ground level.

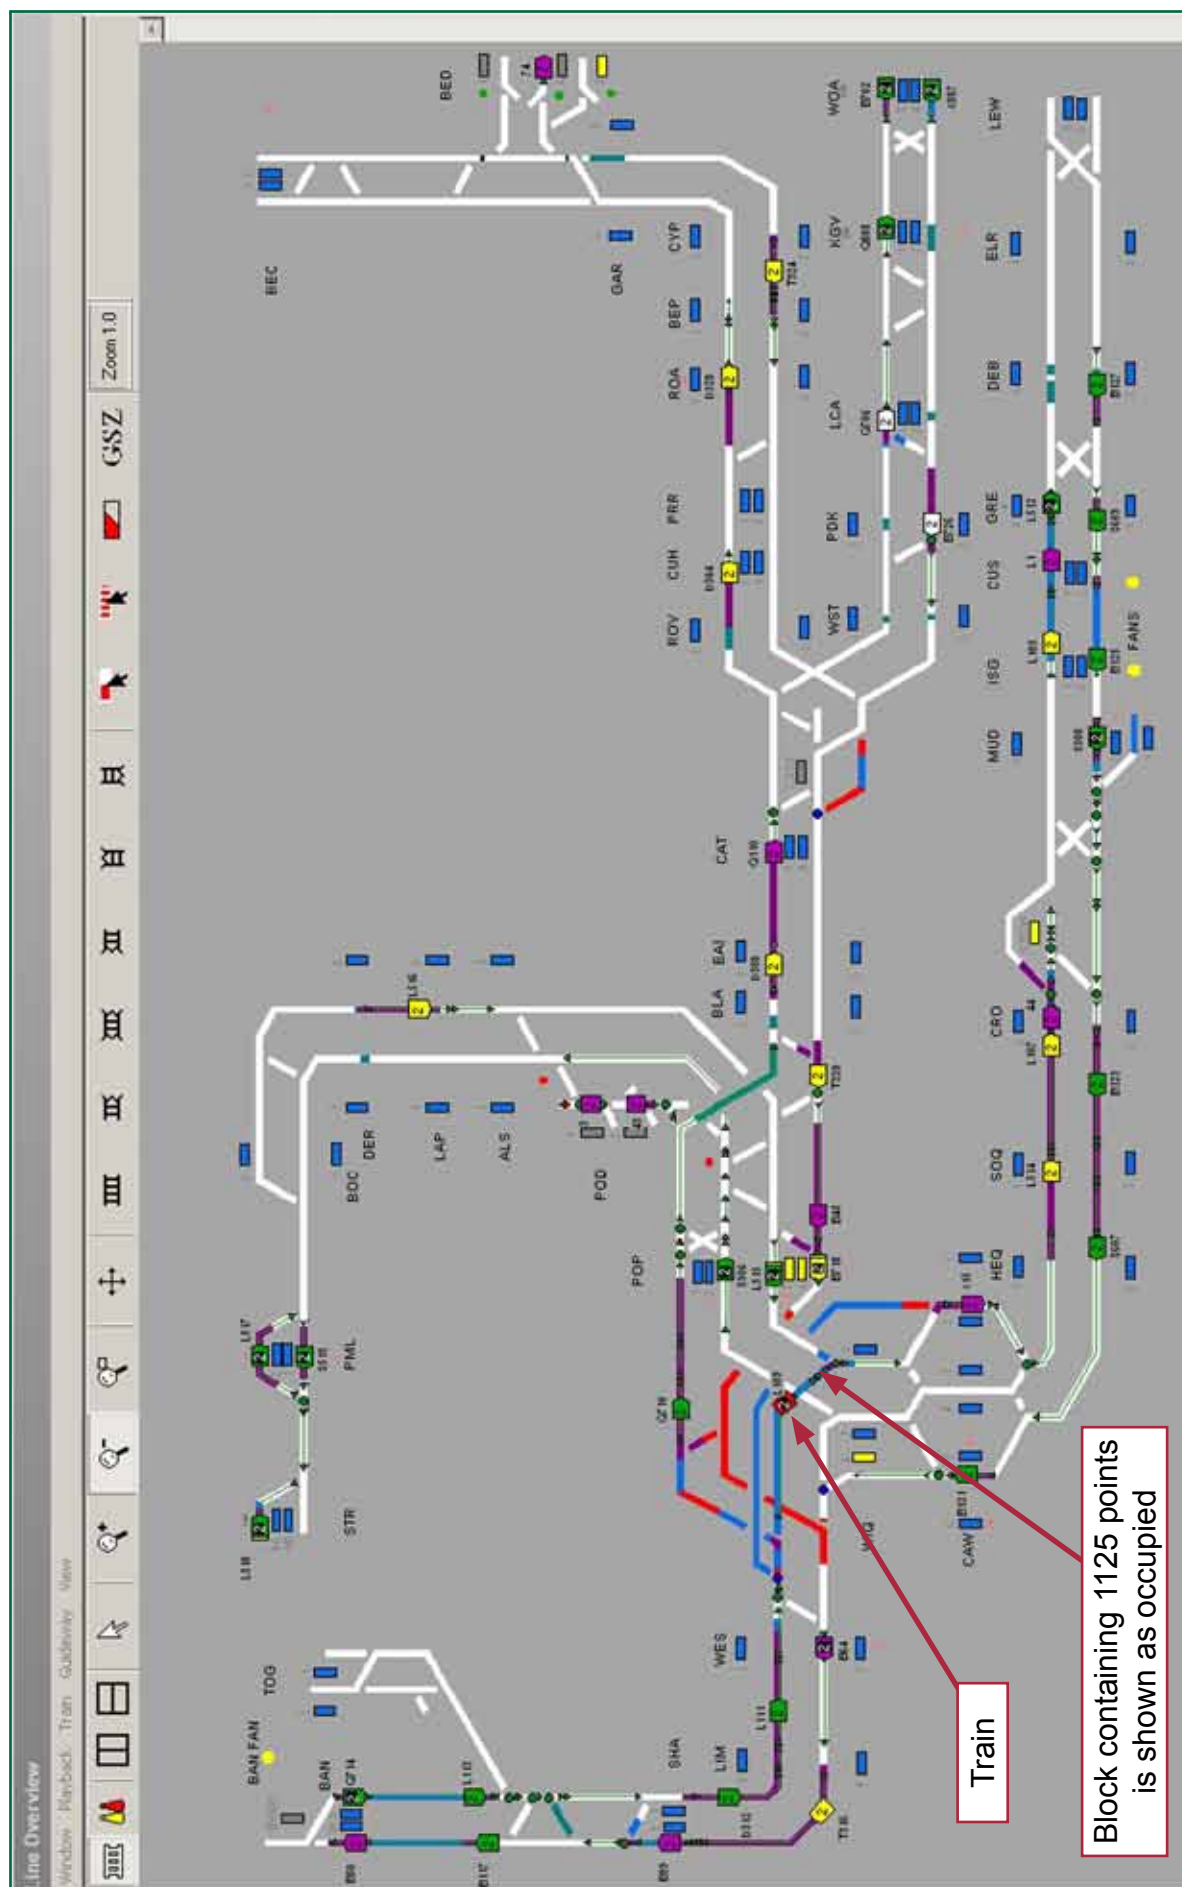
Figure 4: Line overview screen display at 07:42 hrs with the block occupancy turned on

- 78 Figure 4 shows the same line overview screen display as it would have looked if the block occupancy option had been turned on. In this view, the display indicates that the block containing 1125 points is occupied. The effect of the occupied block is that 1125 points cannot be moved.

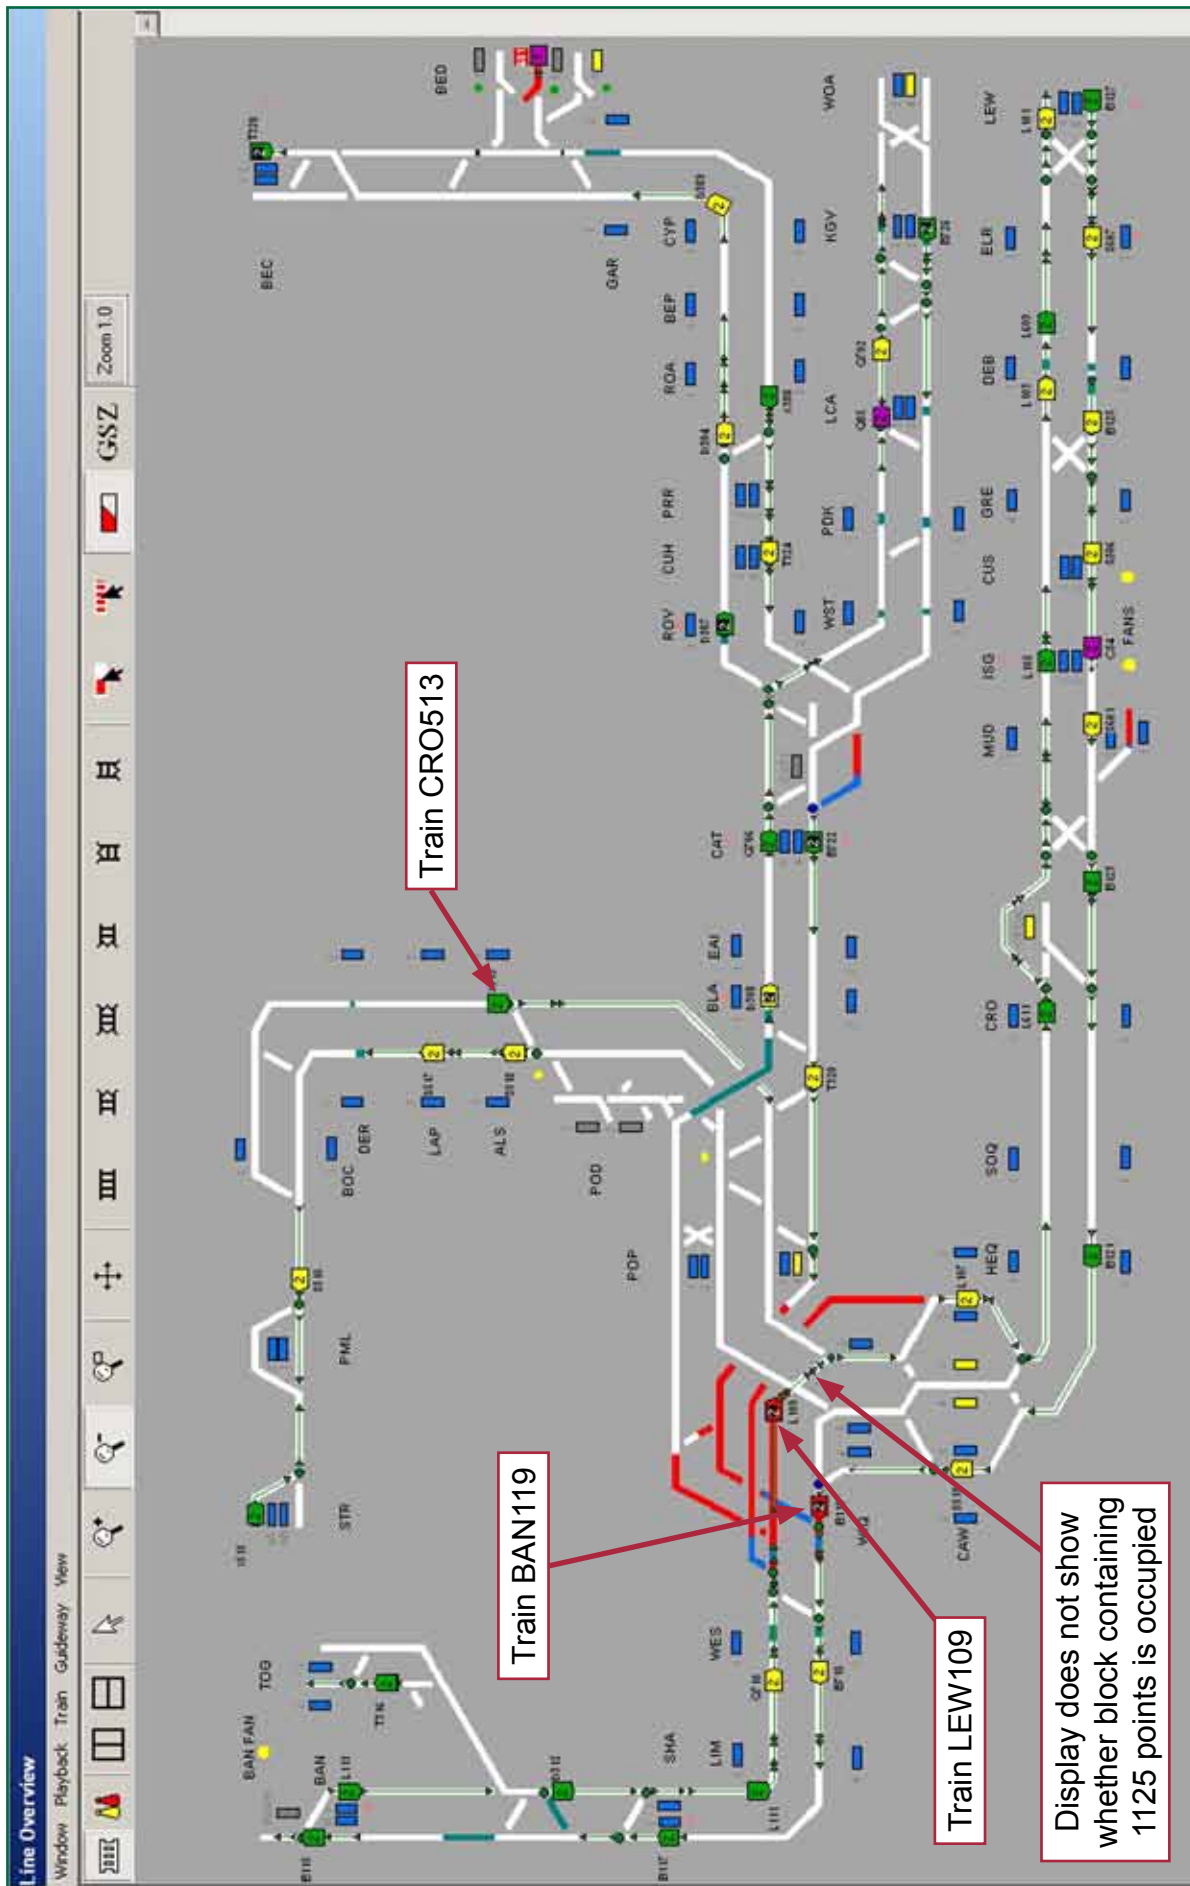
Figure 5: Line overview screen display at 10:00:33 hrs with the block occupancy turned off

- 79 Figure 5 shows the line overview screen that was displayed to the controller at 10:00:33 hrs, approximately two minutes before the derailment. In this case, train LEW109 was 21.1 metres on the approach to 1125B point position indicator. This train (coloured red) can be seen in the delta having just had its automatic emergency brake applied. The green arrows indicated on the track ahead of train LEW109, and the green dot located on 1125 points, indicated to the controller that the VCC system had set and secured the points for train LEW109. Since the block occupancy option was not activated the line overview screen did not indicate whether train LEW109 had occupied the block containing 1125 points.

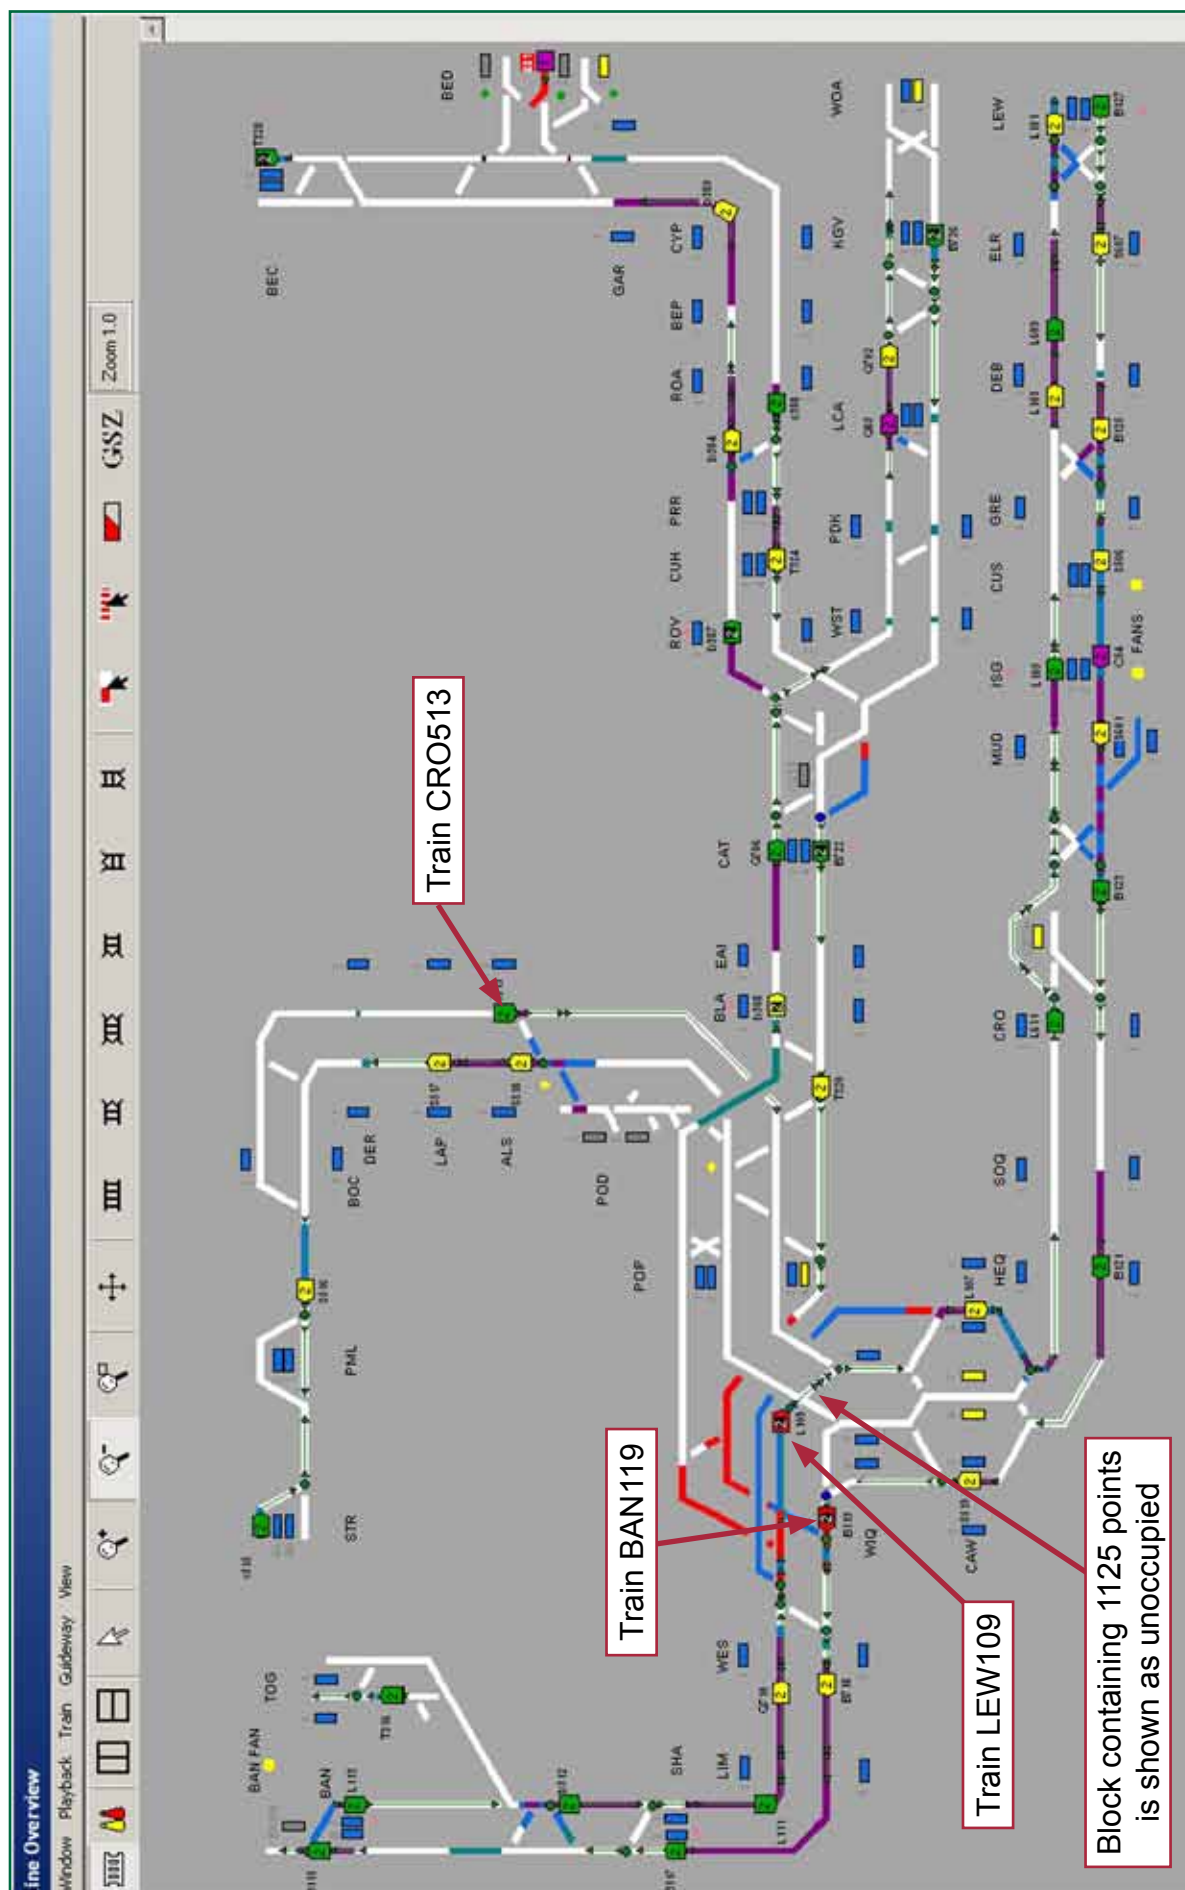
Figure 6: Line overview screen display at 10:00:33 hrs with the block occupancy turned on

- 81 Figure 6 shows the same line overview screen display, as it would have looked if the block occupancy option had been turned on. In this case the line overview screen would have looked similar to that displayed with the block occupancy switched off, but with the addition of blue and purple occupancy indications for each train. However, the screen would also have provided an indication to the controller that train LEW109 had not occupied the block containing 1125 points.
