Rail Accident Report

Bridge strike and road vehicle incursion onto the roof of a passing train near Oxshott Station 5 November 2010

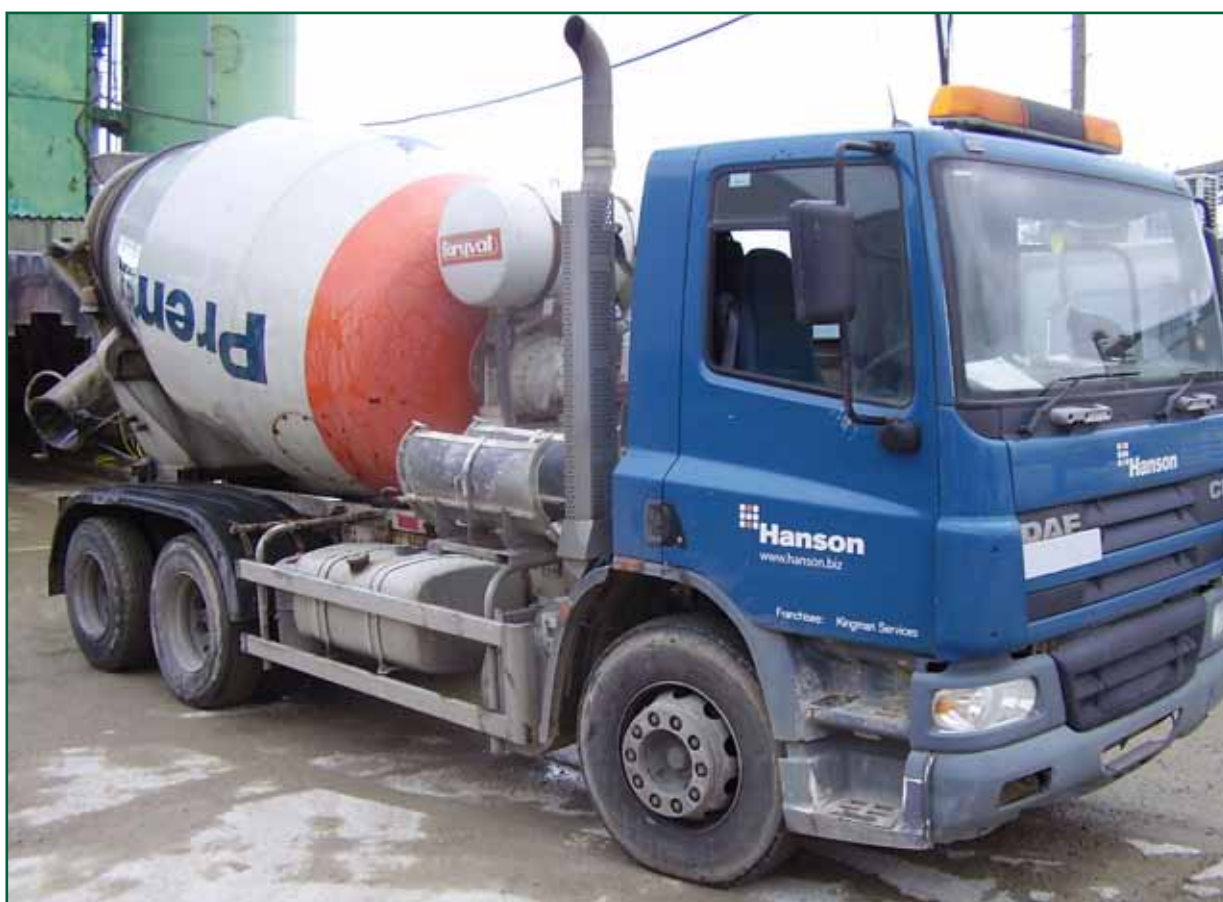
- 20 The lorry involved was a DAF 75 CF three-axle rigid chassis *large goods vehicle* (LGV), first registered in 2005 and fitted with a truck mixer body (figure 3). It had a valid MOT certificate, and examination of the vehicle by an inspector from the vehicle and operator services agency (VOSA) found no pre-existing defect which could have caused or contributed to the accident.

Figure 3: Photograph of a lorry similar to that involved in the accident (photograph courtesy of Kingman Services)
