No.: ŽS - 02/17

## FINAL REPORT ON ACCIDENT INVESTIGATION

Type of accident: Derailment  
Train No.: 62946  
Place: Belgrade, open railway line between Junction “B” and Junction “K”  
Date: August 16, 2017  
Time: 15:30

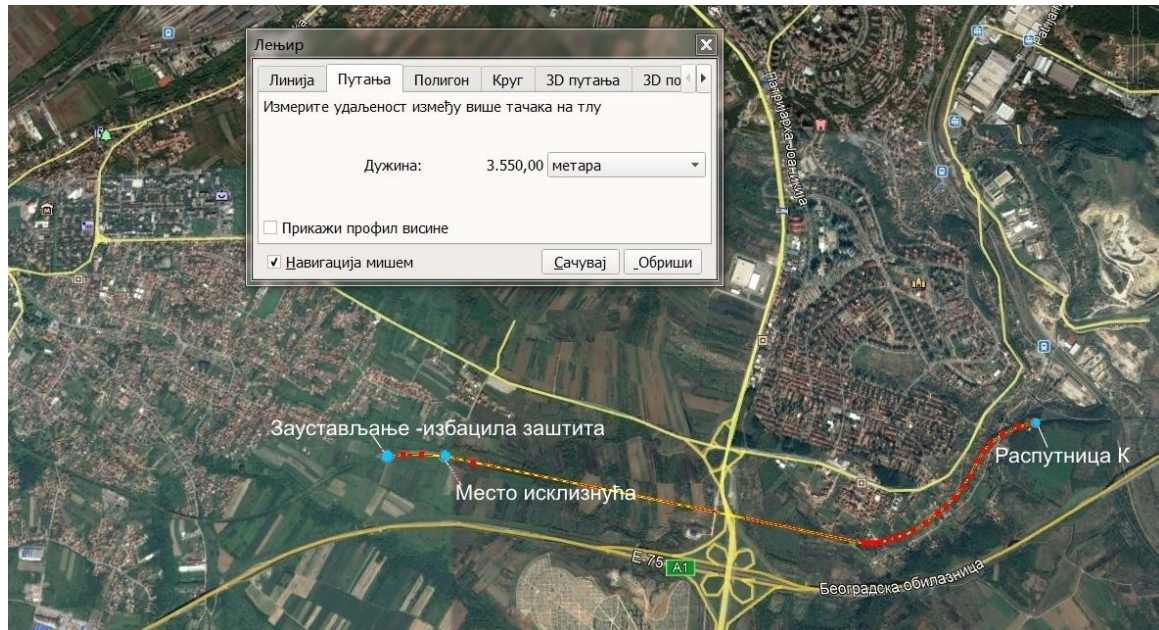
According to the statement of the train driver (Minutes from the interview for the case No. 38/2017-883 from august 23, 2017), after departing from the station Jajinci to the point of derailment (note: obviously here the final stopping is meant after the wagon hit the fence of the bridge), the train had two stops due to the reaction of the protection and the ejection of the main switch.

**Figure 4.2.1.1:** Path crossed from Rasputnica „K“ until the train stopped due to the ejection of the protection (Google Earth)

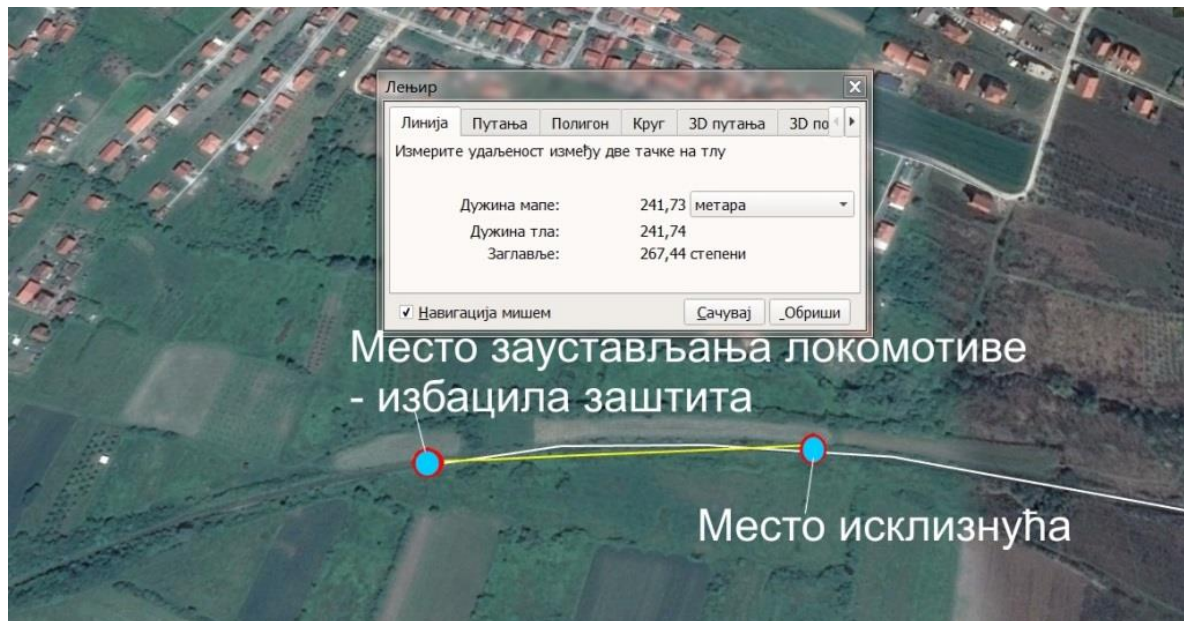
Based on the submitted copy of the speed meter tape of the locomotive 442-512 and the letter from the Section for Train Traction Belgrade No. 3-463: „Information from the speed meter tape“ from August 16, 2017, the locomotive, after departing from Junction „K“, went 3550 m at a speed of up to 19 km/h and stopped. When comparing this to the statement of the train driver, this was the second reaction of the protection. In figure 4.2.1.1 this path is drawn and the point where the front left wheel of the fifth wagon of the train fell into the track is marked. In figure 4.2.1.2 there is a detail from which it can be almost concluded that after this stopping the locomotive was located ca. 240 m behind the point where the wheel fell in. It is very probable that this ejection of the protection happened due to increased movement resistance after the first wheel fell into the track and after the train moved some 70 m with the fallen wheel until the second derailment of the right wheel. The train driver, however, did not notice at that stopping any jolts and once the protection was deactivated he restarted the train.

**Figure 4.2.1.2:** Distance between the point of stopping and the point where the first axle fell into the track (Google Earth)

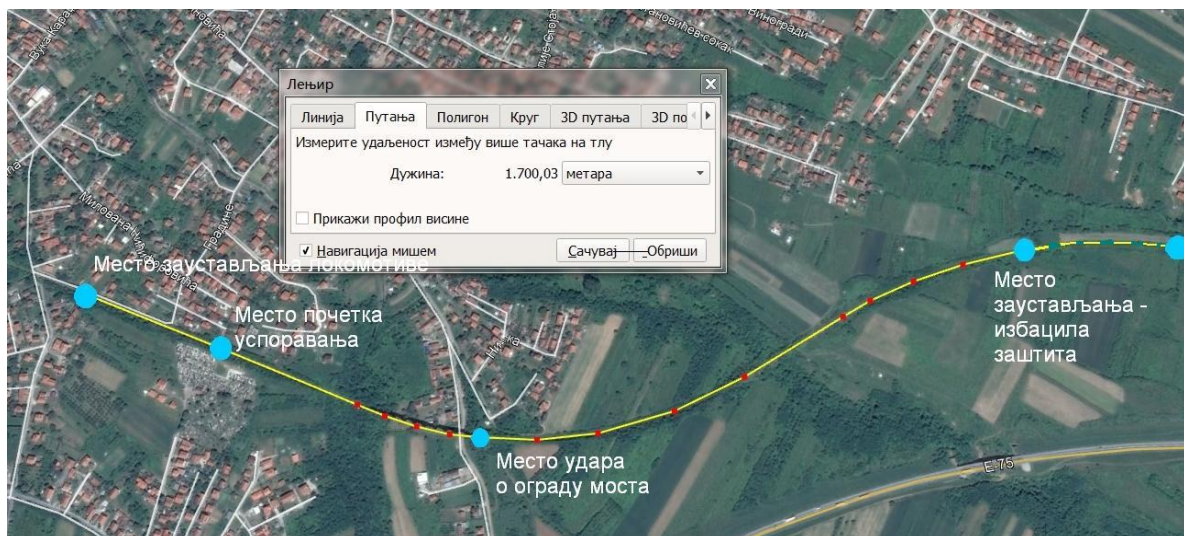
In figure 4.2.1.3 the further movement of the train is shown. After the derailed wagon hit into the beginning of the concrete structure of the bridge, the train driver felt a slight jolt, after which he looked first through the left window, where he did not notice anything. After that he looked through the right window and when he saw the derailed wagon, he initiated full application of the brake.

**Figure 4.2.1.3:** Movement from the ejection of the protection to the final stopping of the train (Google Earth)
