No.: ŽS - 04/17

FINAL REPORT ON ACCIDENT INVESTIGATION

Type of accident:	Derailment of shunting composition
Train No.:	Shunting composition
Place:	Belgrade, open track between junction K1 and station Rakovica
Date:	17 September 2017
Time:	08:45

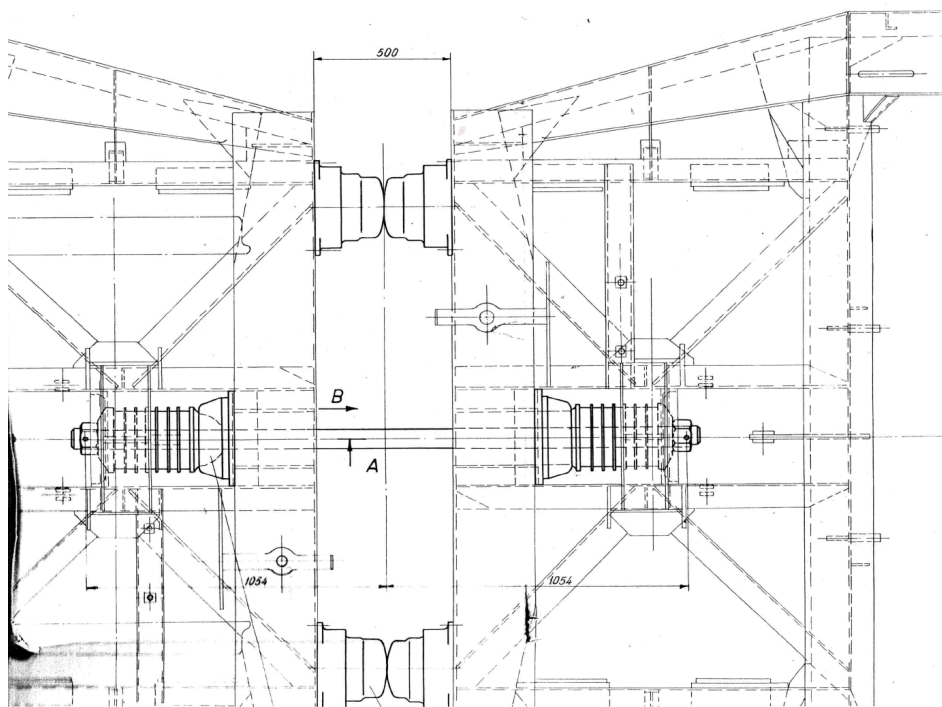
Fig. 4.1.3.1: Traction-reflective devices between wagons

Figure 4.1.3.1. shows a traction-buffing device of wagon of series Faboo and Figure 4.1.3.2. shows the functioning of the traction pole. Between the pole -1 and revolving cup -3, as well as between the thrust poles -1 and the pressure piece -5 there is radial clearance. This should ensure that in urging force is transmitted through the buffer, and drawbar freely slips in the spring, as illustrated in Figure 4.1.3.2. and does not transmit thrust force.

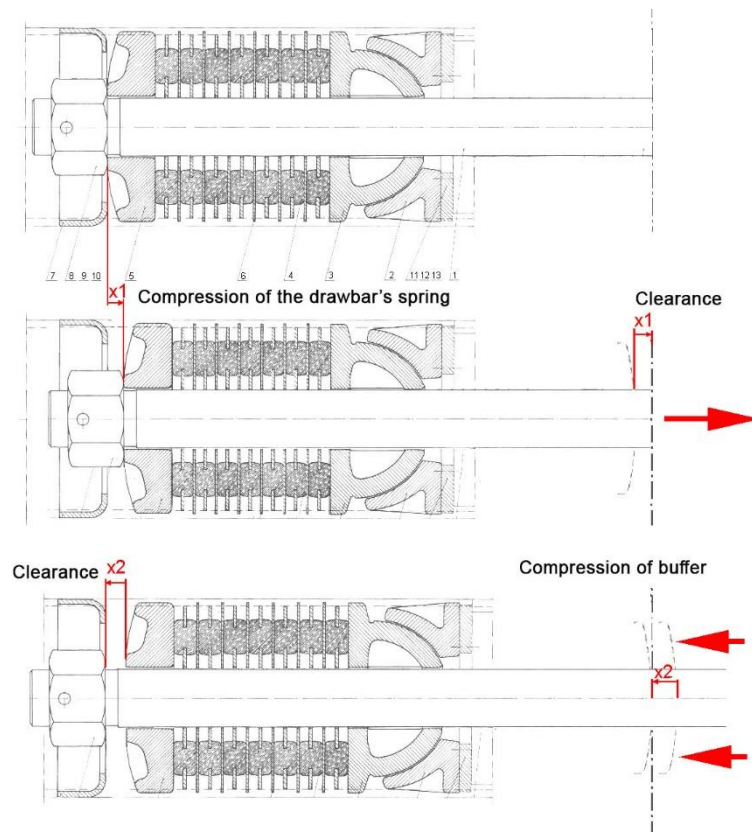
Fig. 4.1.3.2: The manners of operation during the traction and supression

During an investigation after an accident on the shunting composition standing it is determined that on all the buffers between two composite parts of wagon, buffers are apart. Given the fact that shunting composition was stiff, this is not applicable, but it is indicative. At the derailed wagon the situation seen after the derailment is shown in Figure 4.1.3.3.
