REPUBLIC OF SERBIA
CENTER FOR INVESTIGATION OF ACCIDENTS IN TRANSPORT
SECTOR FOR INVESTIGATION OF ACCIDENTS IN RAILWAY TRAFFIC
AND INTERNATIONAL COOPERATION
Nemanjina 11, 11000 Belgrade

FINAL REPORT ON ACCIDENT INVESTIGATION

Type of accident:	Derailment of train
Train No.:	56990
Place:	Despotovac, open track between stations Svilajnac and Despotovac
Date:	11 November 2017
Time:	15:25

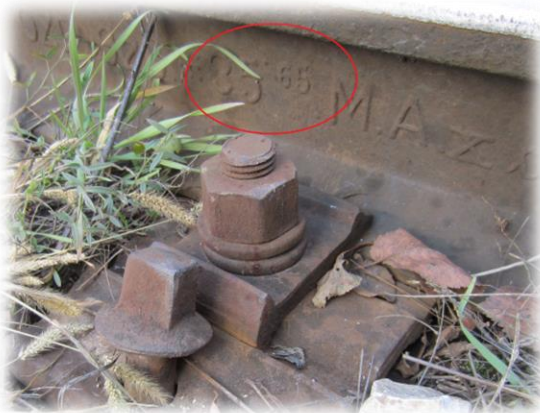
Fig 4.2.3.1: Non-standard rail 35a

At the local railway line Markovac - Resavica standard rails 49E1 and S45 are embedded, as well as non-standard 35a (Figure 4.2.3.1.), Xa and 8a with the corresponding non-standard arrangements of connecting and fastening accessories (mounting of rails with rail nails - Fig.4.2.3.2. and 4.2.3.3.). The rails are interconnected by classic rail joints that are supported (Fig. 4.2.3.4.) and floating (4.2.3.5.)

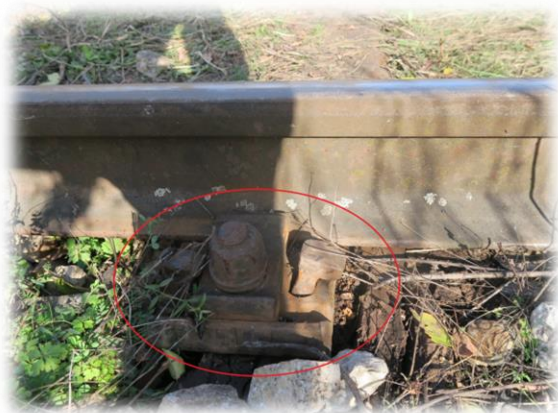
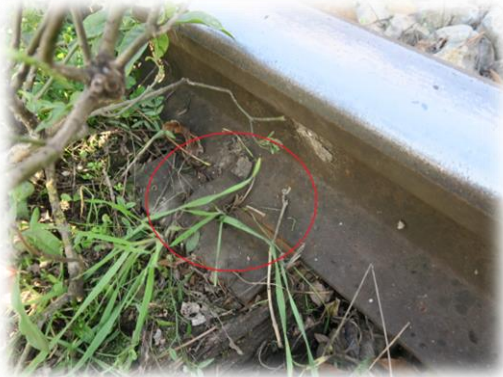
Fig 4.2.3.2: Nails fastening

Fig. 4.2.3.3: Nails fastening

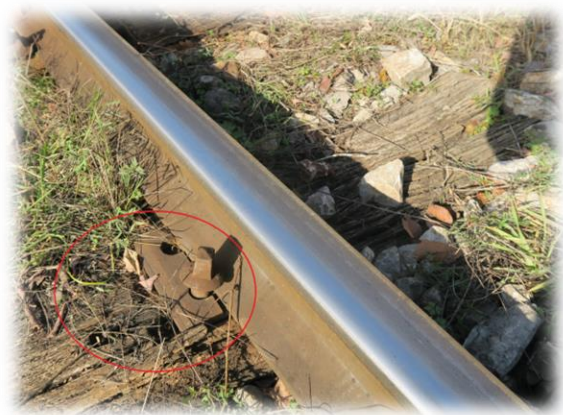
On the open section and main driving tracks 70353 pieces of wooden sleepers have been built in, out of which 31803 pieces due to the large rottenness are unusable (bad connection rail-sleeper, figure 4.2.3.6.), which constitutes 46% of total built-sleepers. At many places there are three or more rotten sleepers in a row ("nests" of rotten sleepers - Figure 4.2.3.7.), which directly affects the stability and geometry of the track. On the section from the station Markovac (km 0+500) to km 19+000 ballastway was formed from highly polluted broken stone (over 15% - Figure 4.2.3.8.), while the rest of the railway ballast is made of slag, which turned into the ground.

Fig. 4.2.3.6: Connection sleeper-rail

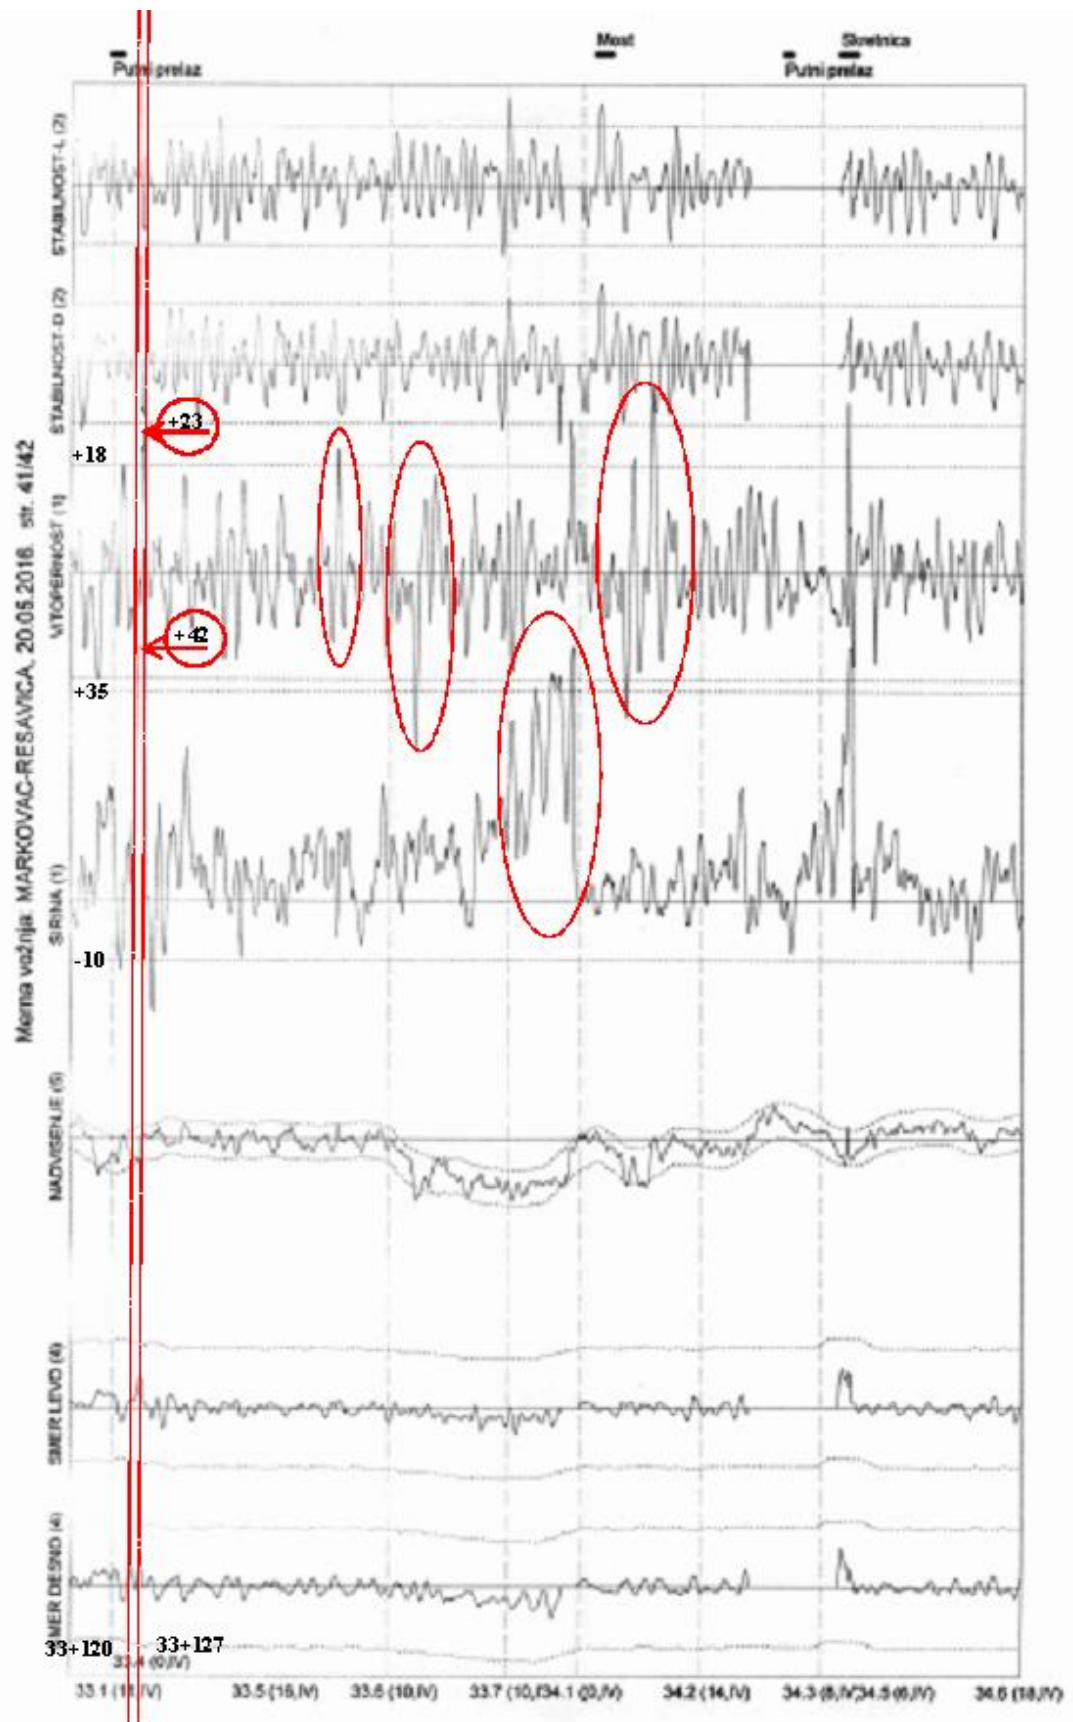
Fig. 4.2.4.2: Graphic record of track examination coach on 20 May 2016

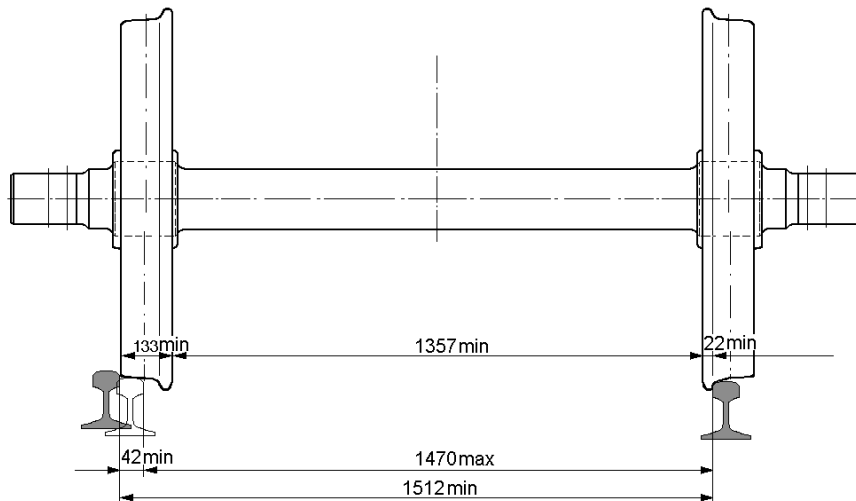
Fig. 4.2.5.1: Conditions for falling of wheel into the track

The figure 4.2.5.1. illustrates needed ratio of track and wheel set to lead to falling of wheel in the track, when the authoritative dimensions are of the permitted limits. It can be seen that it is necessary that the rails due to a loose or missing fastening systems or rottenness of sleepers, are separated by at least 42 mm over the permitted limit of 1435+35 mm. Since from the record of track examination coach it can be seen that in many places enlargement of tracks is greater than exploitation limit of +35 mm, in such places falling of wheel in the track is possible and at low additional spacing of rails.
