REPUBLIC OF SERBIA
CENTER FOR INVESTIGATION OF ACCIDENTS IN TRANSPORT
SECTOR FOR INVESTIGATION OF ACCIDENTS IN RAILWAY TRAFFIC
AND INTERNATIONAL COOPERATION
Nemanjina 11, 11000 Belgrade

FINAL REPORT ON ACCIDENT INVESTIGATION

Type of accident: Derailment of train
Train No: 53527
Place: Novi Bečej, the area of the station Novi Bečej, between the entrance signal and the first entrance switch
Date: 23.12.2017
Time: 13:15

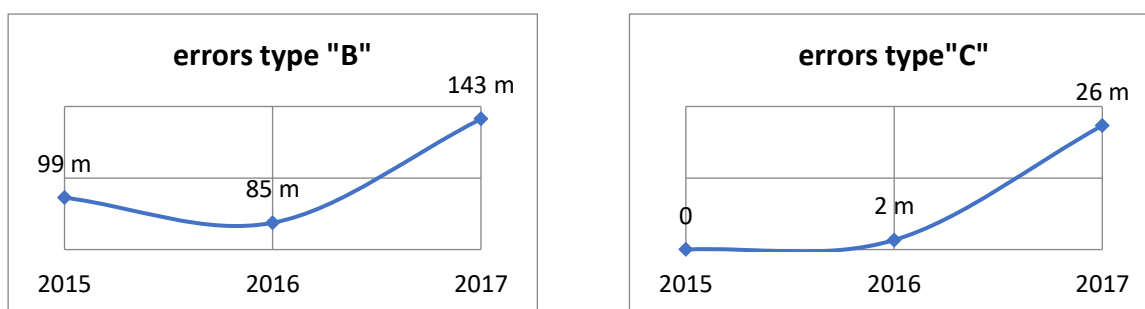
Chart 4.2.5.1: Review of errors type “B” and type “C” with time

- 1) at measuring from 27.10.2015 appear errors type “B” in a length of 99 m,
- 2) at measuring from 12.04.2016 appear errors type “B” in a length of 85 m and errors type “C” in a length of 2 m, and
- 3) at measuring from 30.05.2017 appear errors type “B” in a length of 143 m and errors type “C” in a length of 26 m.

On the basis of the applicable Instruction on common criteria for control of the condition of railways track on the network JŽ, Instruction 339 (*“Official Gazette of ZJŽ” No.2/2001 and 4/2004*), according to the record of measuring with track inspection coach, track in the derailment area was not in satisfactory condition in April 2016, as well as in May 2017.

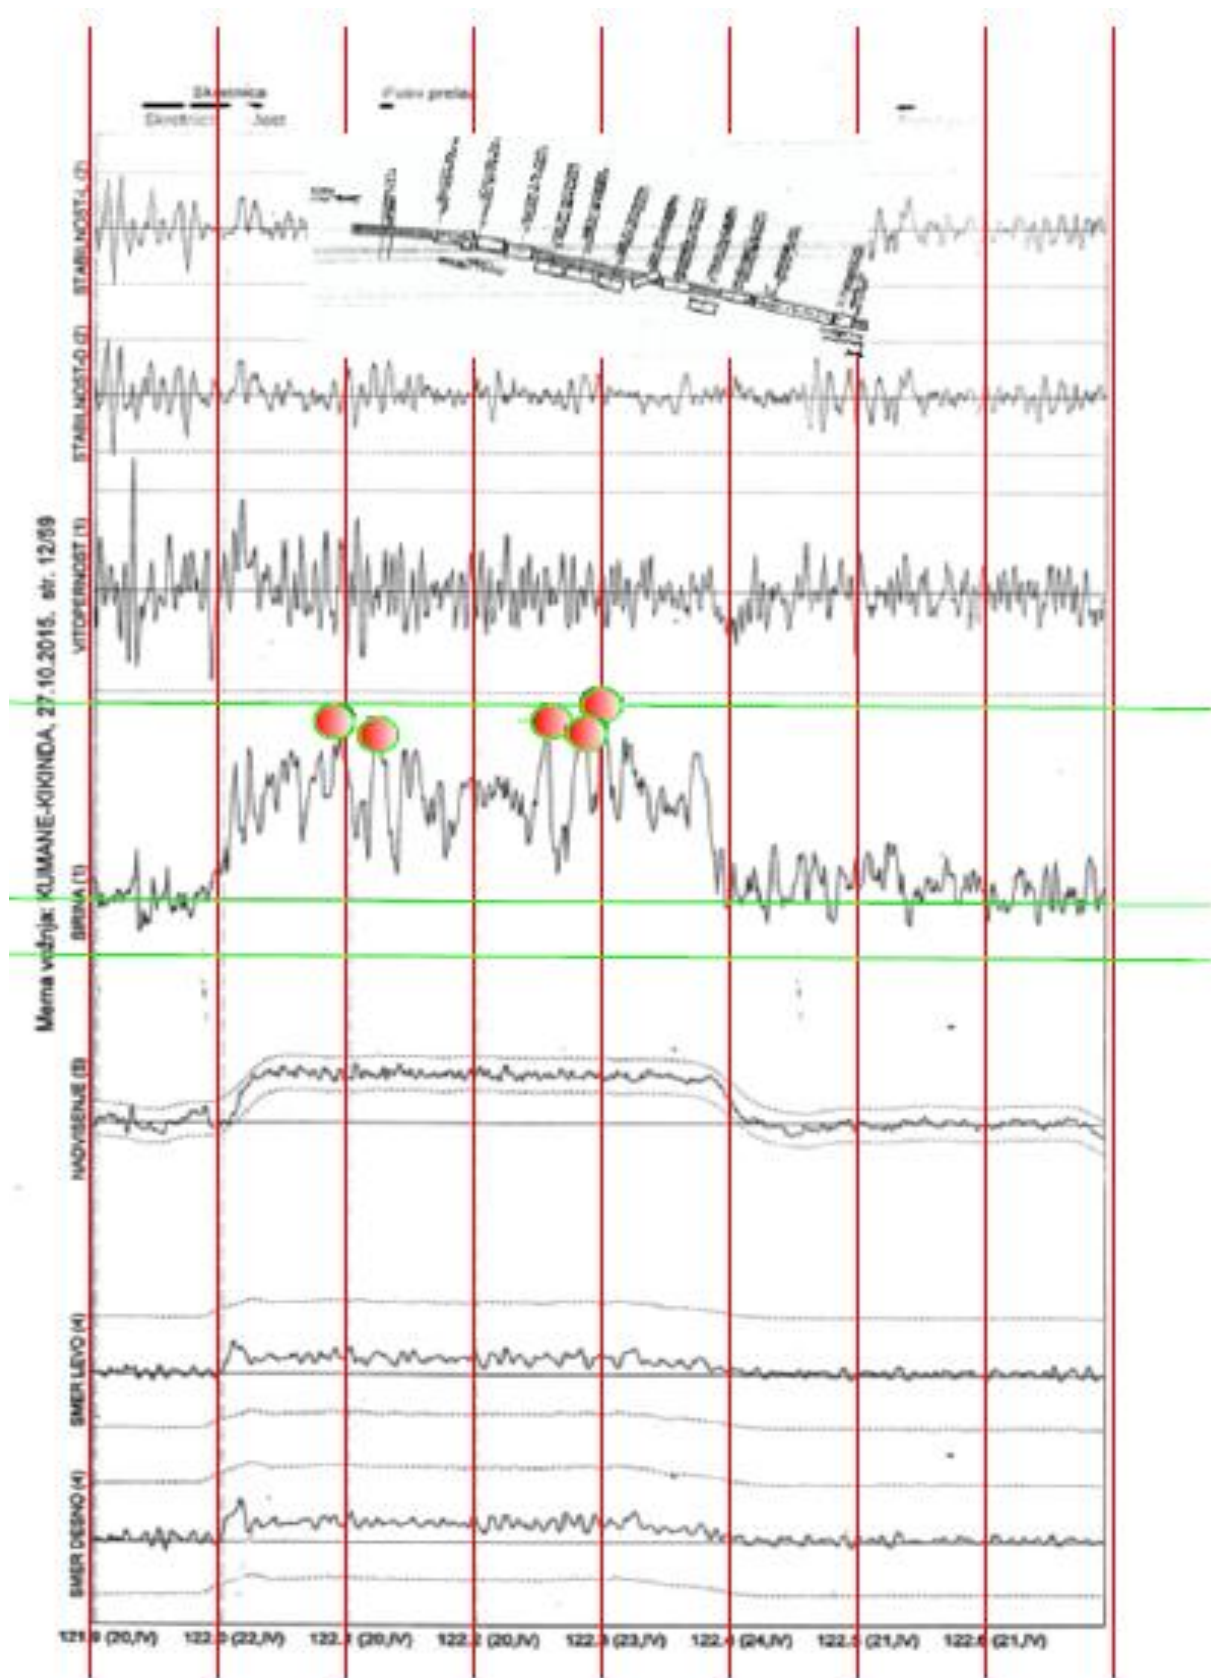
Fig. 4.2.5.1: Graphic record of track inspection coach from 27.10.2015

In Fig. 4.2.5.1, 4.2.5.2. и 4.2.5.3. excerpts of graphic record are shown in the critical zone of the track in October 2015, April 2016 and May 2017, and Fig. 4.2.5.4. and 4.2.5.5. excerpts of numerical records of the track inspection coaches in the critical zone of the track from April 2016 and May 2017.

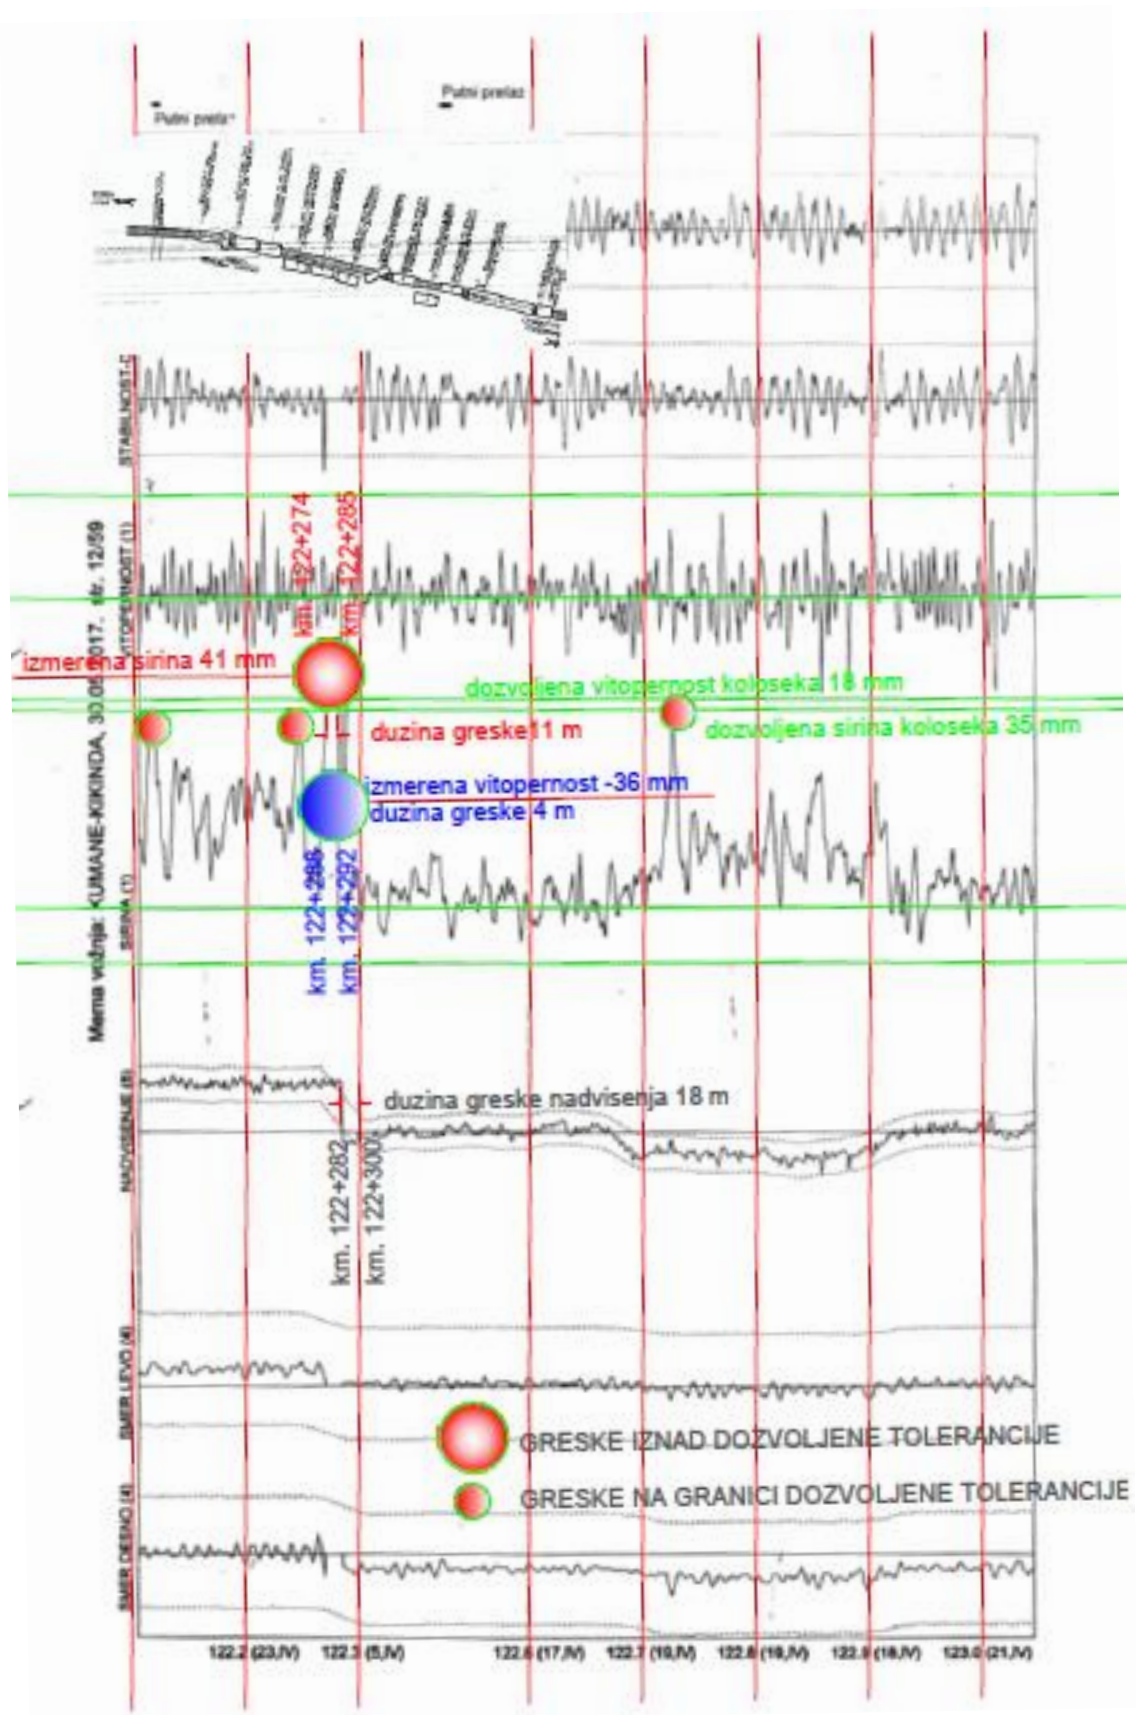
Fig. 4.2.5.3: Graphic record of track inspection from 30.05.2017

In the Report No. 10/17 from 06.06.2017, of the track section Banatsko Miloševo, on the measures undertaken on irregularities noticed when measuring with track inspection coaches on 30.05.2017, it is visible that the noticed errors in the zone of derailment are partly eliminated (twist has been, but track gauge widening and cross level have not).

„ ... it is required that the Head of track section on their section IMMEDIATELY starts with eliminating of errors of TWIST that directly affect the road safety... ”

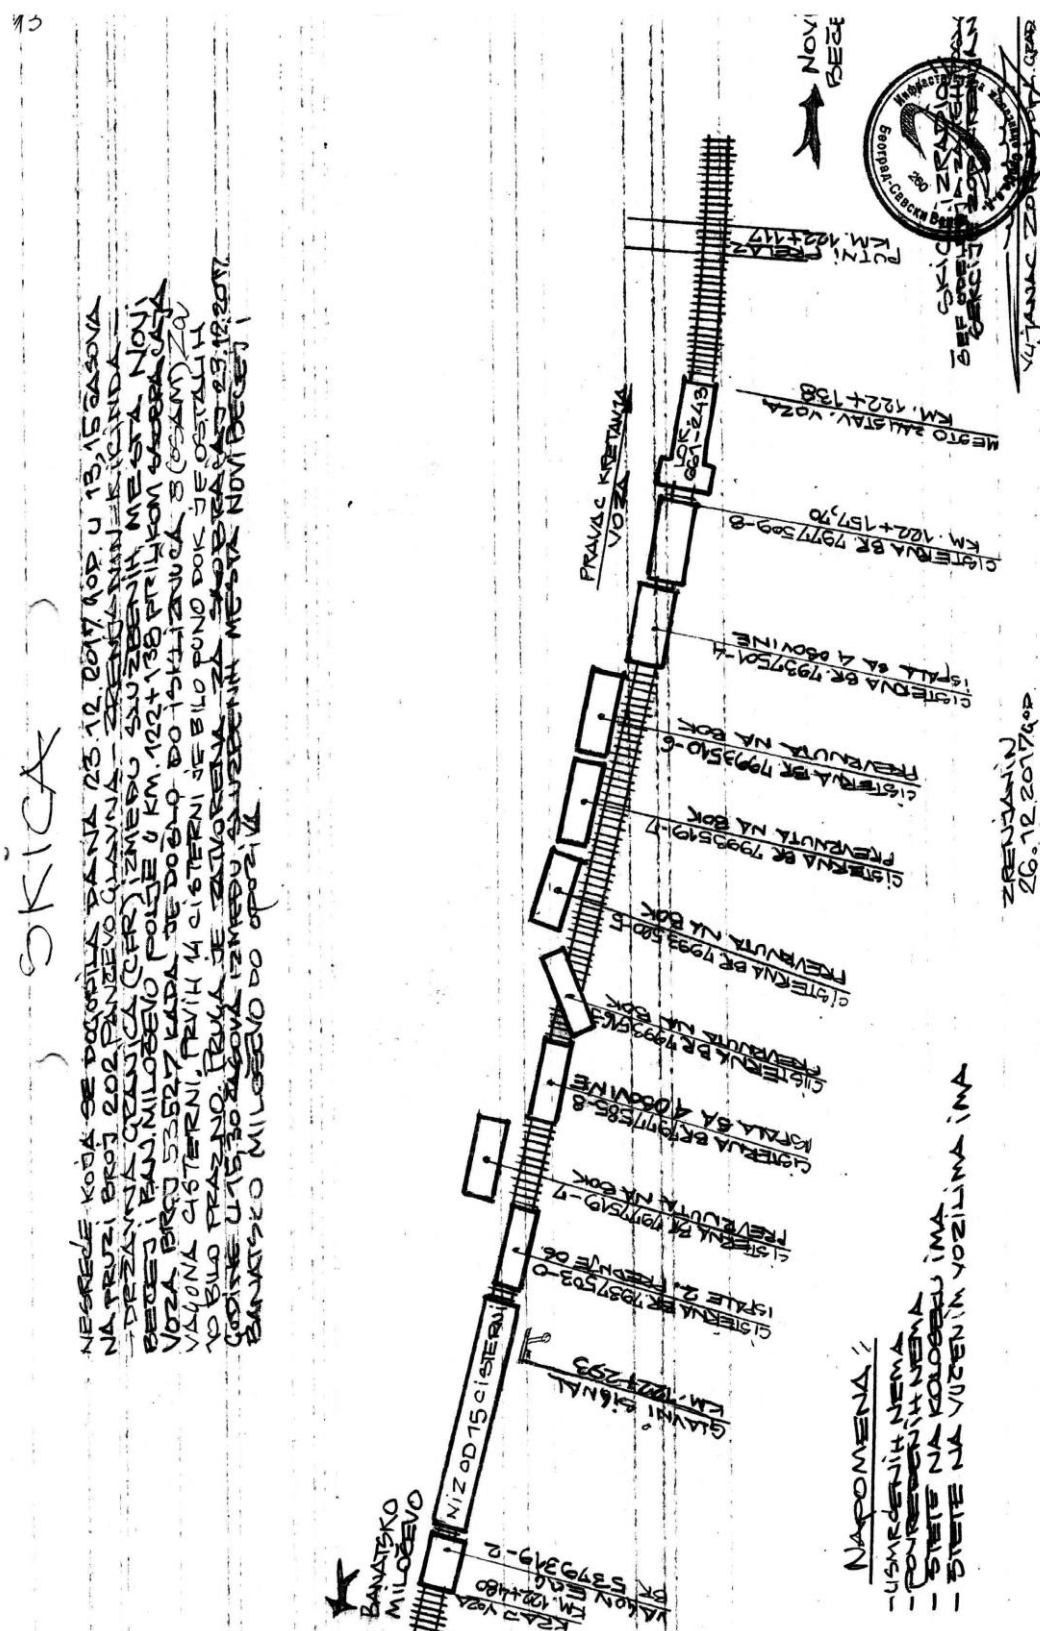
Fig. 4.2.5.6: The sketch of the accident (Source: "IŽS" a.d.)

Note: Figure 4.2.5.6. states: "... remaining 10 were empty.", and the correct is: "... 9 Za wagons and 1 Ea wagon were empty."

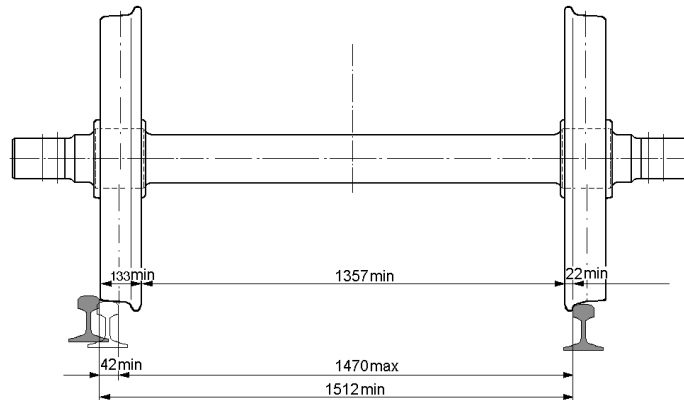
Fig. 4.2.6.1: Condition for falling the wheel into the track

Falling of wheel in track can take place due to movement of the wheels on the axle (looseness of interference fit) in the direction of reducing the internal distances of wheels, or due to the spacing of rails.

Fig. 4.2.6.1. illustrates needed ratio of track dimension and wheel set to lead to falling of the wheel into the track when the authoritative dimensions are in the permitted limits. It can be seen that it is necessary that the rails due to a loose or missing fastening accessories or rottenness of sleepers, are parted by at least 42 mm over the permitted limit of $1435 + 35$ mm. Since the record of track inspection coach shows that in more places there is extension of track greater than the exploitation level of +35 mm, in such places the fall of wheel in the track is possible and at a lower additional spacing of the rails.
