REPUBLIC OF SERBIA
CENTER FOR INVESTIGATION OF ACCIDENTS IN TRANSPORT
SECTOR FOR INVESTIGATION OF ACCIDENTS IN RAILWAY TRAFFIC
AND INTERNATIONAL COOPERATION
Nemanjina 11, 11000 Belgrade

FINAL REPORT ON SERIOUS ACCIDENT INVESTIGATION

Type of accident: Overtaking of the train on the worker
Train No.: Locomotive CEM -7
Place: Obrenovac, TENT Obrenovac, the area of the depot at the station Obrenovac
Date: 13.04.2018.
Time: 13:30

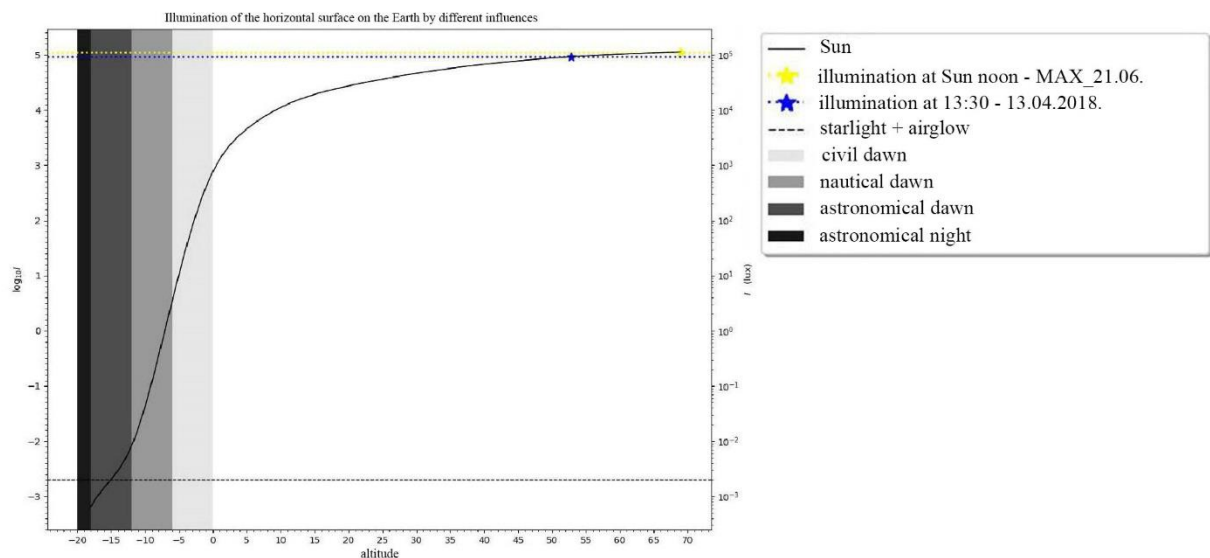
Figure 4.3.6.1: Complete diagram of illumination for a given location 13.04.2018.

Data type	Value
Geographic width of the place	44° 40' 09.7" <i>N</i>
Geographic length of the place	20° 09' 25.7" <i>E</i>
The Sun rising	05:59
The Sun setting (beginning of the civil dawn)	19:22
Height of the Sun 13:30	52.85°
Sun direction at 13:30	200.76° <i>E</i>
Illumination at 13:30	92 358 <i>lux</i>

The illumination of the horizontal surface on the Earth that originates from the scattered sunlight in the atmosphere for 13.04.2018. at 13:30 it was 92 358 lux, for a completely sunny day (without fog) and with maximum meteorological visibility. The maximum illumination of the horizontal surface on Earth by the Sun for the given location, which occurred on 21.06.2018. amounted to 113 197 lux.

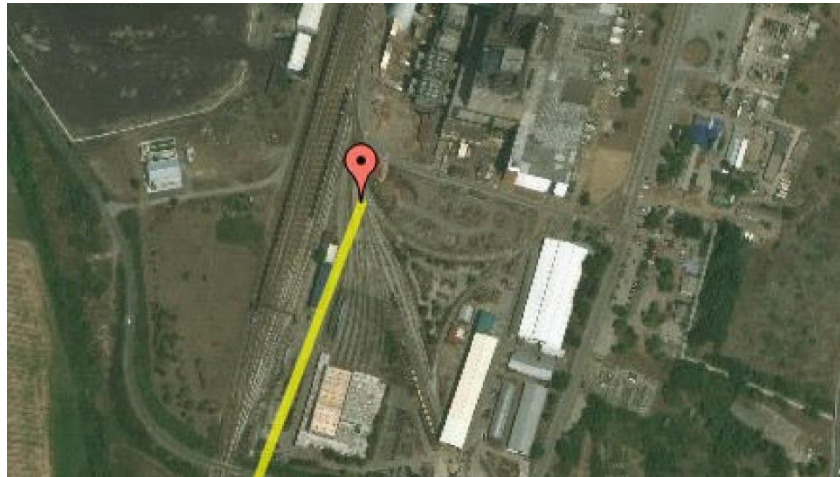
Figure 4.3.6.2: Complete diagram of illumination for a given location on 13.04.2018.

Position of the Sun on 13.04.2018. at 13:30 was: the height of the Sun (elevation) 52.85 ° from the mathematical horizon, the direction of the Sun (azimuth) 200.76 ° measured east.

The position of the Sun, more precisely the direction, for the respective location and at the time of occurrence of a serious accident, is presented in Figure 4.3.6.2.

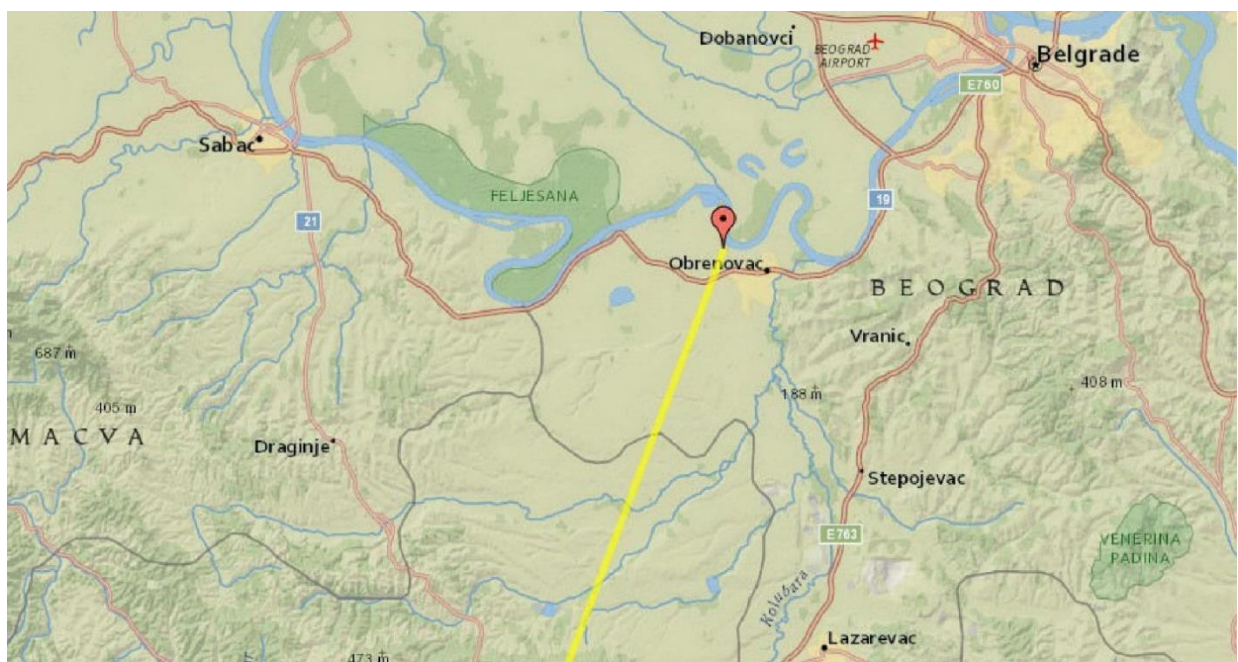
Figure 4.3.6.3: A geographical map of a wider area around the respective location with the drawn direction of the Sun on 13.04.2018. at 13:30

For the position of the Sun, the angle at which the Sun can be seen from the respective location for 13.04.2018. at 13:30 is important, there is no natural object (forest, hill) in the respective location, which would create a shadow large enough to cover the location in question, as can be seen from the geographical map for the location in question in Figure 4.3.6.3.

On the site there are no facilities (buildings) that could have a sufficiently long shadow that could cover the site in question.
