No.: ŽS - 04/18

## FINAL REPORT ON INVESTIGATION OF SERIOUS ACCIDENT

Type of accident:	Serious accident on the level crossing
Train No.:	7821
Place:	City of Niš, settlement Donje Međurovo, area of the switch block 2 of the station Međurovo
Date:	21.12.2018.
Time:	07:30

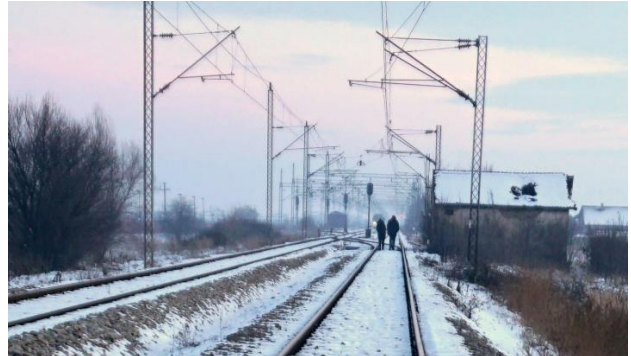
**Figure 2.2.3.14:** Appearance of the switch block 1 of the station Međurovo (view from the direction of the station Niš)
