REPUBLIC OF SERBIA  
CENTER FOR INVESTIGATION OF ACCIDENTS IN TRANSPORT  
SECTOR FOR INVESTIGATION OF ACCIDENTS IN RAILWAY TRAFFIC  
NEMANJINA 11, 11000 BELGRADE

No.: ŽS - 03/20

## FINAL REPORT ON INVESTIGATION OF AN ACCIDENT

Accident type:	Train derailment
Train No.:	45022
Place:	Municipality of Jagodina, open track between the stations Jagodina and Bagrdan
Date:	28.11.2020.
Time:	19:27

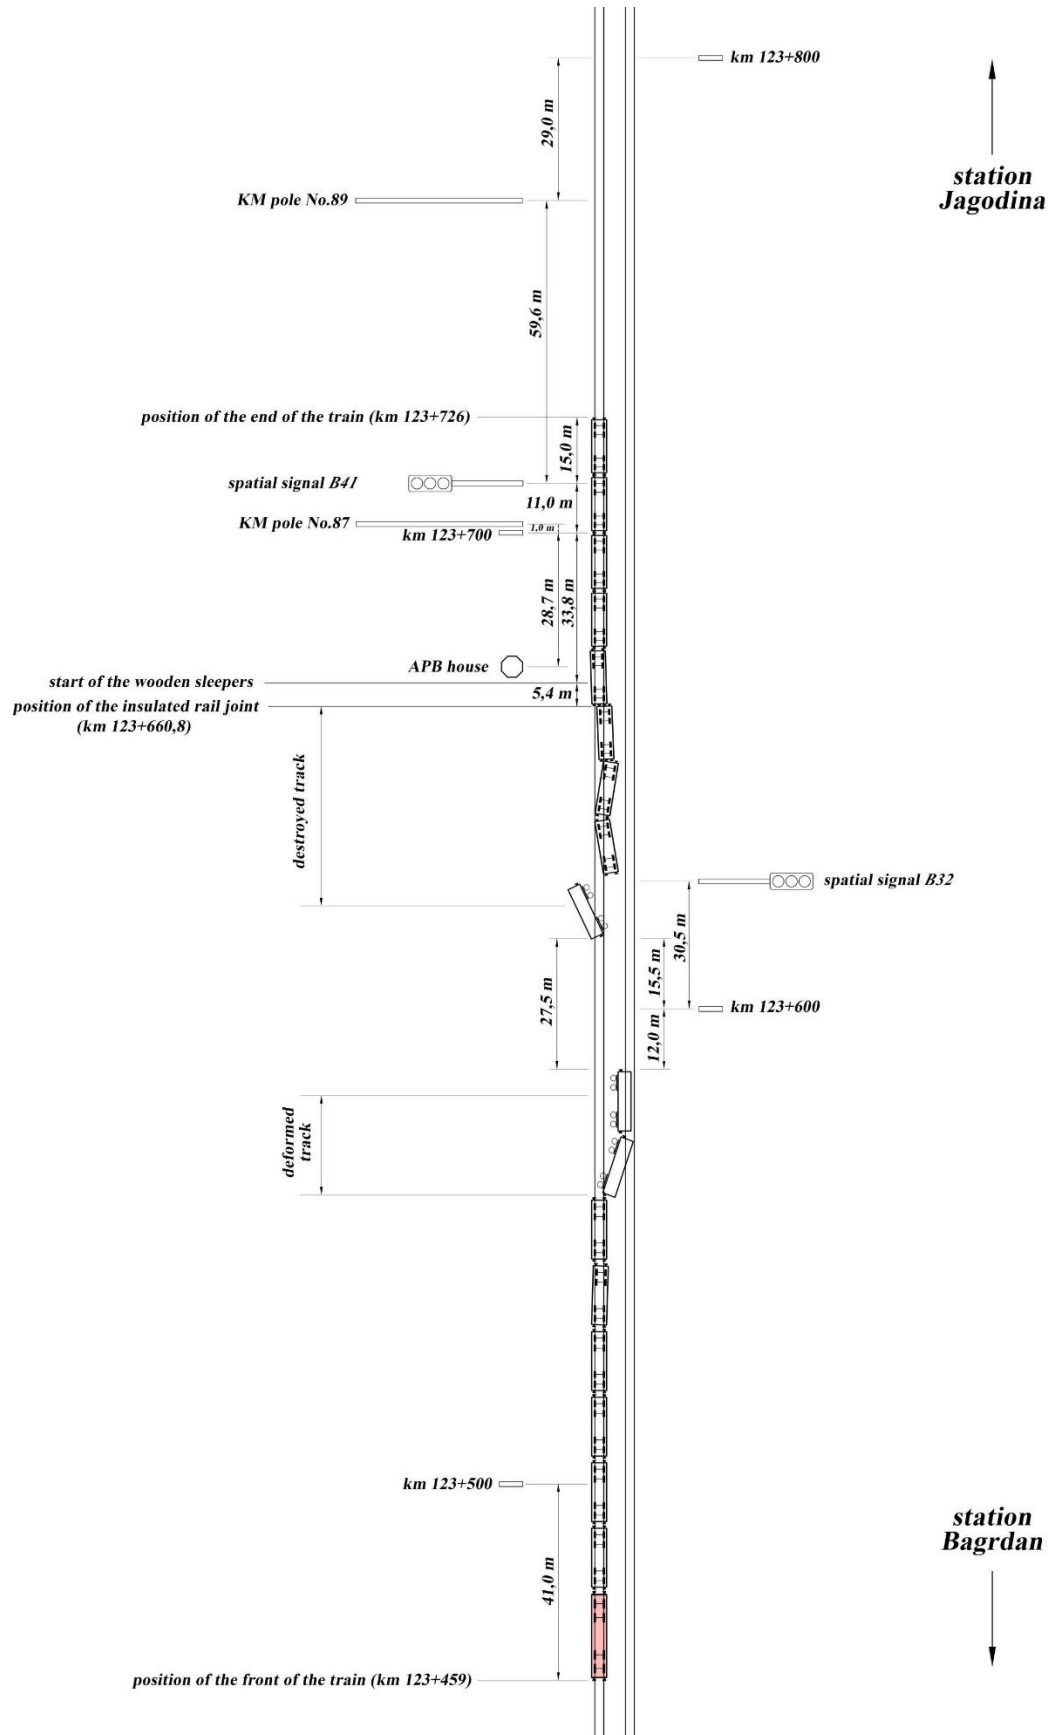
Figure 2.1.2.2: Accident site sketch (CINS)

After derailment, train No. 45022 crossed for another 110 m, after which it stopped (the exact distance could not be determined due to damage to the railway line and railway vehicles). After derailling, and before stopping, train No. 45022 decoupled in place between the eighth wagon of the Zacs-z series No. 33 72 7867 853-3 and the ninth wagon of the Zacs-z series No. 33 72 7867 846-7, so that after stopping the train, the distance between the end of the eighth and the beginning of the ninth wagon was 27.5 m.

In Figure No. 2.1.2.2. a schematic representation of the mutual position of the vehicles in the train after the accident is shown.

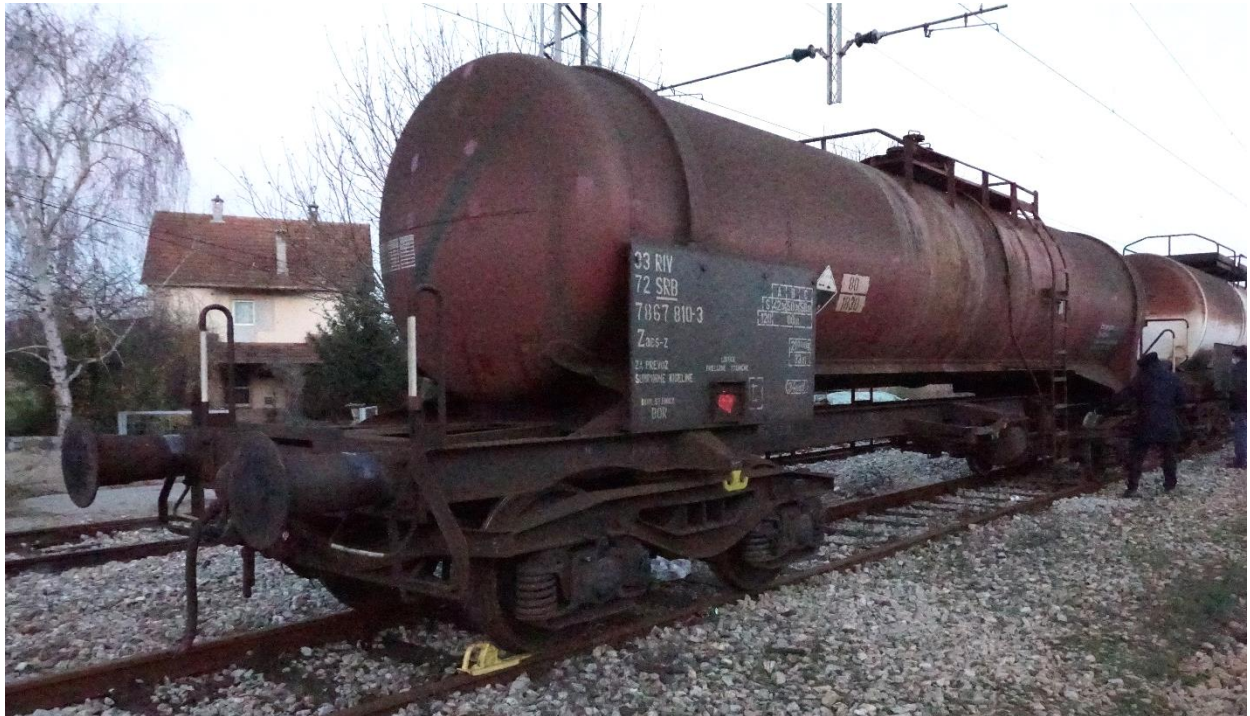
**Figure 2.2.2.1:** Appearance of Zacs series wagon that derailed in the accident in question

A total of 8 (eight) wagon tanks of the Z series derailed out of the train composition.

The view of the Zacs wagon tanks that derailed in the accident in question is shown in Figure 2.2.2.1.

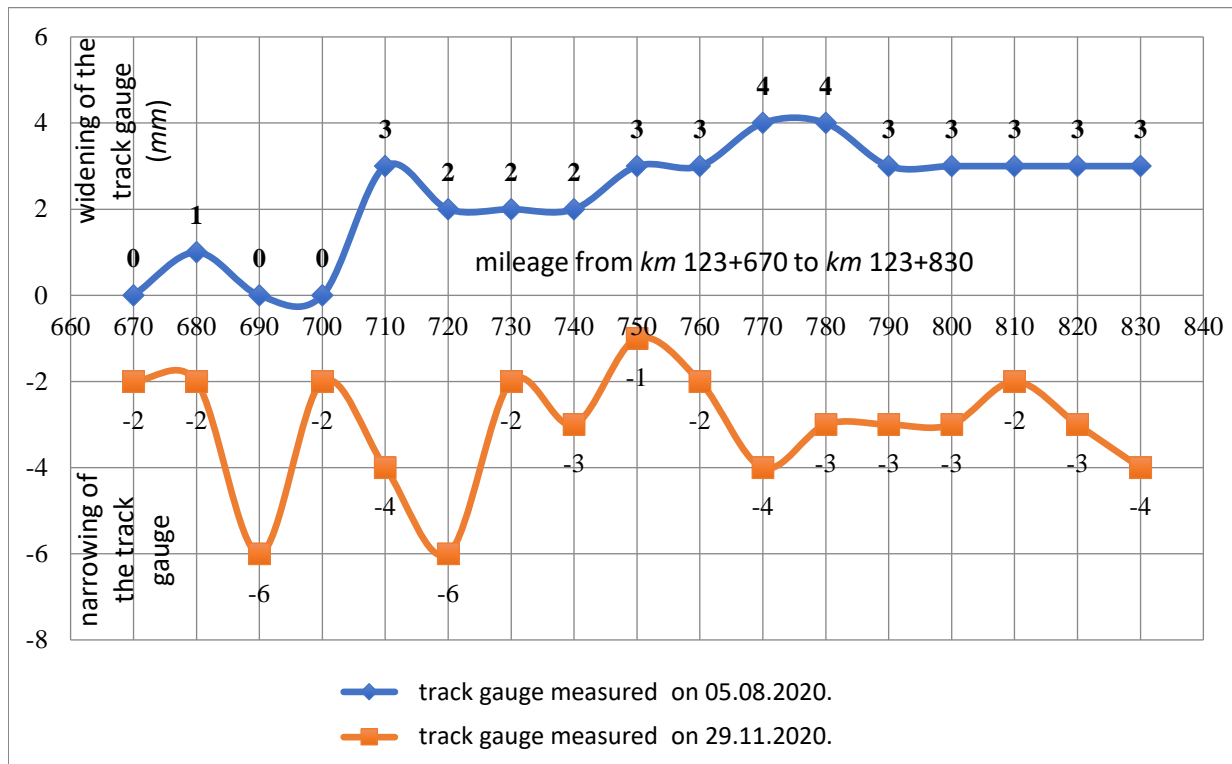
**Chart 3.4.2.1:** The ratio of the track gauge measured immediately after the accident and the track gauge measured on 05.08.2020 after the mechanical regulation of the track in the direction and level (OC ZOP Paraćin)

On the chart 3.4.2.1. the ratio of the track gauge measured immediately after the accident and the track gauge measured on 05.08.2020 is shown and after the mechanical regulation of the track in the direction and level (OC ZOP Paraćin).

Based on the above, as well as the visual inspection of the track in the derailment zone performed on 29.11. and 01.12.2020. by the representatives of CINS, it can be concluded that the narrowing of the track occurred due to inadequate maintenance of the track welded in DTŠ for which there is no record of longitudinal and transversal movement of the track, which was stated on the basis of letter No. 20/2021-97 of 19.01. 2021 of the Sector for Construction Affairs, which was submitted as an attachment to letter No. 1/2021-169 of 28 .01.2021. of “IŽS”a.d., and as a consequence of the accident. In this section of the track, the speed is limited due to the poor condition of the substructure, which is reflected in the direction and level of the track.

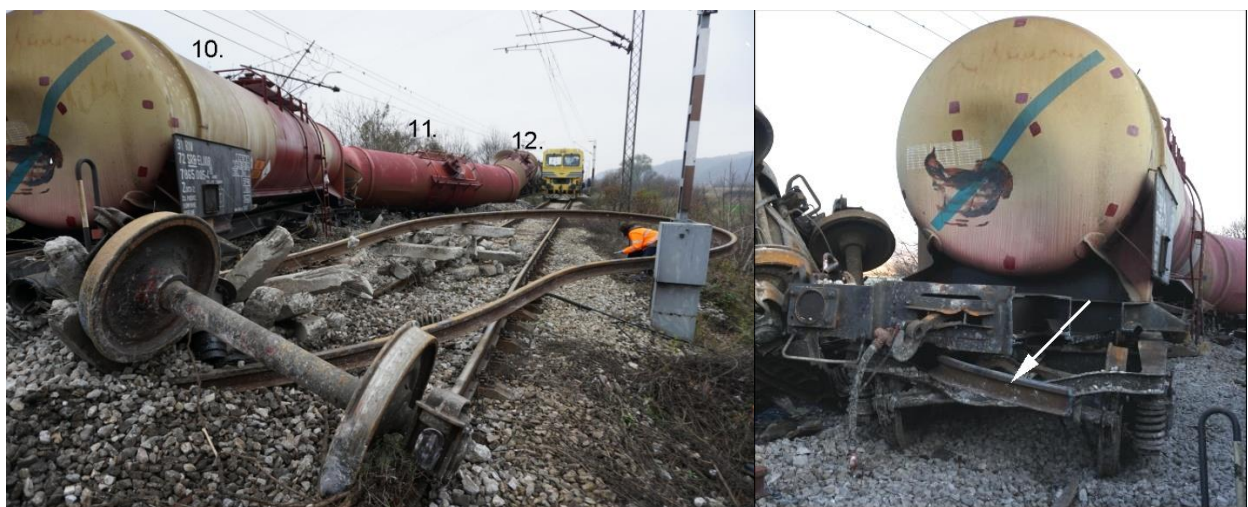
According to the situation found, after the detachment that occurred during the derailment between the eighth and ninth wagons, the ninth wheels sank into the superstructure of the track and overturned on the right side in the direction of movement. Then the head of the tank of the tenth wagon collided with the buffer of the overturned ninth wagon, upon which it was not broken, but a large indent remained on it (Figure 4.2.1.9).

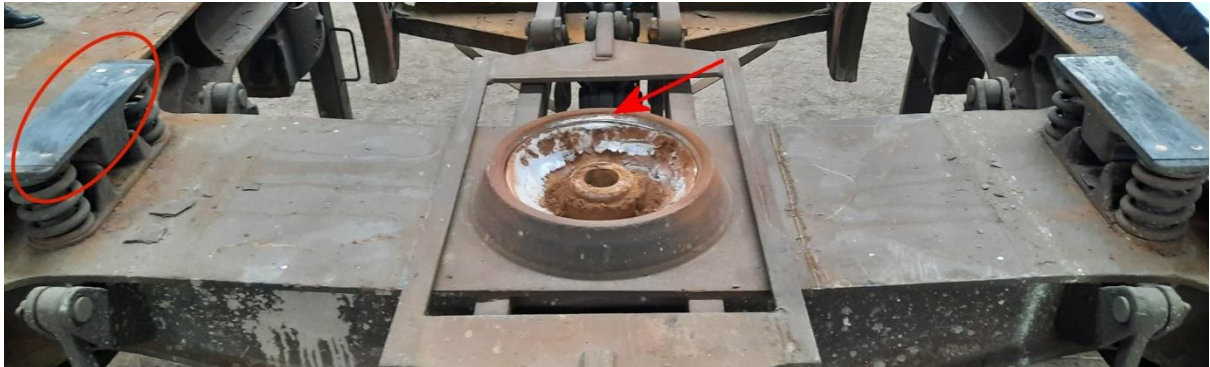
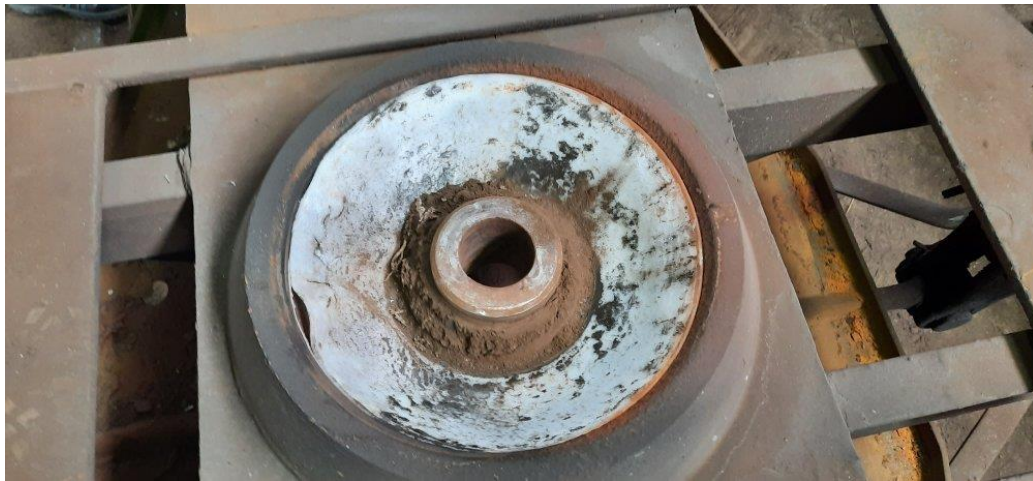
**Figure 4.2.2.1.1:** Condition of slides and lower center bowls of the wagon No. 33 87 7868 736-2

In the workshop “Srbija Kargo” a.d. in Velika Plana, damage and excessive wear of plastic inserts in center bowl s and on the side elastic slides of the fifth and thirteenth wagon in the train were noted. This wears and damages can significantly increase the swivel resistance of the bogies. This fact is not the direct cause of this accident, but it increases the swivel resistance when turning

in curves, which is reflected in the increase of lateral guiding forces on the wheels, which in certain situations can contribute to wagon derailment by climbing the wheel on the rail.

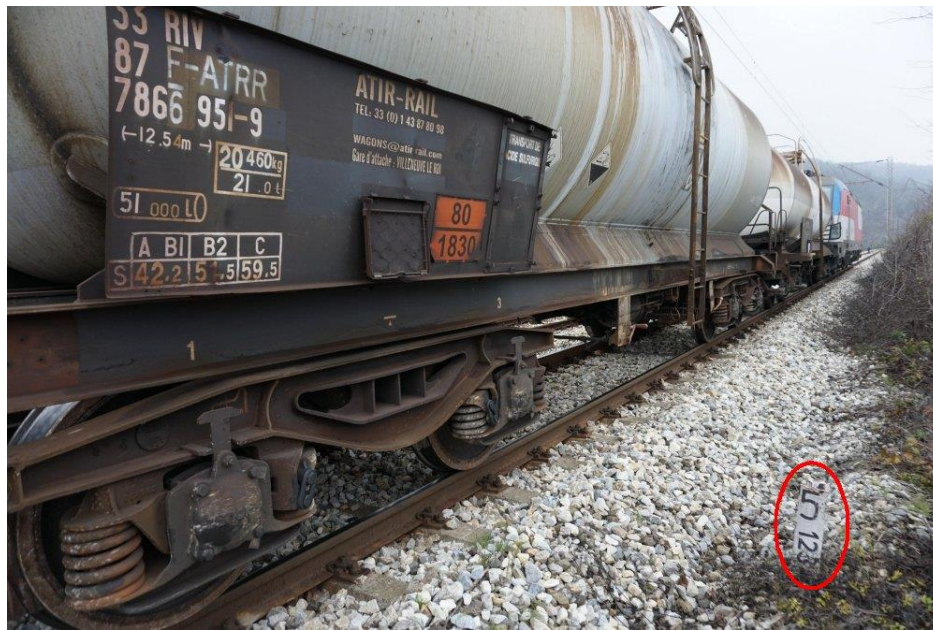
**Figure 4.2.5.1:** The position of the train front in relation to the hectometer pole

In Figure 4.2.5.1. the position of the train front in relation to the hectometer mark for km 123+500 is shown. Having in mind the length of the locomotive (18.98 m), the first wagon (12.99 m) and the second wagon up to the third axle (12.54 m - 2.57 m - 0.9 m), the front of the train stopped at km 123 +459.

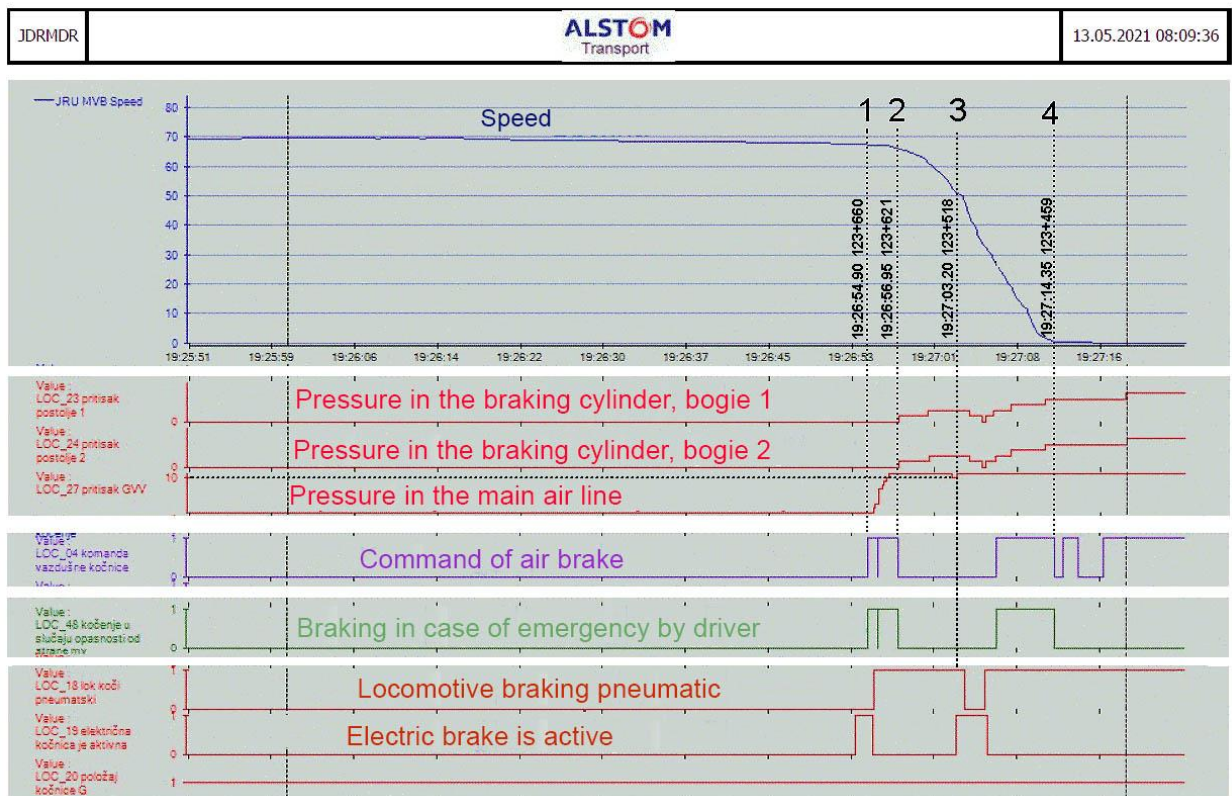
Figure 4.2.5.2: Excerpt of data from the locomotive data log device 193-916

In Figure 4.2.5.2. an excerpt of the diagrams obtained from the locomotive 193-916 movement data recording device for the period of approximately 1.5 minutes before and during the accident is shown. The diagrams mark the characteristic moments:

- 1- the moment of introduction of fast braking by the train driver,
- 2- the moment of stopping of fast braking by the train driver,
- 3- approximate moment of train decoupling,
- 4- moment of stopping the locomotive with the front part of the train.

Based on detailed data from the device from the moment of introducing the fast braking to the moment of stopping, the locomotive crossed 201 m. Based on that, it follows that the train driver started fast braking at km 123+660, which is 0.8 m after crossing the insulated joint on the track at 19: 26: 54.90. This train position is schematically shown in Figure 4.2.5.3.

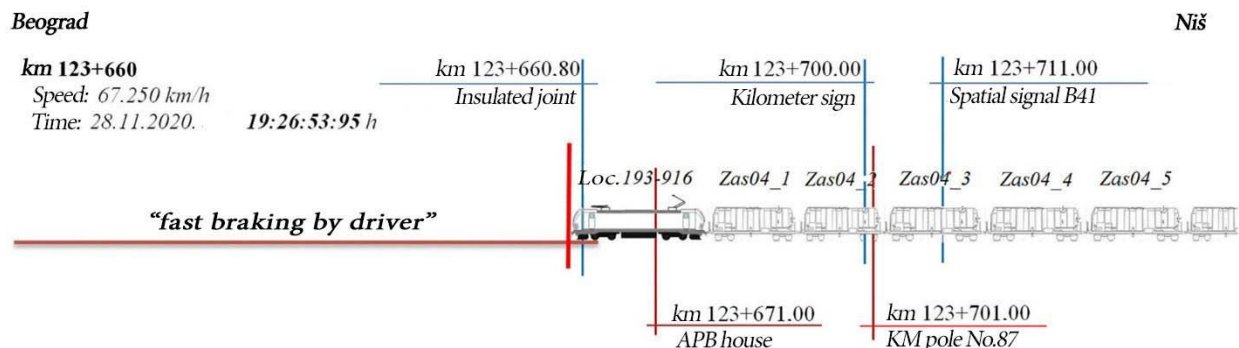
Figure 4.2.5.3: Position of the train at the moment of introducing the fast braking

According to the train driver's statement, he started the braking after overcoming a large deformation of both rails, which he had previously noticed. Having in mind the position of the train from Figure 4.2.5.3. and the train driver's statement, the deformation should be in the area around the APB house, and certainly in front of the insulated joint. That section of the track remained undamaged. It did not show a large deformation to the right side, as described by the train driver, or credible traces that there was such a large transversal movement of the track.

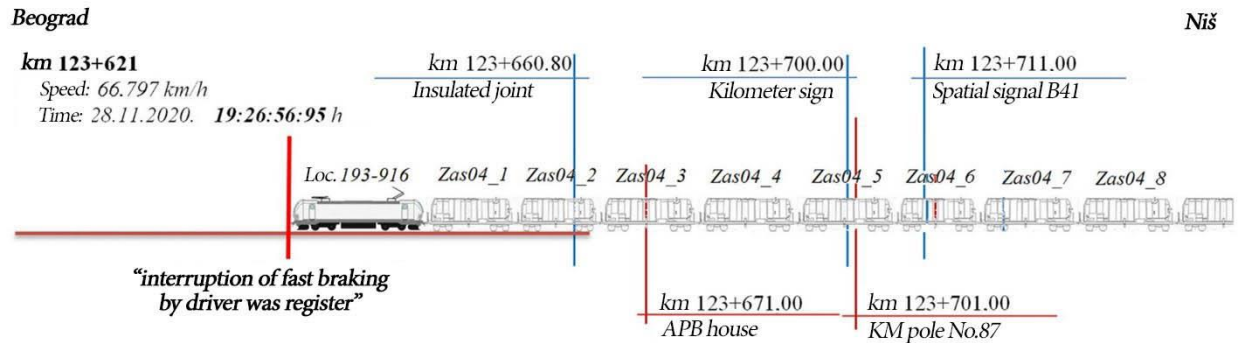
Figure 4.2.5.6: The train position at the moment of cessation of fast braking

After 2.05 s from the introduction of fast braking, the braking interruption was noticed by the train driver. Based on the train driver's statement, it was not his conscious action and was most likely the result of a longitudinal jerk. The longitudinal jerk could not be caused by the action of the brake. From the pressure diagram in the brake cylinders of the locomotive, it can be seen that it did not even start to grow until that moment, that is, the locomotive did not start to brake. Having in mind the explanation given in chapter 4.2.3, up to that point the pressure in the brake cylinders of the first wagon could reach only approximately 35% of the maximum value, and for the last wagon a little over 10%. Accordingly, a drop in speed was recorded in the first 2.05 s for only 0.453 km/h.

Previously, it indicates that the jerk could have been a consequence of the beginning of the derailment. In Figure 4.2.5.6. the train position at that time is shown. Based on this position, having in mind very few traces of derailment in front of the insulated joint, which occurred in the final phase of derailment of the twelfth and thirteenth wagon, it can be assumed that the jerk could have occurred due to collision of locomotive wheels or the first two wagons on some kind of obstacle or broken rail in the zone of insulated joint or behind it.

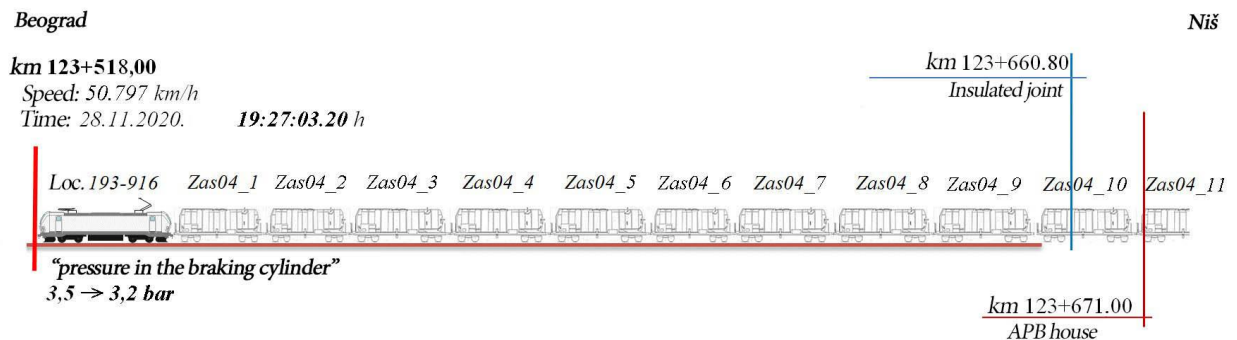
Figure 4.2.5.7: The train position at the moment of decoupling

In the next half second, the pressure in the main line goes to level 11 again (the pressure drops - the main line empties) even though the position of the brake valve handles is still in the position of the fast braking interruption. This indicates that at that moment, the main air line was broken, most likely between the eighth and ninth wagon due to the overturning of the seventh and eighth wagons on the left side. The position of the train at that time is shown in Figure 4.2.5.7.

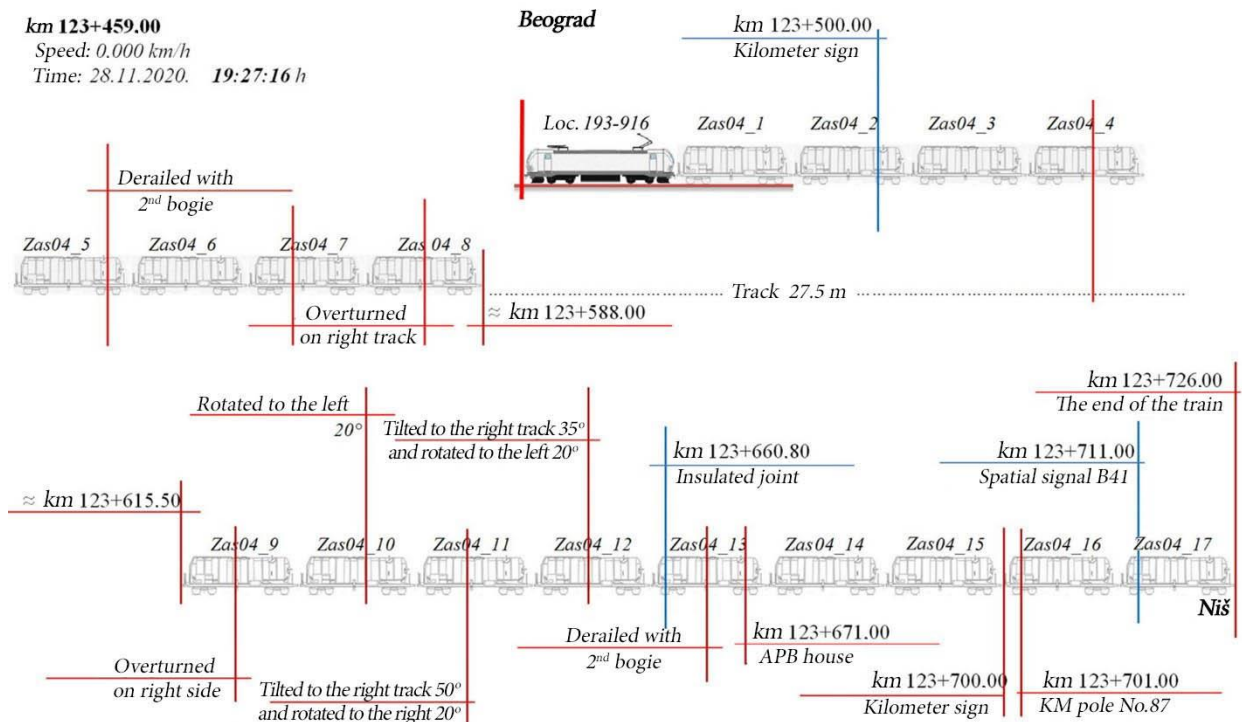
Figure 4.2.5.8: The train position after stopping upon derailment

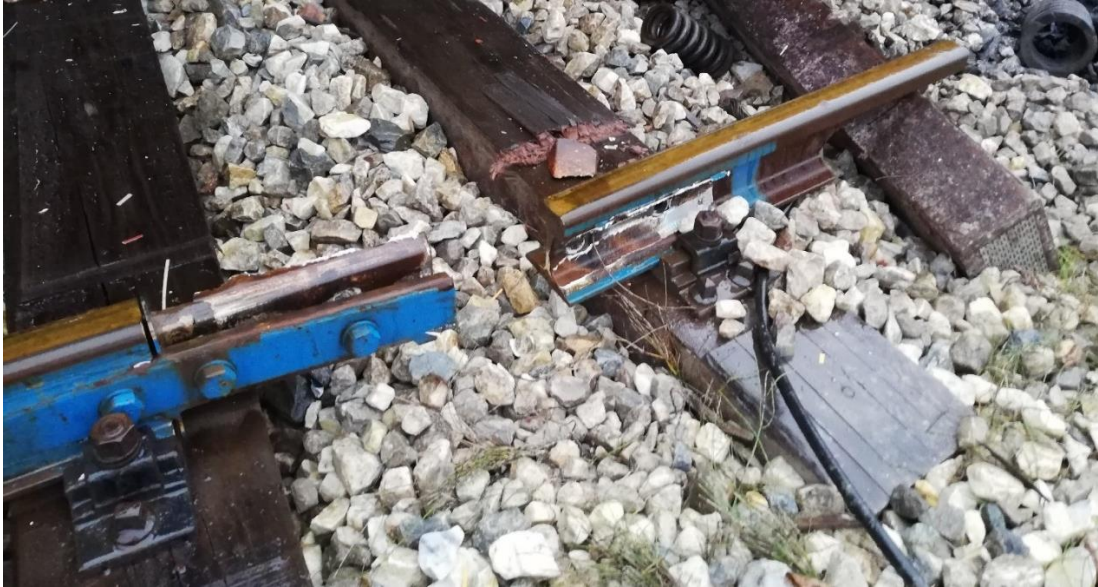
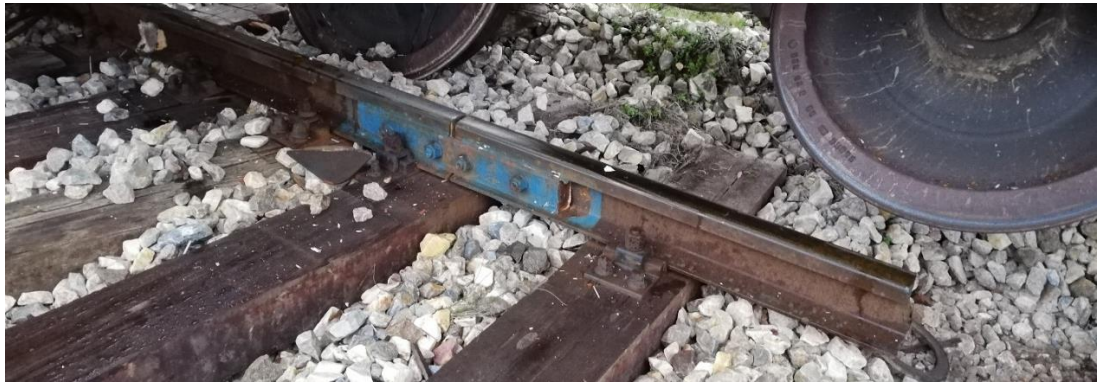
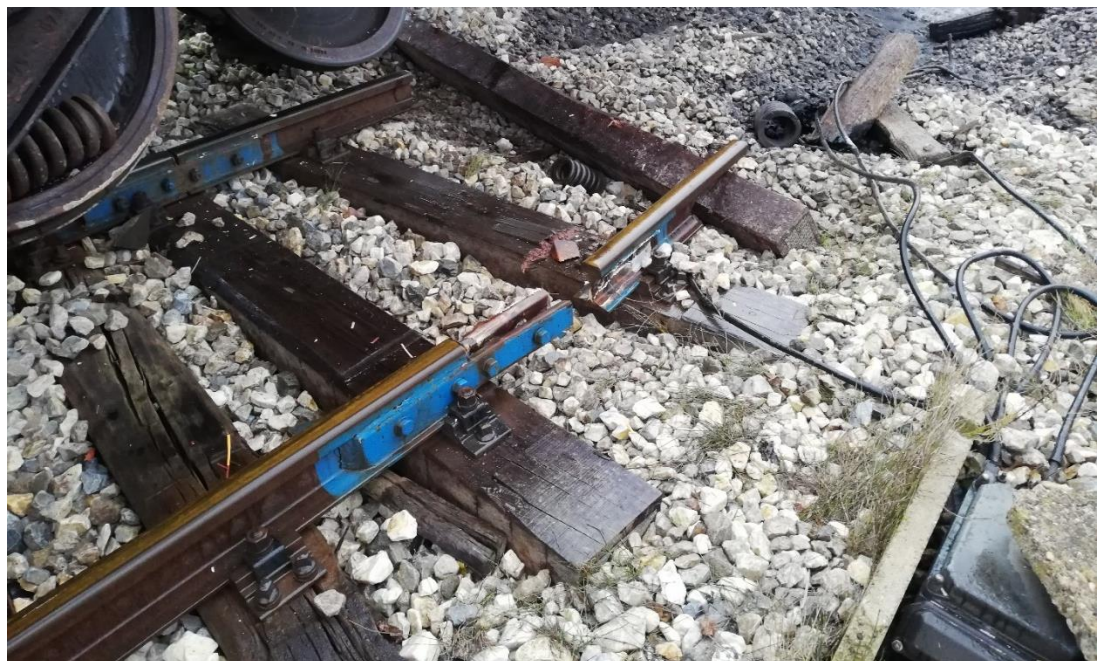
Based on the submitted material by "IŽS"a.d. it can be stated that during 2018 and 2019 the planned detailed inspections of insulated joints were not done by OC ZOP Paraćin and in the registry sheet it is stated that the insulated joint at km 123+660.80 on the left track on the left rail was replaced 27.09.2019. and that it was replaced on the right rail on 23.09.2019. (no work orders were submitted). Also, the registry sheet states that the construction of the duplicate composition of sleeper is on the right rail, which does not correspond to the condition found during the investigation of the accident by the CINS' representatives (see Figures 4.2.7.1 and 4.2.7.2. b and c).

*a) The view of the insulated joint on the left rail in direction of increasing stationing*

*b) The view of the insulated joint on the right rail in direction of increasing stationing*

*c) The view of the insulated joint on both rails*

**Figure 4.2.7.2:** The view of insulated joint at km 123+660.80

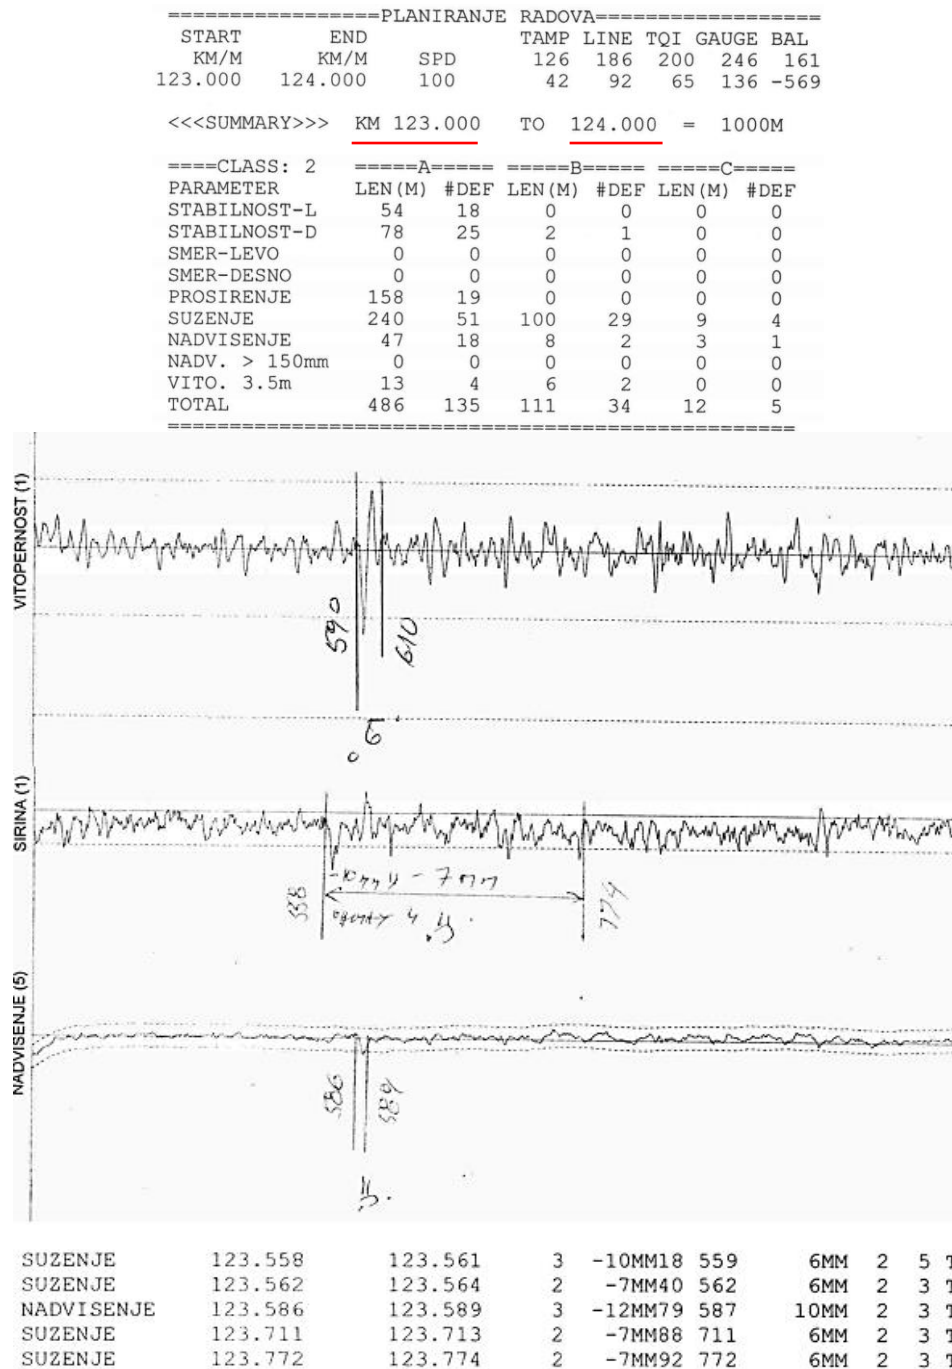
Figure 4.2.8.1: Numerical and graphic record excerpt of track inspection coach from 02.03.2017.

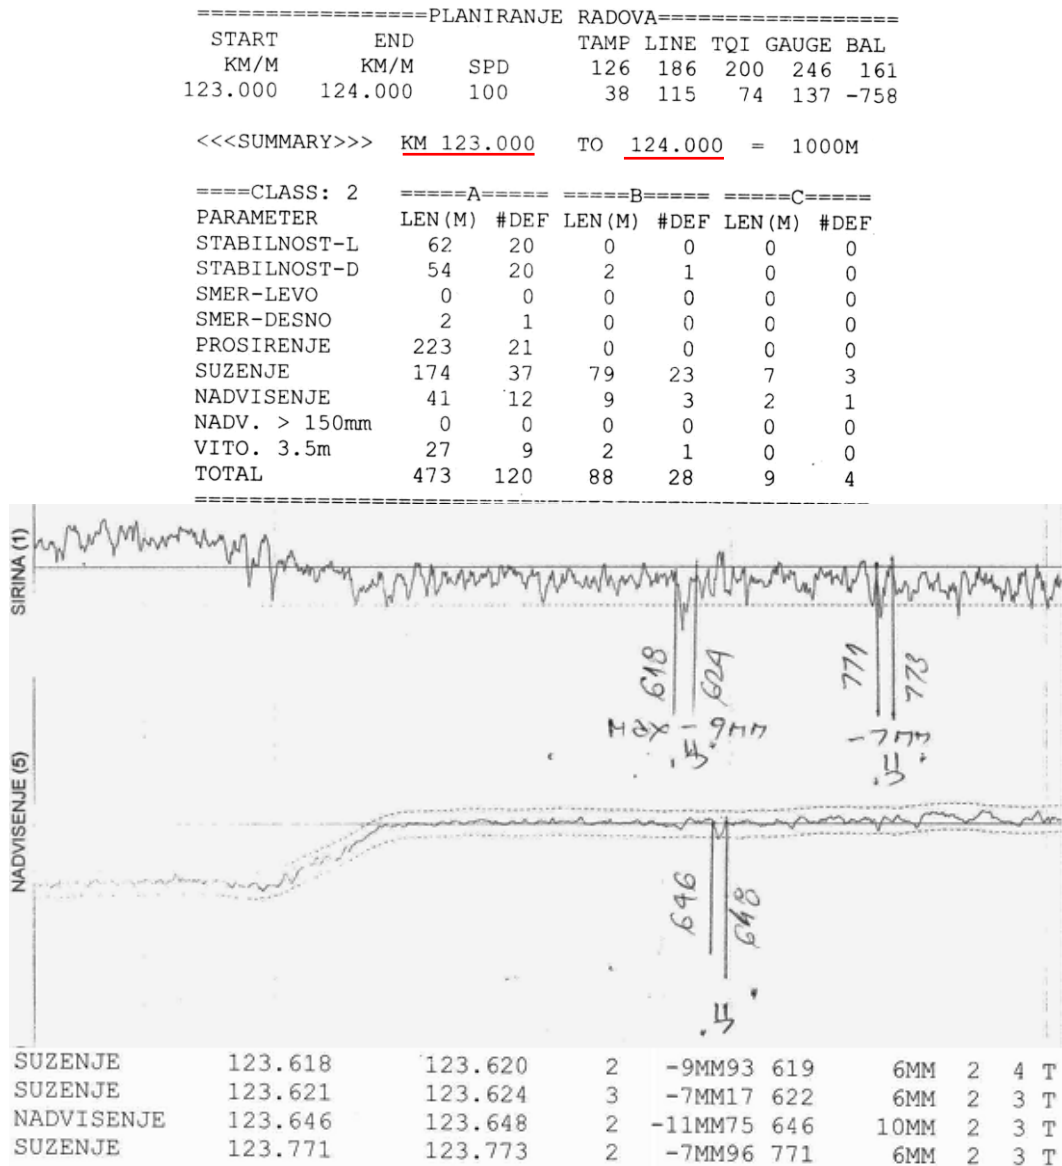
Figure 4.2.8.2: Numerical and graphic record excerpt of track inspection coach from 23.05.2017.

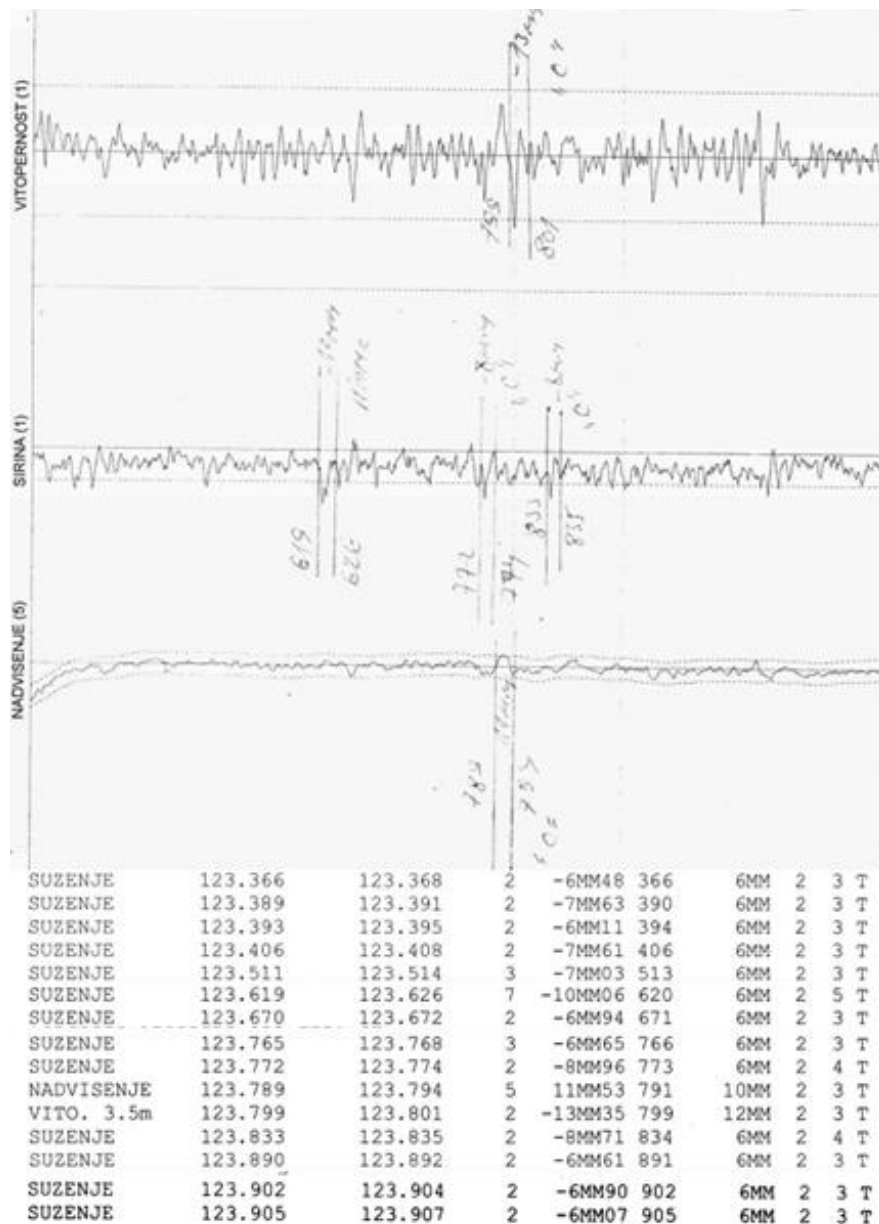
Figure 4.2.8.3: Numerical and graphic record excerpt of track inspection coach from 27.10.2017.

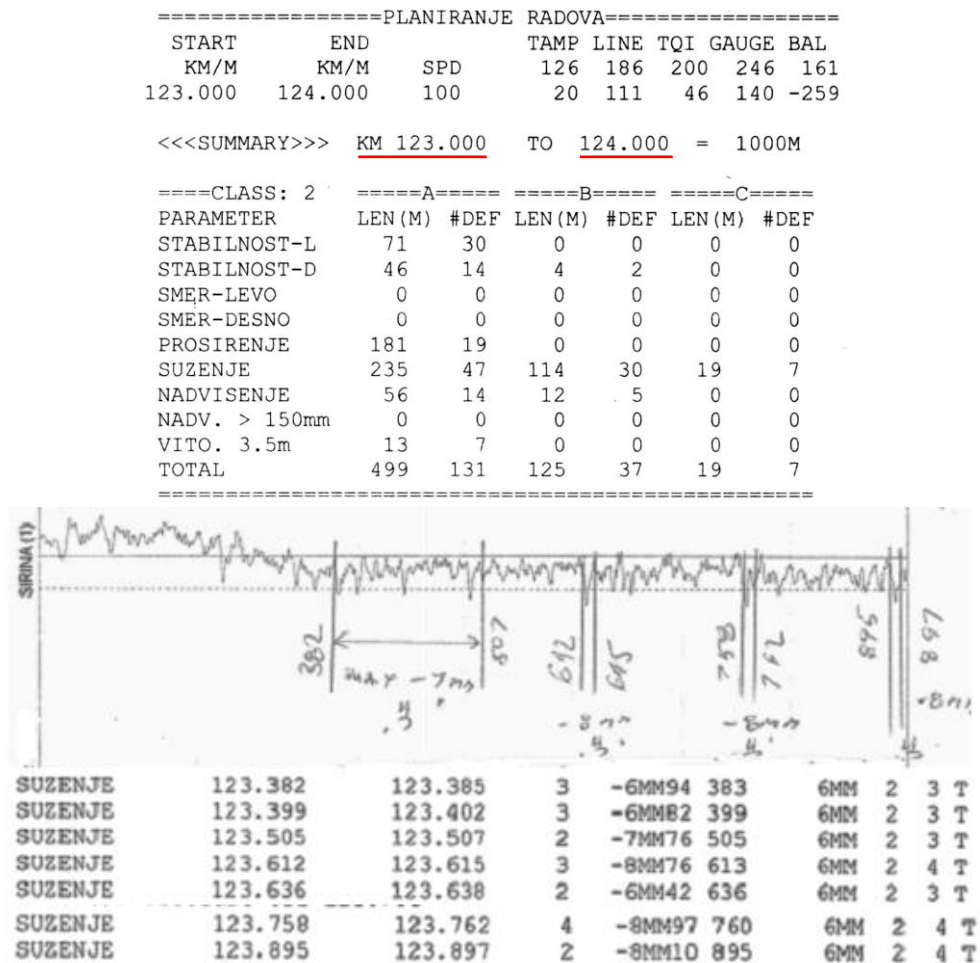
Figure 4.2.8.4: Numerical and graphic record excerpt of track inspection coach from 26.10.2018.

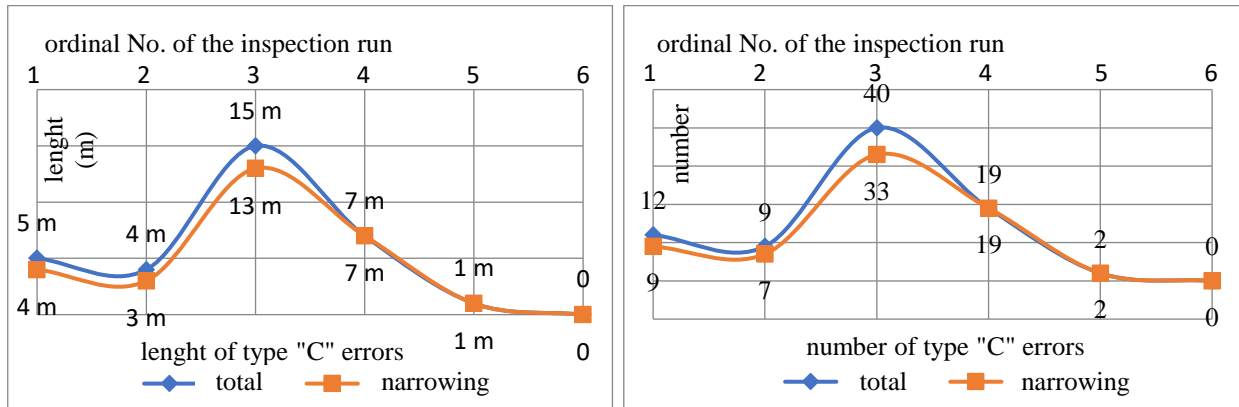
**Graph 4.2.8.1:** Overview of the length and number of "C" type errors over time  
from km 123+000 to km 124+000

From the submitted numerical and graphic records from the measurement of the condition of section of the railway line 102: Belgrade Center - Junction "G" - Rakovica - Mladenovac - Lapovo - Niš - Preševo - state border - (Tabanovce), from the station Markovac (exclusively) km 101+057 to station Jagodina (inclusive) km 136+000 on the left track with track inspection coach EM-80L it can be concluded that in the zone of derailment of the train No. 45022 in the summary of the report from km 123+000 to km 124+000, of the total number of errors type "C" **more than 75% are track narrowing errors**, indicating uneven longitudinal movement of the rails in the track.

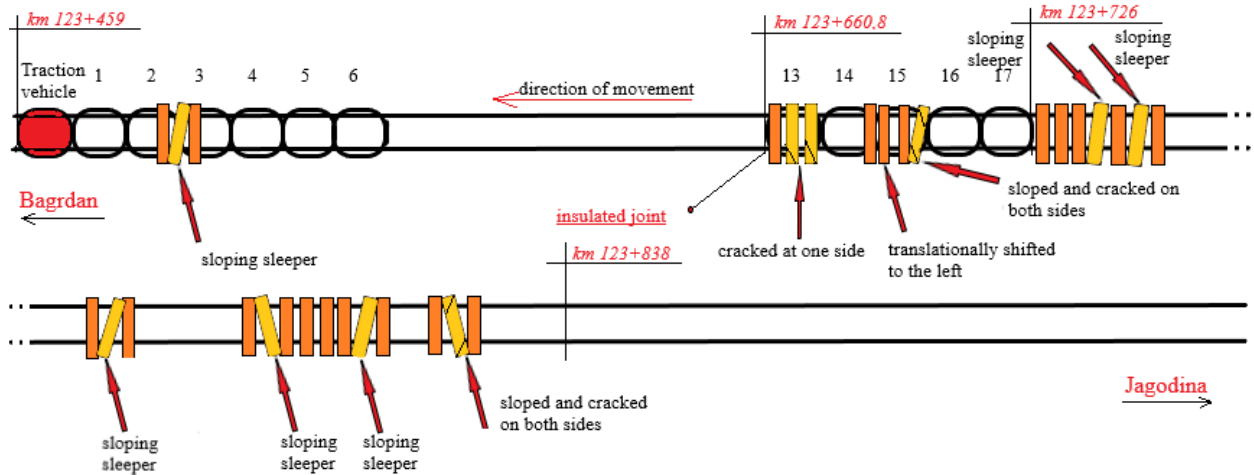
**Figure 4.2.9.4:** A schematic representation of the sloping sleepers in the accident zone
