**REPUBLIC OF SERBIA**  
**CENTER FOR INVESTIGATION OF ACCIDENTS IN TRANSPORT**  
**SECTOR FOR INVESTIGATION OF ACCIDENTS IN RAILWAY TRAFFIC**  
**NEMANJINA 11, 11000 BELGRADE**

## **FINAL REPORT ON SERIOUS ACCIDENT INVESTIGATION**

Accident type:	Serious accident on the level crossing
Train No.:	Train No. 6431
Accident location:	City of Subotica, Municipality of Bajmok, distance between the stations Bajmok - Aleksa Šantić
Date:	02.12.2020.
Time:	08:15

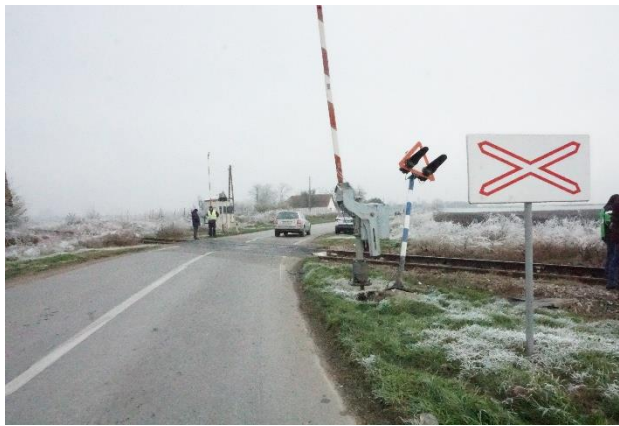
**Figure 2.2.3.1:** The view of the level crossing  
(view from direction of Sombor)

The condition of the asphalt pavement near the level crossing is in order, without any noticeable damage. The state road in question is at the point of intersection with the railway in a curve with a radius of 110 m. The road at the level crossing is horizontal.

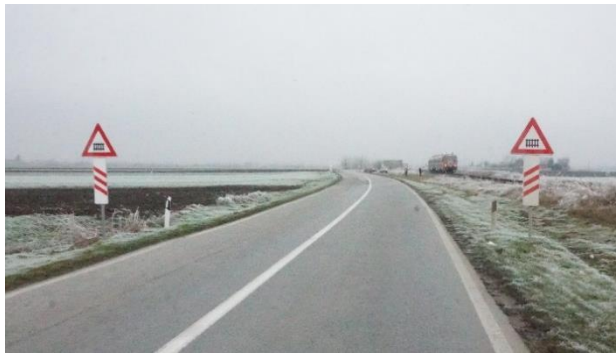
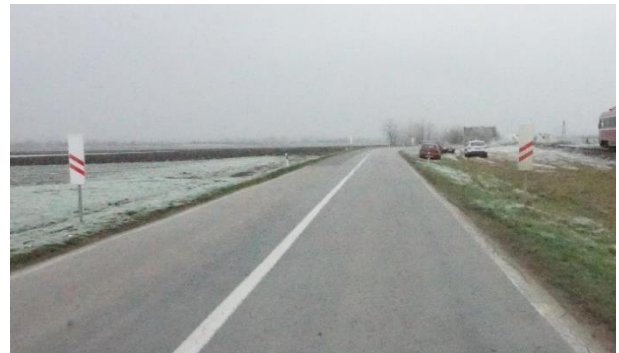
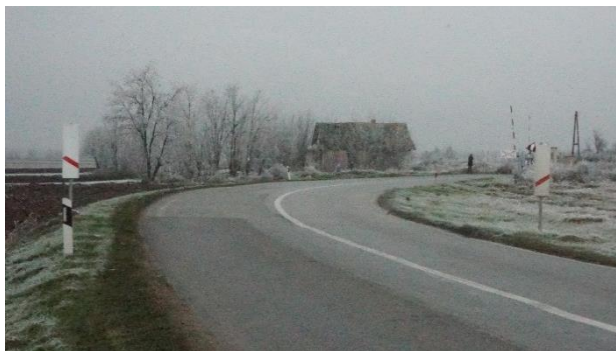
On the state road in question, before encountering the level crossing from the direction of Sombor to the settlement of Bajmok, on the supporters located on the left and right side of the road next to the roadway and from the level crossing are approximately 240 m away, the following traffic signs are placed: I-32: “Crossing of a road with a railway with barriers or half-barriers” and I-35: “Approaching the place of crossing of the road and the railway” (Figure 2.2.3.4.). On the supporters, located on the left and right side of the road next to the roadway and from the level crossing are approximately 160 m away, the following traffic signs are placed: I-35: “Approaching the place of crossing of the road and the railway” (Figure 2.2.3.5.) On the supporters, located on the left and right side of the road next to the roadway and from the level crossing are approximately 80 m away, the traffic signs are placed: I-35: “Approaching the place of crossing of the road and the railway” (Figure 2.2.3.6.). On the supporter, located on the right side of the road next to the roadway and is 8.2 m away from the level crossing (start of the rubber panel), the traffic sign: “Saltire” is placed, on the supporter located on the right side of the road, next to the roadway and is 5.3. m away from the level crossing (start of the rubber panel), the traffic lights IV-9, regulating the crossing of the road over the railway line at the same level, are placed (serving for announcing the train approaching and announcing of the half-barrier lowering), while the half-barrier supporter is placed on the right side of the road next to the roadway and is 4 m away from the level crossing (Figure 2.2.3.7.)

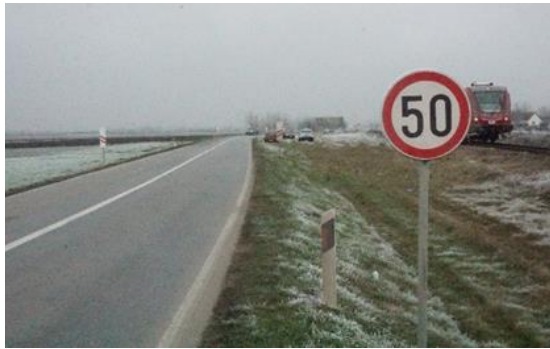
**Figure 2.2.3.8:** The view of traffic signalization  
(view from direction of Sombor)

Apart from the mentioned traffic signs, on this section of the state road from the direction of Sombor to the settlement Bajmok, the following traffic sign is set: II-30: “Speed limit” (placed on the supporter on the right side of the road next to the roadway and is approximately 190 m away from the level crossing, Figure 2.2.3.8.). Other traffic signs on this section of the road are not set.

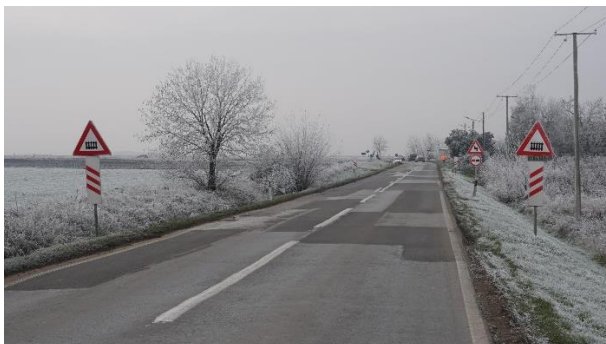
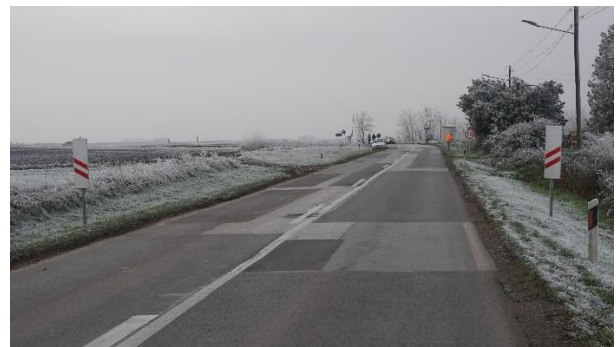
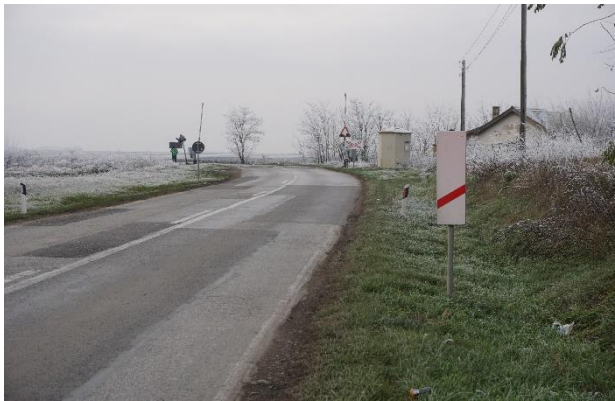
On the state road in question, before encountering the level crossing from the direction of the settlement Bajmok, towards Sombor, on the supporters, located on the left and the right side of the road next to the roadway, on the supporters located on the left and right side of the road next to the roadway and from the level crossing are approximately 240 m away, the following traffic signs are placed: I-32: “Crossing of a road with a railway with barriers or half-barriers” and I-35: “Approaching the place of crossing of the road and the railway” (Figure 2.2.3.9.). On the supporters, located on the left and right side of the road next to the roadway and from the level crossing are approximately 160 m away, the following identical traffic signs are placed: I-35: “Approaching the place of crossing of the road and the railway” (Figure 2.2.3.10.) On the supporters, located on the left and right side of the road next to the roadway and from the level crossing are approximately 80 m away, the identical traffic signs are placed: I-35: “Approaching the place of crossing of the road and the railway” (Figure 2.2.3.11.). On the supporter, located on the right side of the road next to the roadway and is 5.5 m away from the level crossing (start of the rubber panel), the traffic sign: “Saltire” is placed, on the supporter located on the right side of the road, next to the roadway and is 3.8 m away from the level crossing (start of the rubber panel), the traffic lights IV-9, regulating the crossing of the road over the railway line at the same level, are placed (serving for announcing the train approaching and announcing of the half-barrier lowering), while the half-barrier supporter is placed on the right side of the road next to the roadway and is 2.4 m away from the level crossing (Figure 2.2.3.12.)

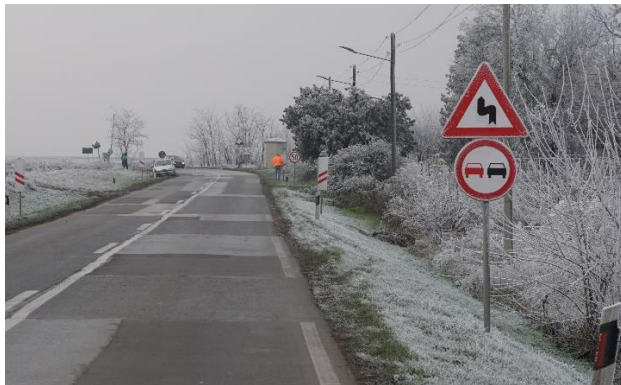
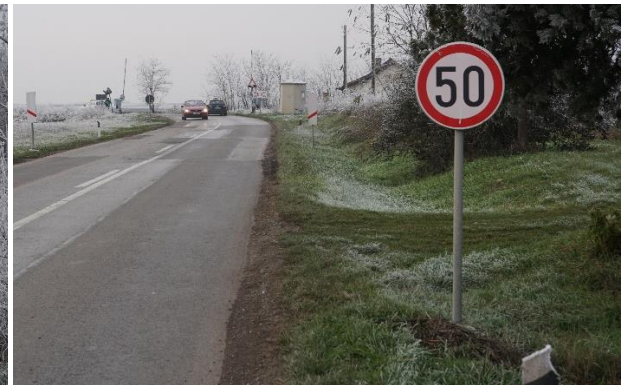
Apart from the mentioned traffic signs, on this section of the state road from the direction of Bajmok to the direction of the level crossing, the following traffic signs are placed: I-2: "Double curve or more than two consecutive curves, the first of which is on the left" and II-28: "Overtaking ban for motor vehicles" (placed on the same supporter, which is located on the right side of the road, next to the roadway and is approximately 210 m away from the level crossing, Figure 2.2.3.13.) and the traffic sign II-30: "Speed limit" (placed on the supporter on the right side of the road next to the roadway and is approximately 115 m away from the level crossing, Figure 2.2.3.14.). Other traffic signs on this section of the road are not set.

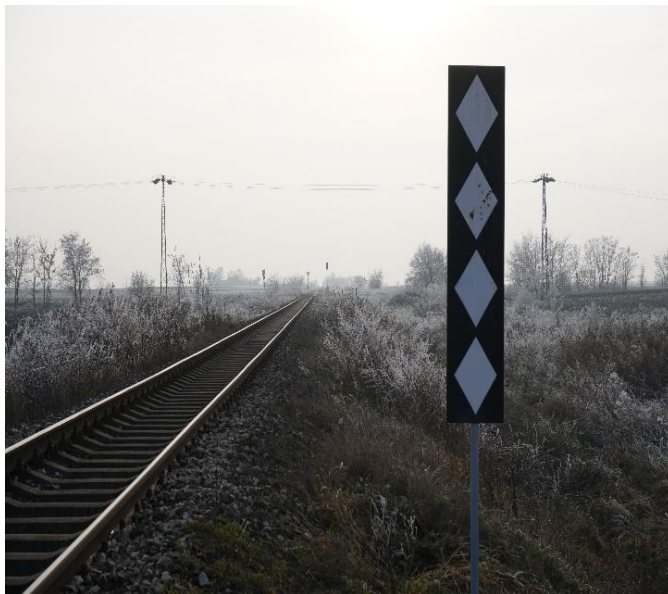
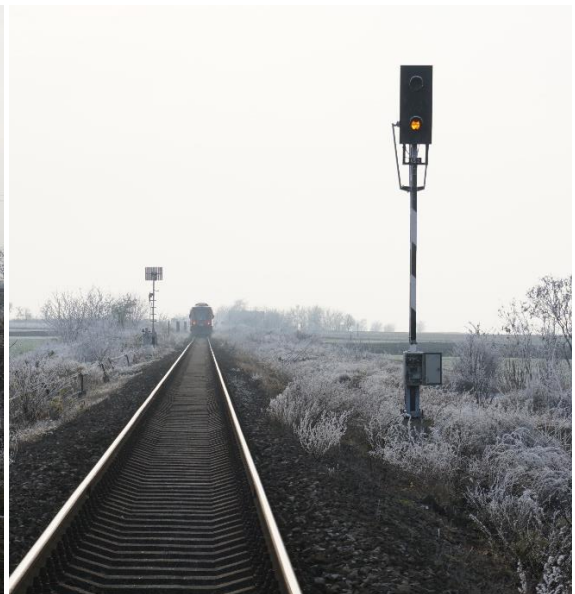
On the main arterial line, before encountering the level crossing in question, from the direction of the station Bajmok to the station Sombor, at km 103+866, the switching point signal is set, aspect of a signal 57: “Switching point, expect control signal”, and at km 103+587 the control light signal KS 2 is set (Figures 2.2.3.15. and 2.2.3.16.). The mentioned signals are placed on the right side of the track, viewed in the direction of decreasing stationing, that is, in the direction of the train No. 6431 movement.

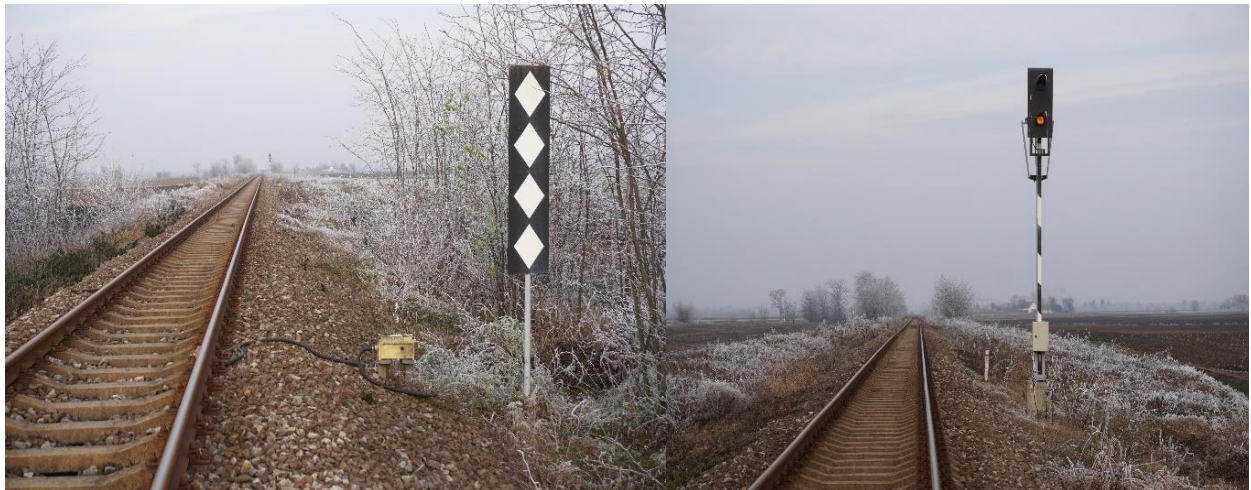
**Figure 2.2.3.17:** The view of the switching point signal on the main arterial line (view from direction of station Aleksa Šantić)

On the main arterial line, before encountering the level crossing in question, from the direction of the station Sombor to the station Bajmok, at km 101+909 the switching point signal is set, the aspect of a signal 57: “Switching point, expect control signal”, and at km 102+187, control light signal KS 1 is set (Figures 2.2.3.17. and 2.2.3.18.) The mentioned signals are placed on the right side of the track, viewed in the direction of increasing stationing.

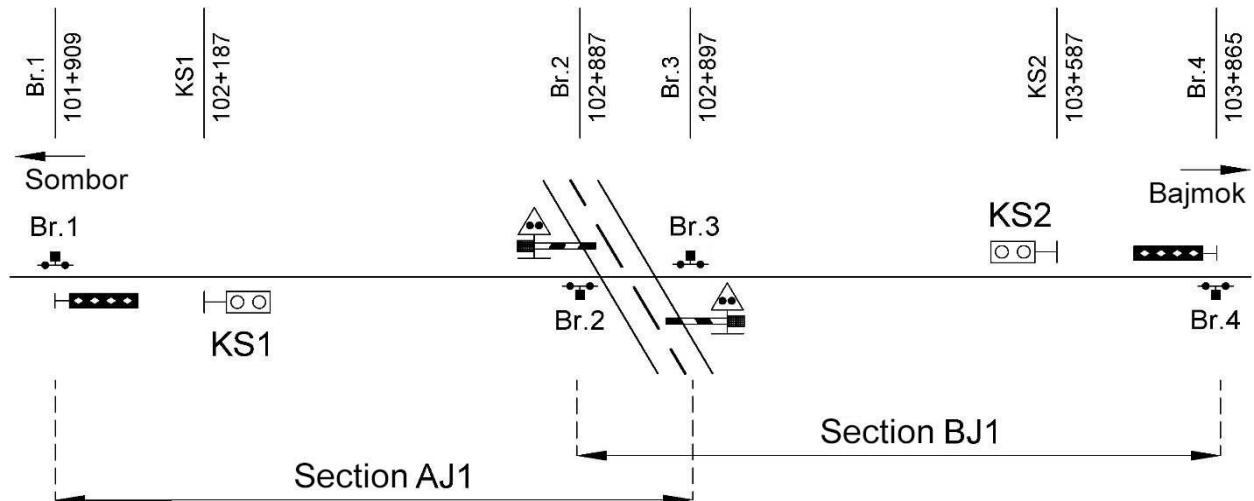
Figure 2.2.3.3.1: Block diagram of inclusive sections and disposition of external elements

- switching point K1/11 at km 101+909, ie axle counter sensor No.1 - at this point a command is given for switching on the road crossing for trains coming from the direction of Sombor,
- switch-off point K31/131 at km 102+887, ie axle counter sensor No.2 - at this point a command is given to switch off the road crossing for trains coming from the direction of Bajmok,
- switch-off point K32/132 at km 102+897, ie axle counter sensor No.3 - at this point a command is given for switching off the road crossing for trains coming from the direction of Sombor,
- switching point K2/12 at km 103+865, ie sensor of axle counter No.4 - at this point a command is given for switching on the road crossing for trains coming from the direction of Bajmok.

Appropriate counting sections are formed between these counting points, the switching section AJ1 between the axle counter sensors No.1 and No.3, and the switching section VJ1 between the axle counter sensors No.4 and No.2 (Figure 2.2.3.3.1.).
