No.: ŽS - 02/21

Date: 01.06.2022.

FINAL REPORT ON SERIOUS ACCIDENT INVESTIGATION

Accident type:	Overtaking of the pushed shunting composition on the railway worker
Shunting composition:	Locomotive 443-06 and 2 (two) wagons of type Arbel, series Faboo
Accident location:	Obrenovac, TENT Obrenovac, area of the station Obrenovac
Date:	12.07.2021.
Time:	07:43

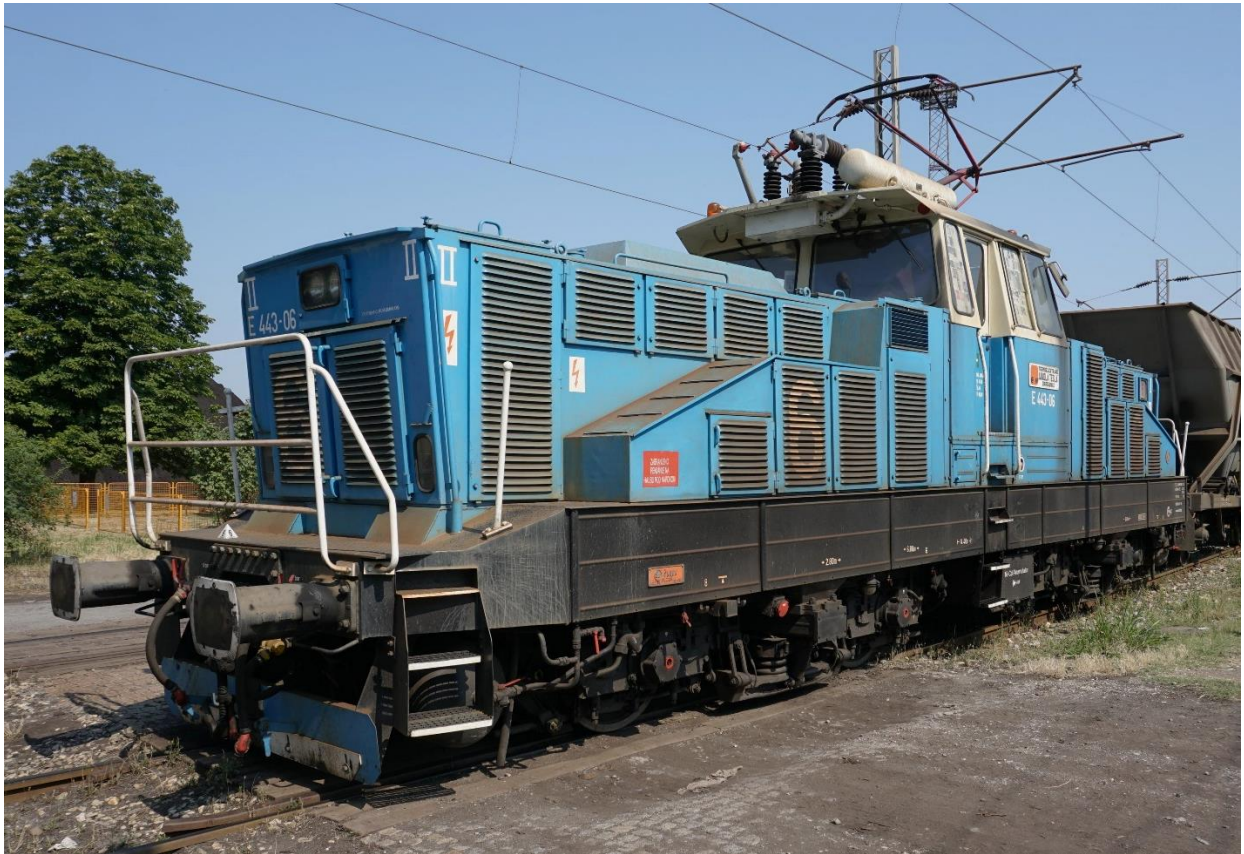
Figure 2.2.2.1: Appearance of locomotive 443-06

In the driver cab of the locomotive 443-06 there are two control tables, placed diagonally, so that the train driver when operating the locomotive can see only one longitudinal side of the locomotive, ie the shunting composition. The view of the track directly in front of the locomotive, ie the shunting composition, is limited by the length of the part of the locomotive from the driver cab to the front part of the locomotive, ie the length of the shunting composition. The view from the driver cab of the locomotive 443-06 from the position where the train driver was at the time of this serious accident, is shown in Figures 2.2.2.2. and 2.2.2.3. On the front sides of the locomotive there are platforms with access steps and handrails. The appearance of the platform with handrails on the front side of the locomotive 443-06 is shown in Figure 2.2.2.1.

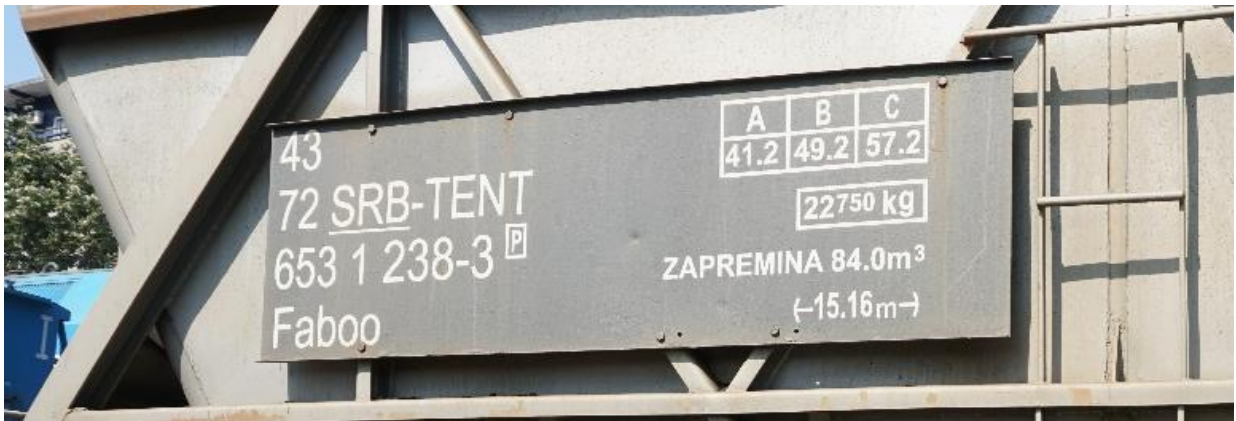
Figure 2.2.2.5: Tables of the Arbel type wagon, Faboo series No.43 72 6531 238-3

On Arbel type wagons, the Faboo series, the installation of steps and handrails for the shunter is not structurally envisaged (see Figure 2.2.2.4).
