Rail Accident Report

Freight train derailment near Gloucester 15 October 2013

Report 20/2014
October 2014

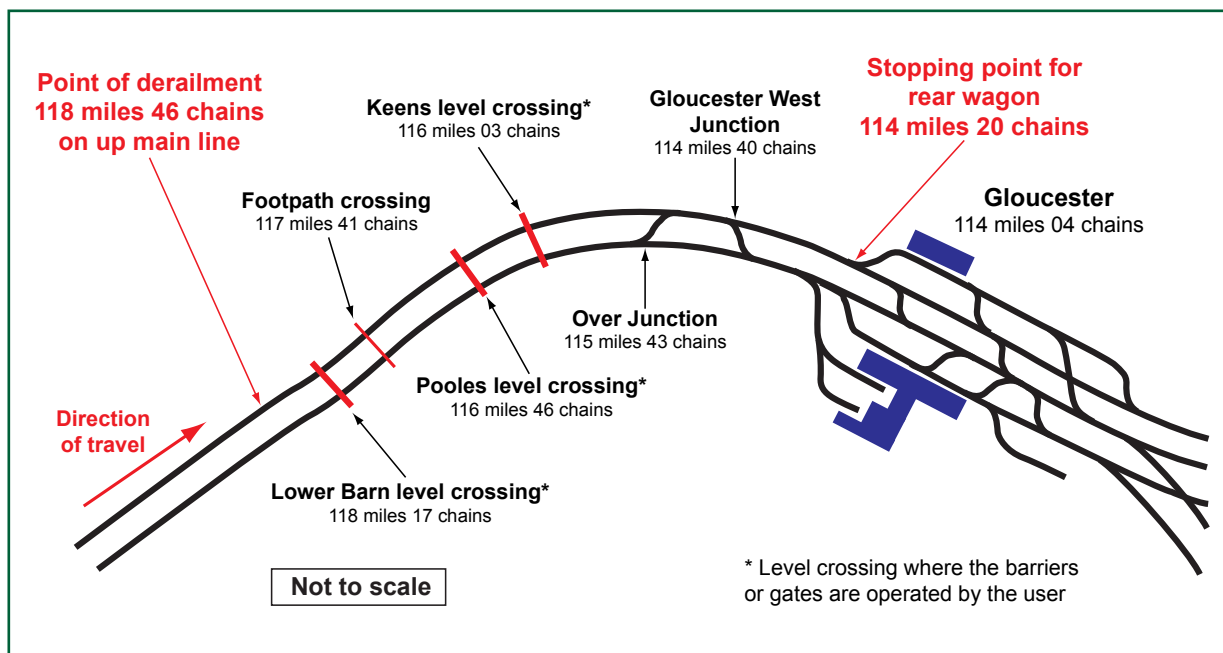
Figure 2: Track layout from the point of derailment through to the train's stopping point

- 7 The train driver was unaware of the derailment and the train continued with one wheelset derailed for a distance of around 3.8 miles (6.1 km) until, at Gloucester West Junction (figure 2), the derailed wagon collided with a set of *facing points* while travelling at 22 mph (35 km/h). Here both wheelsets were torn from the rear *bogie* and the empty container on the rear of this wagon was thrown off into the cess (figure 3).

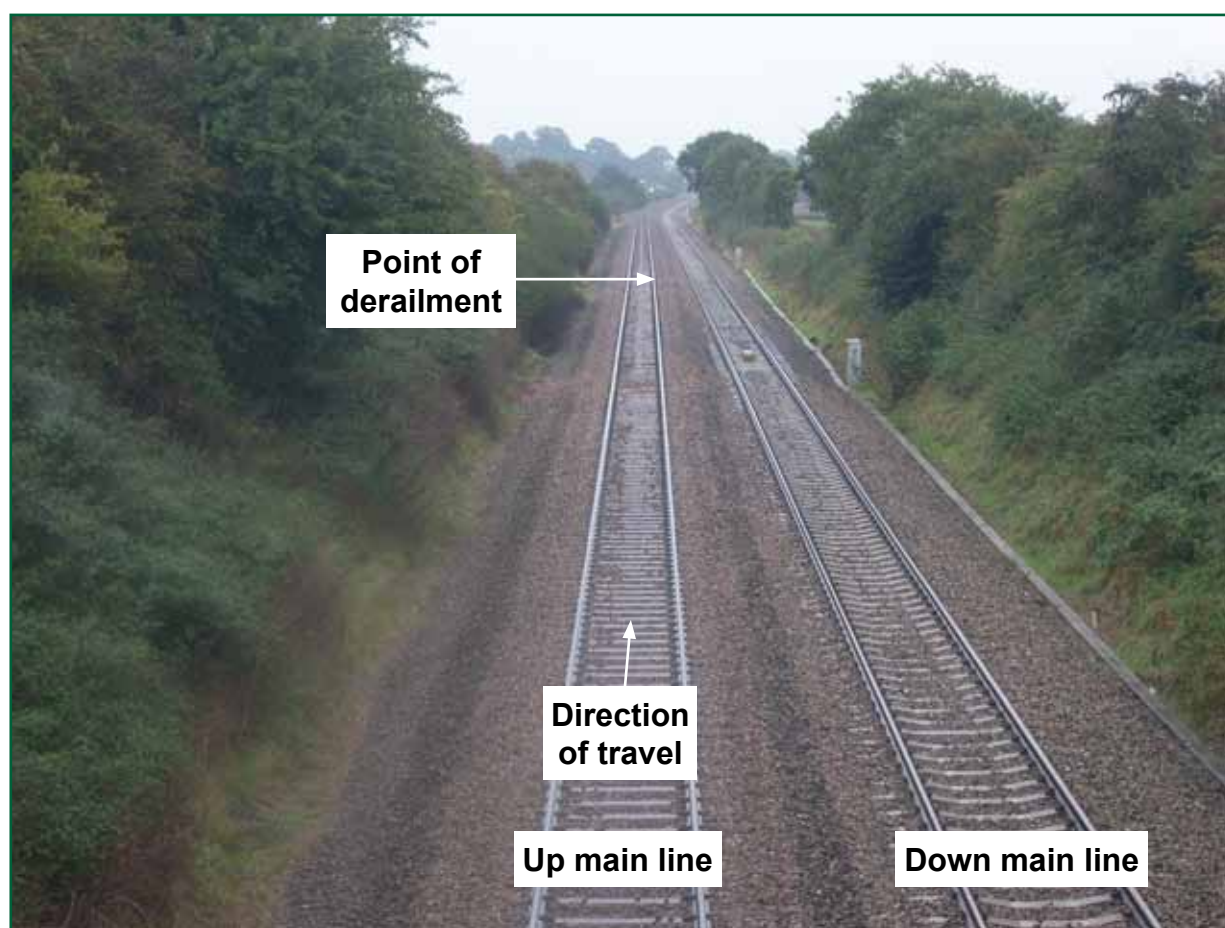
Figure 4: Location of the derailment

- 10 The derailment occurred on the *up main* line between Lydney and Gloucester, at 118 miles and 46.64 *chains* (from a zero reference at London Paddington station), which is part of Network Rail's *Western Route*.
- 11 At this location, the two track railway comprises the *up main* and *down main* lines (figure 4). The permitted speed for trains on both lines is 90 mph (145 km/h), although the maximum speed for the train that derailed was 75 mph (121 km/h). The derailment happened in a cutting, where the track is straight and on a gradient of about 1 in 370 (0.27%), rising in the train's direction of travel.

- 69 The track where the cyclic top track defect was found was in a cutting (figure 4). Water was draining into the adjacent land, flowing under the cutting and beneath the track (figure 13). There was no track drainage installed along the cess to intercept the water flowing under the cutting before it reached the up main line.

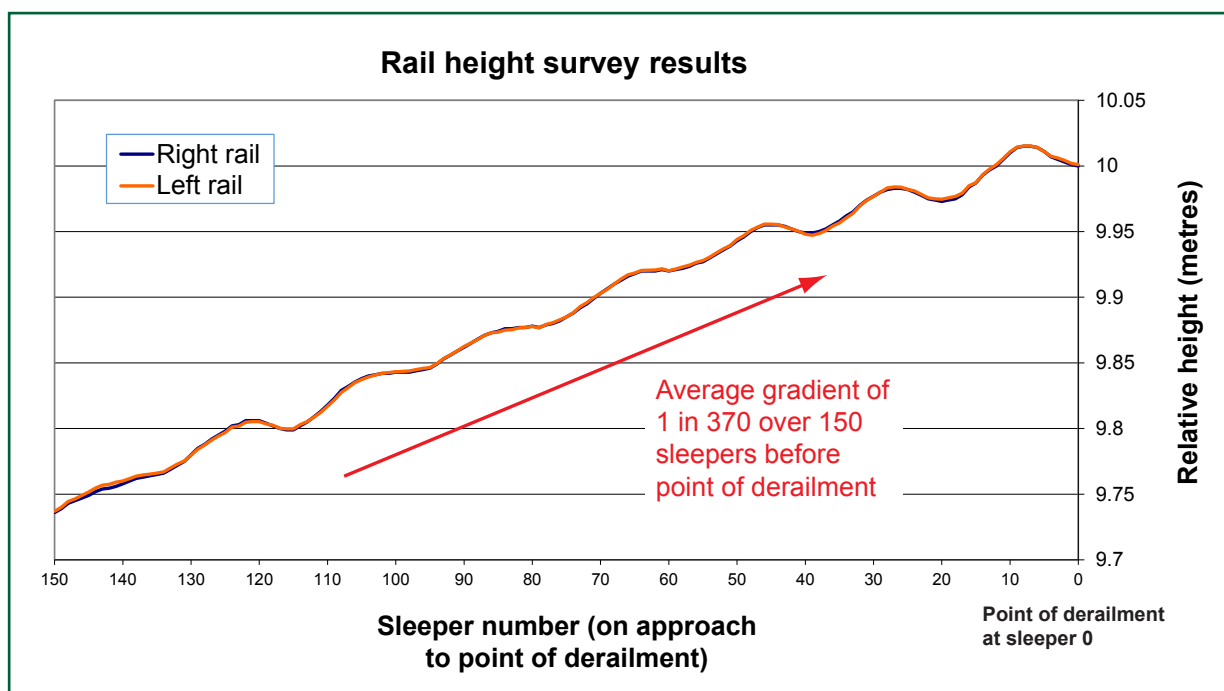
Figure 10: Graph showing the changes in vertical height of the rails

- 59 The point of derailment was located on the up main line. A visual examination and survey of the track at this location identified regularly spaced variations in the vertical height of both rails, consistent with cyclic top (figures 9 and 10). Analysis of the survey data found the cyclic top fell into the track defect category requiring immediate action according to NR/L2/TRK/001/mod11 (table 1).

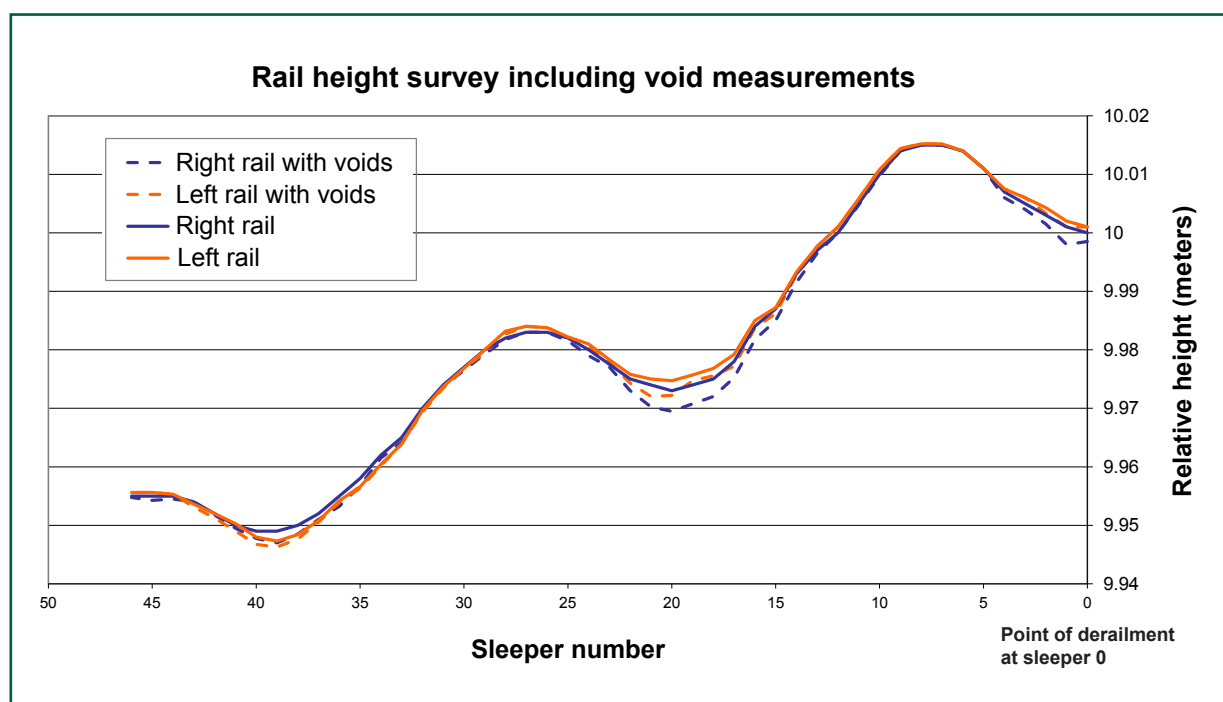
Figure 12: Graph showing the changes in vertical height of the rails with the void measurements included

- 64 Regularly spaced dips in the height of both rails, at a wavelength of about 13 metres, could be seen by eye on the approach to the point of derailment. In addition to the track geometry survey (paragraph 61), the RAIB also surveyed the height of the rails over 150 sleepers before the point of derailment (figure 10) to measure the size of these regular dips. Voiding under the sleepers was measured over 46 sleepers before the point of derailment to obtain data to understand the effect of the weight of a passing train. The highest void measurements coincided with locations of dips, whereas no voiding was found elsewhere (figure 12), indicating that the dips were bigger when the track was loaded by a passing train.

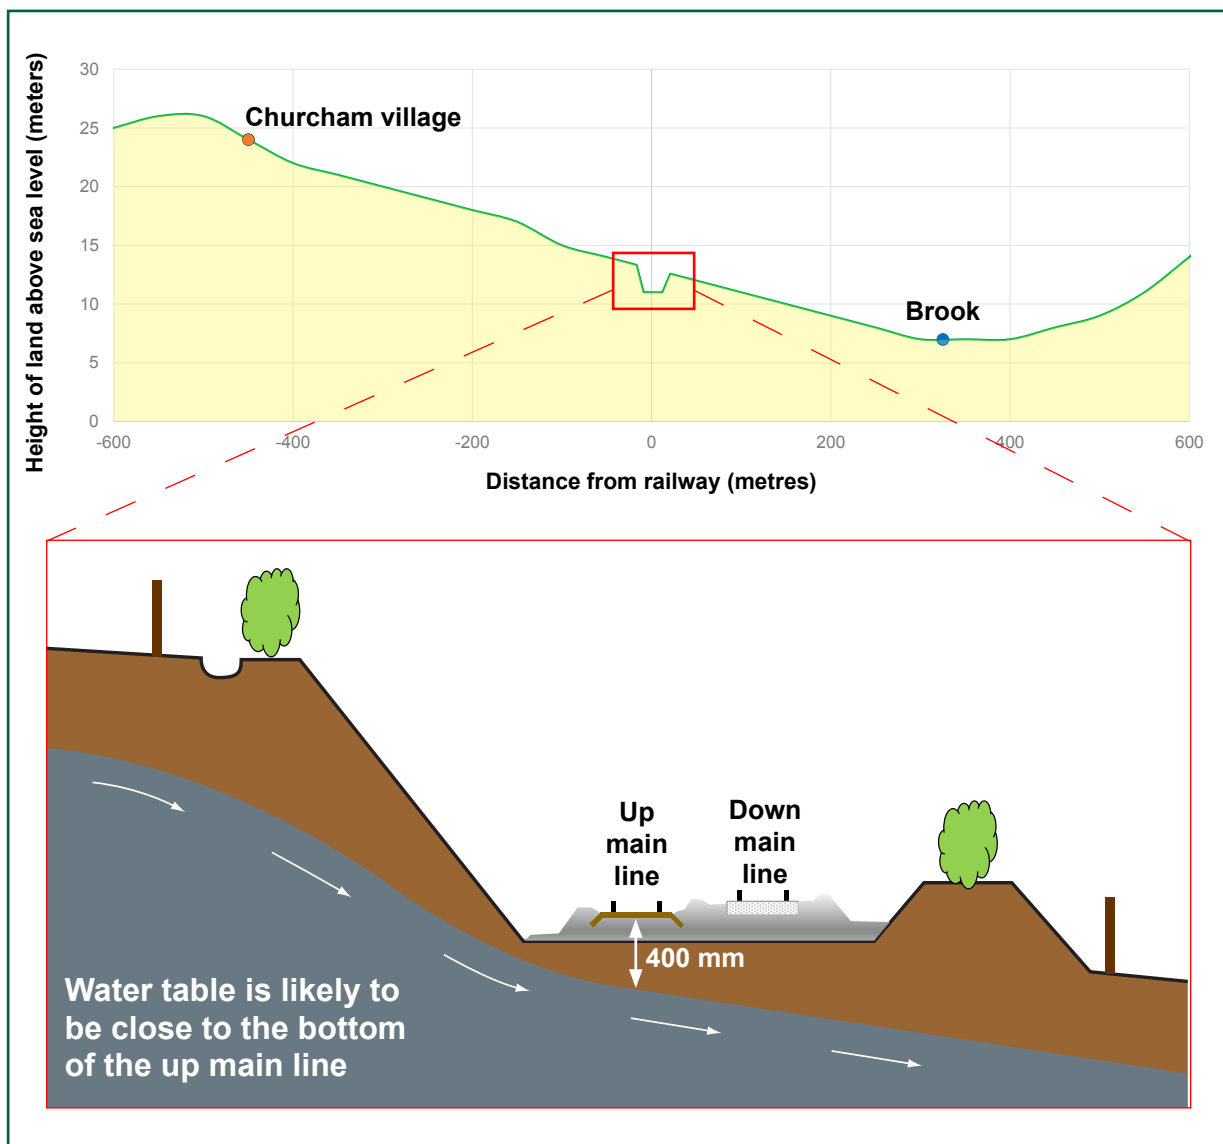
Figure 13: Profile of the land perpendicular to the railway and side view of the cutting

- 71 The profile of the land perpendicular to the railway line on which the train derailed is shown in figure 13. This shows the height of the land falls steadily over a distance of about 800 metres, from 26 metres above sea level near to Churcham village, to 7 metres above sea level, where a brook flows from east to west before reaching the River Severn. The railway is located about 500 metres from the high point, about 13 metres above sea level. When the railway was built, it was cut through the side of this slope, with the deepest point cut into the slope coincident with the bottom of the cutting slope on the up main line. It is likely that following periods of heavy rainfall, water permeated into the ground above the railway and flowed downhill through the ground towards the brook, causing the local water table to rise. This meant the raised water table was close to the bottom of the track bed on the up main line as shown in figure 13.

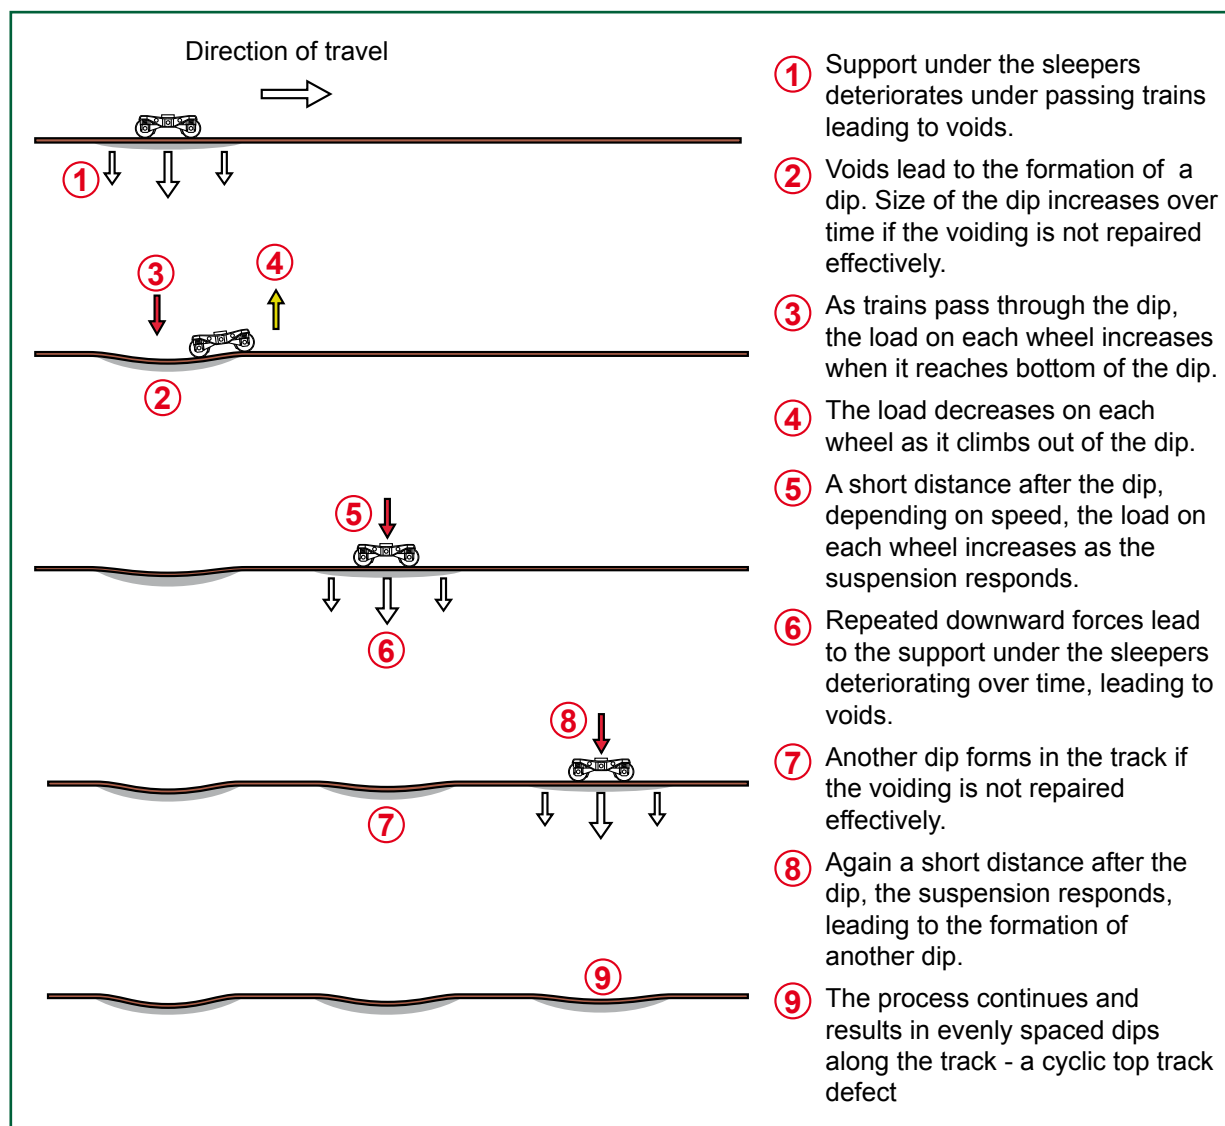
Figure 17: Formation of a cyclic top track defect

- 76 Over time, water flowing under track had softened the soil in the formation. The softened soil then mixed with water to create mud. The weight of passing trains had caused this mud to seep up through the ballast, forming a feature commonly known as a 'wet spot'. The wet spot coincided with a loss of support under the sleepers due to the softened formation, resulting in a dip in the track. One dip can then be the trigger for the formation of a cyclic top track defect. Figure 17 shows that when a wheelset passes through the dip, its suspension responds to the change in rail height, so after the wheelset exits the dip the load on its wheels is decreased. Further along the track the suspension will respond again and the load on the wheels will increase, exerting a downward force on the track. If the speed of each passing train is similar, these repeated downward forces will be in the same place and will eventually cause the support under the sleepers in that location to deteriorate. This deterioration leads to voiding and the formation of a new dip. Trains passing over this new dip cause another dip to form and so on. Therefore as trains continued to pass over the up main line, more and more dips had formed at regular intervals, resulting in a cyclic top track defect. Data from Network Rail's track geometry recording train shows that the cyclic top grew in size from 2010 onwards (paragraph 82).

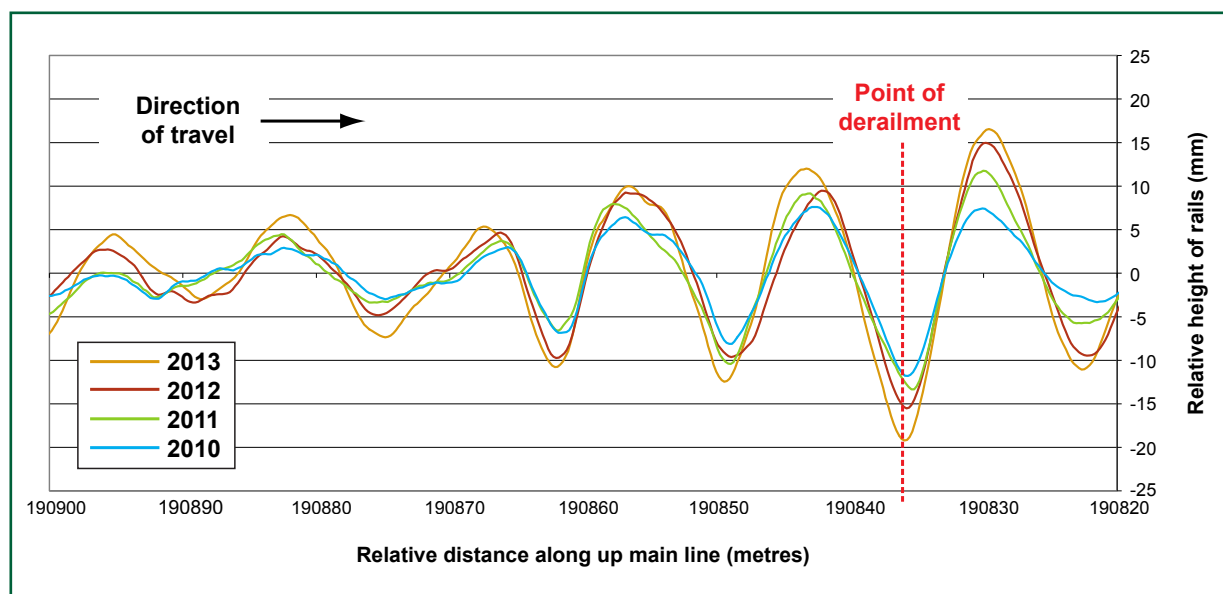
Figure 18: Track geometry recording data from 2010 to 2013

82 Following each inspection, work orders were raised for the defects that were found and each work order was given a time within which the work was required to take place. Records show that the local Network Rail maintenance team were responding to these faults by carrying out short term repairs. However, none of this work was effective or long lasting as the cyclic top, and therefore track quality too, continued to worsen. This can be seen from the data recorded by track geometry recording trains since September 2010 (figure 18). At the same time, medium term work to repair these defects was planned and carried out in October 2013 and a longer term solution was planned from August 2013. The short, medium and long term activities are now considered in turn.

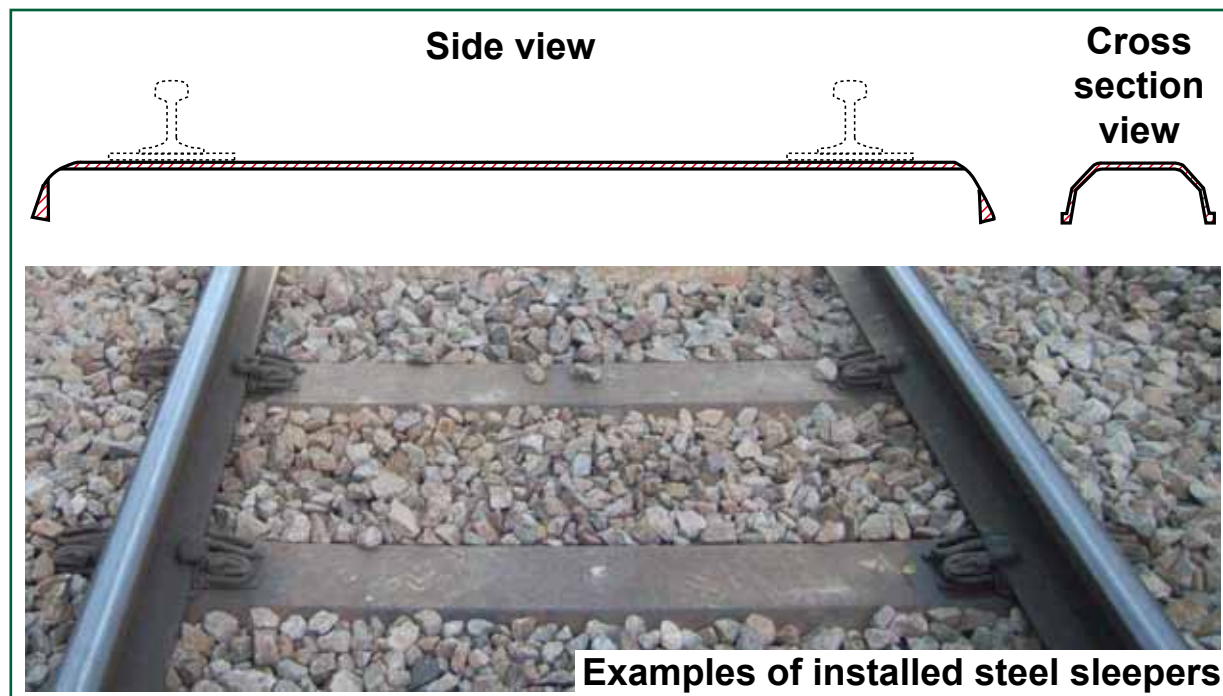
Figure 19: Steel sleeper profile

- 83 For track with poor vertical track geometry, the standard repair method used by track maintenance teams is measured shovel packing (paragraph 44) using small stones or chippings. However, Railtrack had installed steel sleepers on the up main line at this location in 2002¹³ and their hollow shape (figure 19) meant that measured shovel packing could not be used (paragraph 46).

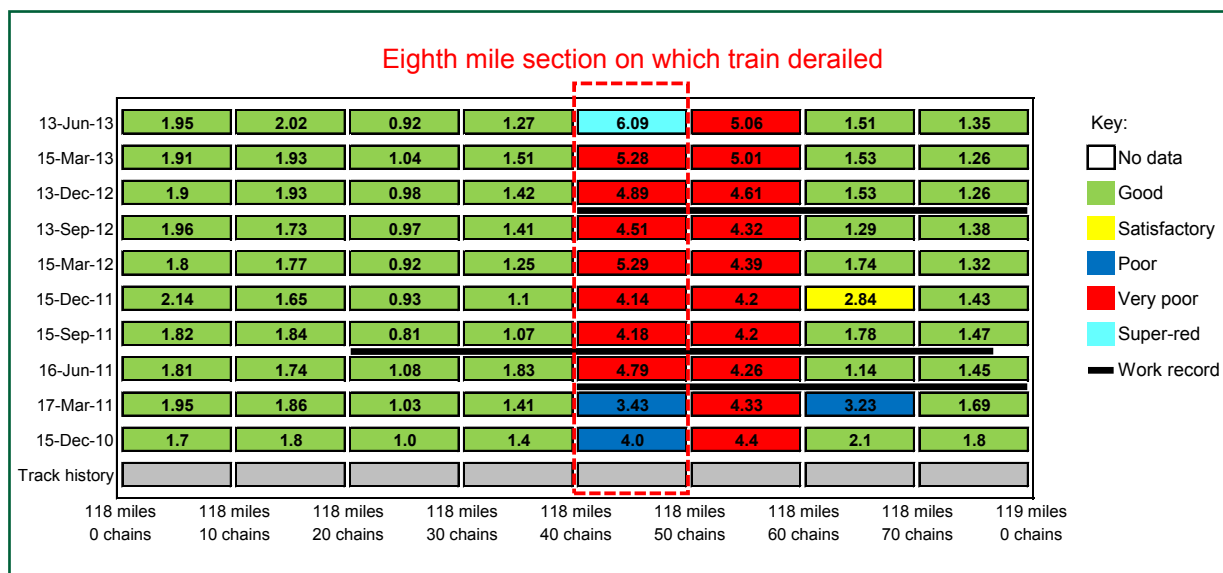
Figure 20: SD chart for the up main line

106 The overall poor quality of the vertical track geometry also meant that Network Rail should have imposed a speed restriction to comply with NR/L2/TRK/001/mod11. Figure 20 shows the SD chart (paragraphs 42 to 43) covering the point of the derailment after the last ten track geometry recording runs up until June 2013. It shows how the eighth of a mile section where the derailment happened had worsened over time.

107 By June 2013, its SD value was in the maximum band, the 'super-red' category. Once it became a super-red site, NR/L2/TRK/001/mod11 required the Track Maintenance Engineer to take action to improve its quality. NR/L2/TRK/001/mod11 also states that if the action undertaken is not sufficient to move the SD value out of the maximum band then a speed restriction must be imposed.

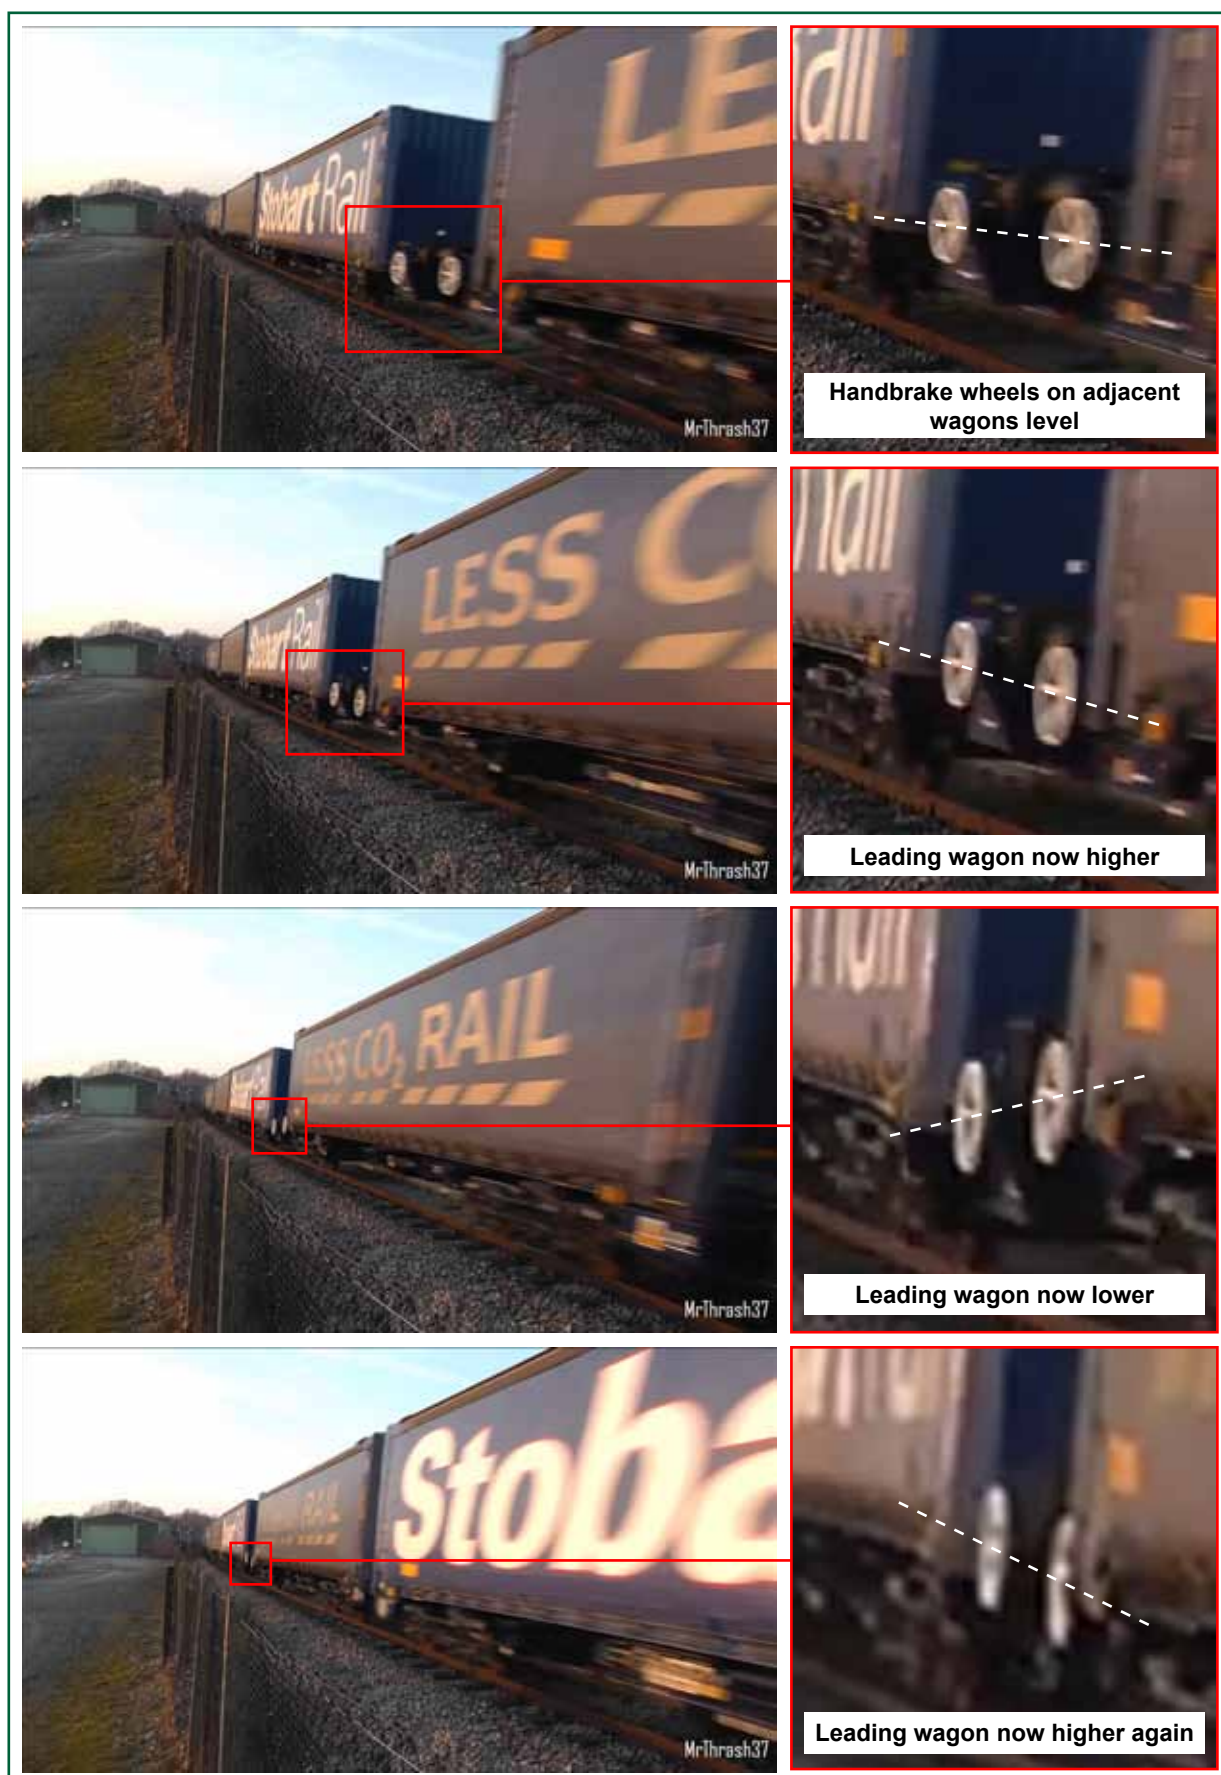
Figure 22: IDA wagons passing Moreton on Lugg (images courtesy of MrThrash37 – YouTube)

- 124 Video footage of a train comprising IDA wagons passing Moreton on Lugg, Herefordshire, on 9 March 2014 demonstrates how this type of wagon rides over changes in vertical track geometry (figure 22). The wagons were either tare or partially loaded and passed over a cyclic top track defect at 67 mph (108 km/h). A track geometry recording train had passed over this line on 14 February and found a cyclic top track defect that required repair within 60 days. The size of the reported defect was 21 mm, at a wavelength of 13 metres, on the right-hand rail, over a distance of 2 chains (40 metres).

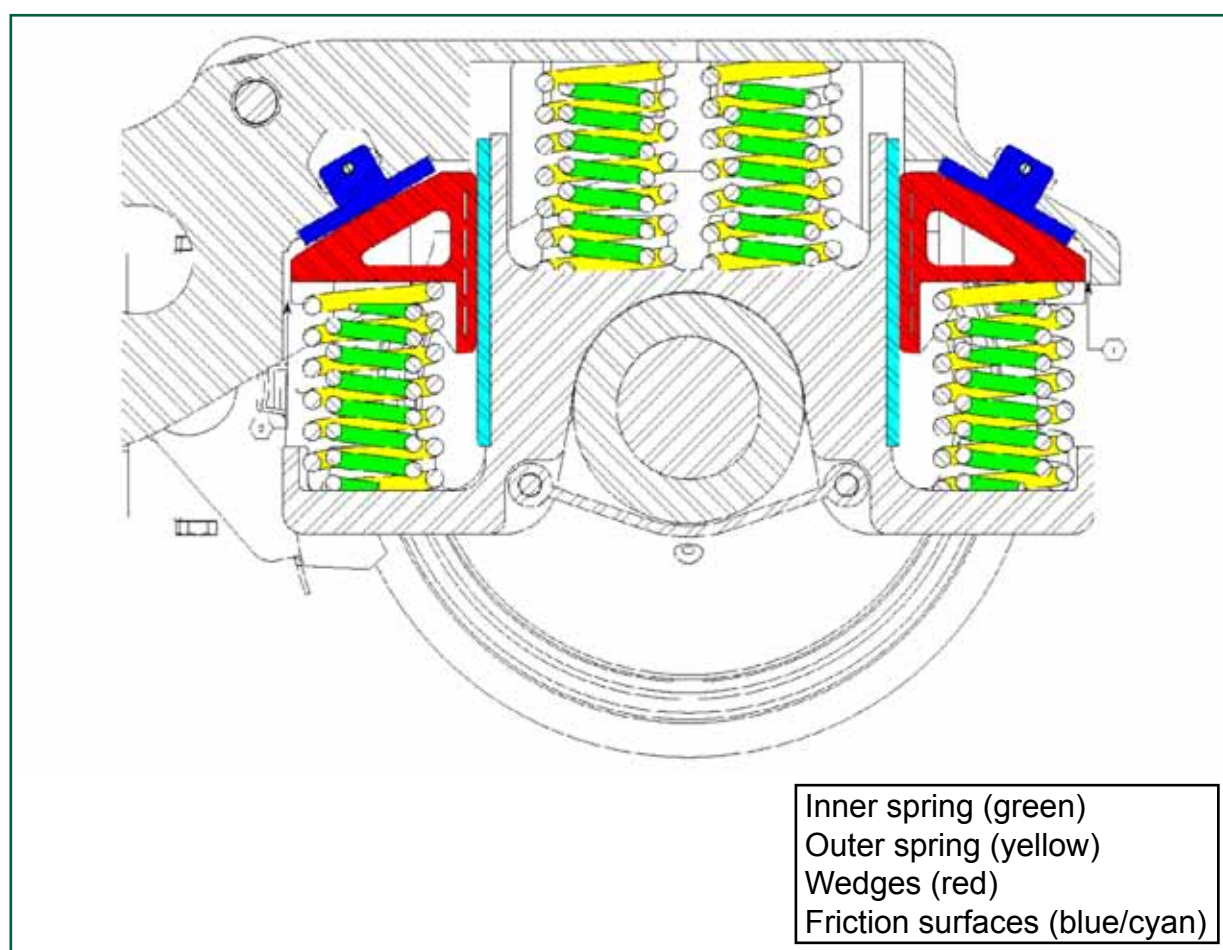
Figure 23: The primary suspension on an IDA wagon

127 The suspension on the IDA wagon uses friction to provide its damping. The *primary suspension* at the end of each axle has four sets of springs, each comprising an inner and an outer spring (figure 23). With no load other than the weight of the wagon itself (ie tare), only the outer spring is in contact between the axlebox and the bogie frame. As the load on the wagon is increased, the inner spring also comes into contact and this increases the vertical stiffness of the suspension. Figure 24 shows that the inner spring comes into contact with a load of 5.76 tonnes on the wagon (2.88 tonnes on each bogie). When the wagon has a partial load on it, such as an empty curtain-sided container which weighs 5.99 tonnes, the inner spring is just in contact but with a comparatively light load. This is generally the worst condition for vertical ride performance as vertical inputs from the track then cause the inner springs to move into and out of contact leading to rapid changes in the suspension stiffness. These changes in stiffness, combined with the light load and the commensurately small amount of friction damping, give rise to a bigger response to vertical track inputs than is seen for either the tare or fully laden wagon.

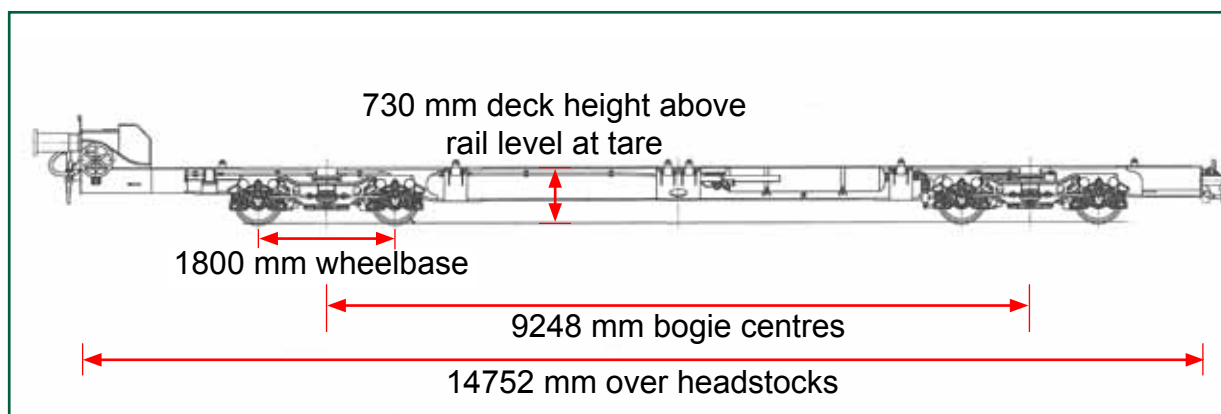
Figure 25: Dimensions of an IDA wagon (courtesy of W H Davis)

128 The response to vertical track inputs seen with both a tare and a partially loaded wagon can result in large amounts of wheel lift (paragraphs 121 to 122). The IDA wagon has a very low profile so it can carry 9 foot 6 inch (2.9 metre) high containers over routes which these containers would otherwise be prohibited from. With no load on it, the wagon's deck is just 730 mm above rail level (figure 25), which is achieved by using small wheels measuring 577 mm in diameter and a compact bogie design. The bogie design is also constrained by the maximum height limit for the wagon when loaded. The maximum amount of upward vertical movement within the suspension is 25 mm. For any further vertical movement after this distance, the suspension becomes very stiff with no damping, as the end of the vehicle, including its bogie and wheels, is lifted up. This behaviour is evidenced by damage found during maintenance examinations. It would also result in large vertical accelerations at the bogie pivots, as found during the actual and simulated on-track testing (see paragraphs 134 to 149).

186 The dimensions of the IDA wagon are shown in figure 25. The distance from the centre of one bogie to the other on a vehicle is 9.25 metres. The wavelengths of cyclic top track defects are commonly derived from 60 foot (18.29 metres) rail lengths (paragraph 40). One of these wavelengths is about 9.14 metres, and being very close to the bogie centre spacing, cyclic top at this wavelength will cause the wagon to bounce. Other common wavelengths for cyclic top are 18.29 metres, 12.19 metres and 6.10 metres, which will cause a wagon with this bogie centre spacing to pitch (figure 32). Therefore the likelihood of the IDA wagon being excited by cyclic top track defects is greater than most other wagons, because the cyclic top wavelengths it will encounter match those which tend to stimulate pitching or bouncing due to its bogie centre spacing.

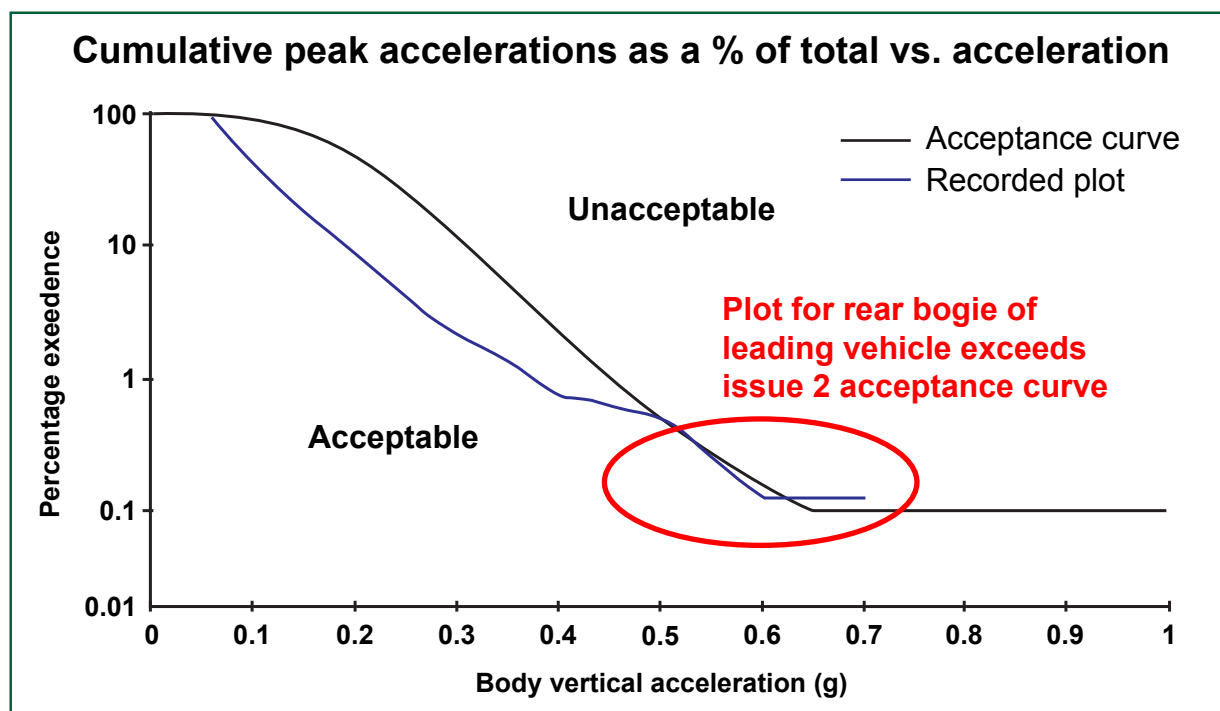
Figure 27: Peak counting plot for tare IDA wagon at 54 mph (87 km/h) on jointed track (from actual on-track tests)

138 The measurements for each on-track test run were analysed, looking for the number of peak accelerations above defined values. The results were then plotted on a graph and compared with an acceptance curve as defined in issue 2 of GM/RT2141. The results showed ride performance was marginally non-compliant to the acceptance curve at times, both in its tare and fully laden conditions. On sections of jointed track between Crewe and Derby at speeds above 50 mph (80 km/h), the distribution of vertical accelerations peaks exceeded the acceptance curve at the trailing bogie of the leading vehicle and the trailing bogie of the rear vehicle. An example of one of the recorded non-compliances is shown in figure 27.

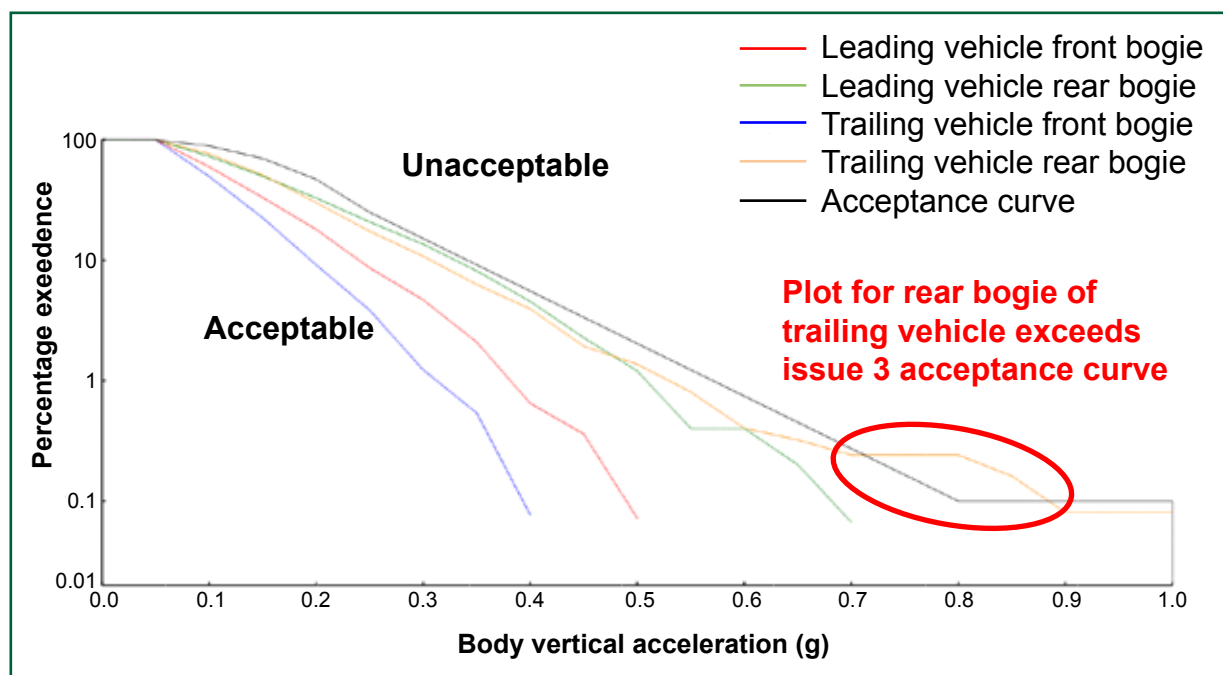
- 148 The results for the partially laden simulations found that the ride performance did not meet the GM/RT2141 issue 2 acceptance curve on twelve occasions. Each exceedance was recorded while running on jointed track, at a range of speeds between 50 mph (80 km/h) and 70 mph (113 km/h). Seven exceedances were at the rear bogie of the trailing vehicle and five at the rear bogie of the leading vehicle. When the results were compared against the issue 3 acceptance curve, there were still four exceedances at the rear bogie of the trailing vehicle, at a range of speeds between 60 mph (97 km/h) and 70 mph (113 km/h). One of the exceedances recorded at 60 mph (97 km/h) is shown in figure 29. Therefore these test results did not meet the revised ride performance criteria in issue 3 of GM/RT2141. Similar to the simulation results for the track geometry at Gloucester (paragraph 123), the worst ride performance was recorded at the unrestrained rear bogie of the trailing vehicle.

Figure 29: Peak counting plot for a part laden IDA wagon at 60 mph (97 km/h) on jointed track (from simulated on-track tests)

149 The study concluded that if the actual on-track testing had included a test with a wagon partially loaded so the suspension was at its stiffness change point, it is probable that the wagon would not have passed the acceptance tests.

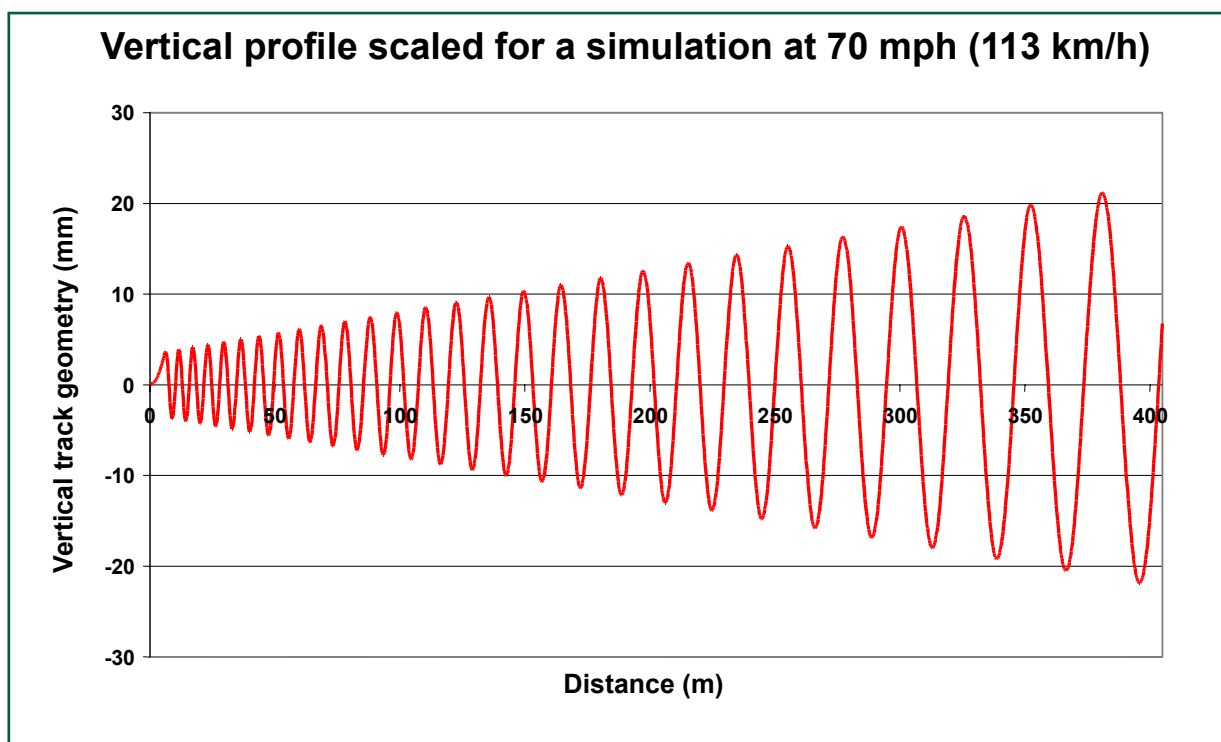
162 The test that was proposed in the draft GM/RT2141 was a computer simulation to evaluate a vehicle's response to defined cyclic top input from the track. The track input was 405 metres long and the wavelength of its vertical geometry altered throughout, from 5 metres at the start to 31 metres at the end (figure 30). The amplitude of input is adjusted as the wavelength changes over the length of the track to maintain a constant amount of energy from the track into the vehicle. The track input is also scaled depending on the speed of the vehicle being run over it.

Figure 30: The vertical track geometry used to evaluate a vehicle's response to a defined cyclic top input

- 163 Each vehicle is run over this track at speeds ranging from 40 mph (64 km/h) to 10 mph (16 km/h) above its maximum operating speed, in 5 mph (8 km/h) increments. The amount of wheel unloading is predicted at each wheel and to pass it must not be greater than 80%. The RAIB's study carried out this evaluation on the IDA wagon vehicle model in its tare, partially laden and fully laden conditions.

- 164 The results found that the fully laden vehicle passed this test but wheels on the tare wagon were completely unloaded at 50 mph (80 km/h) and above. Wheels on the partially laden vehicle were completely unloaded at 35 mph (56 km/h) and above. The maximum amount of wheel lift found was 33 mm during the test at 65 mph (105 km/h).

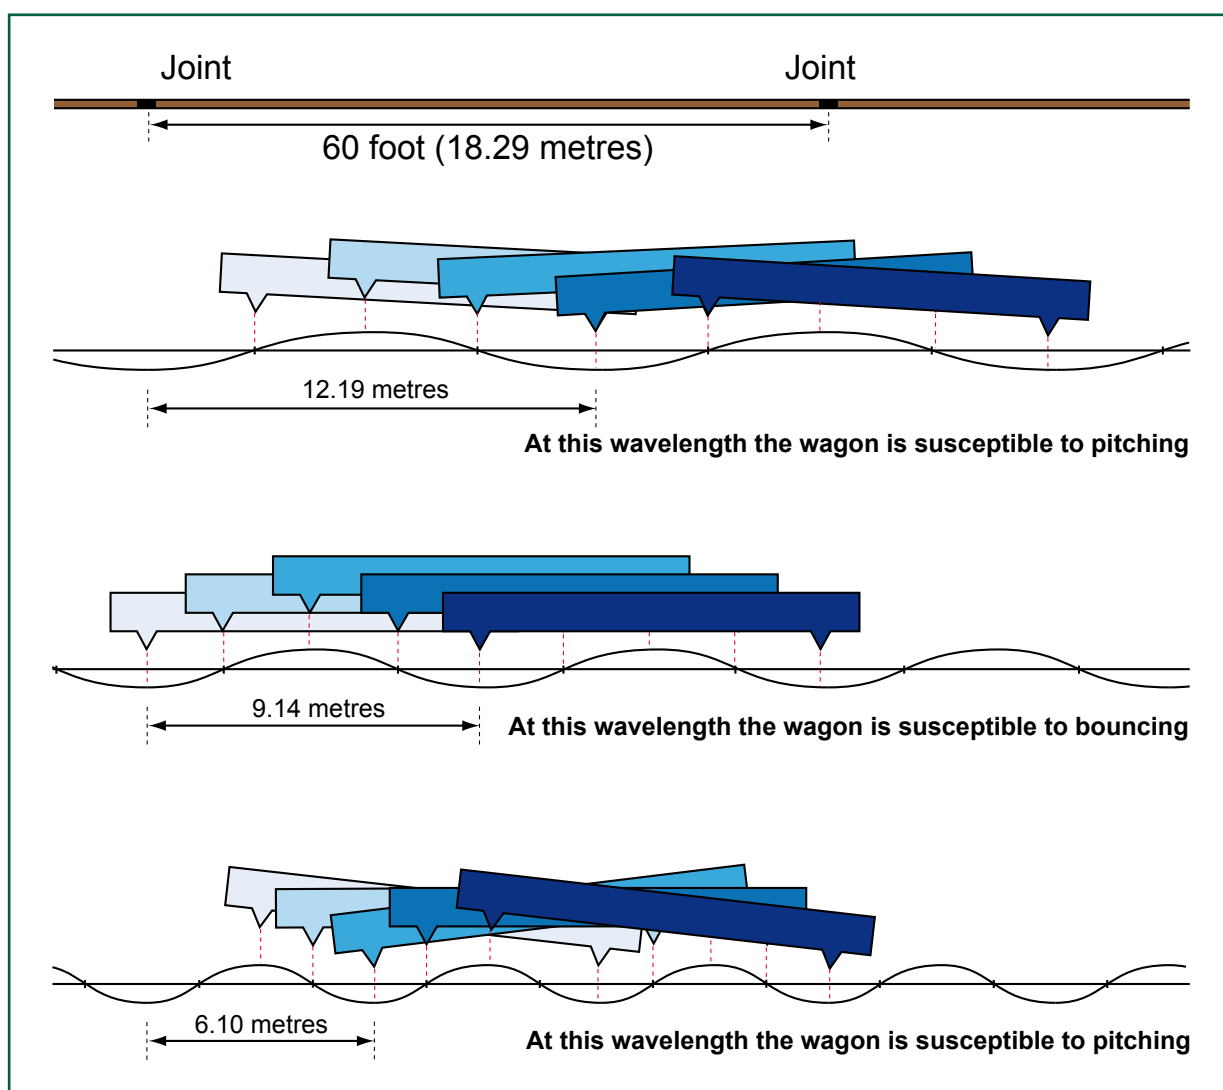
Figure 32: Cyclic top wavelengths derived from 60 foot (18.29 metres) rail lengths that cause the IDA wagon to bounce or pitch

187 The report for the on-track ride performance testing (paragraphs 137 to 141) also noted that the wagon's bogie centre spacing was about half the length of rails used on jointed track and that wagons with dimensions which are exact divisions of rail lengths are susceptible to resonance when running over jointed track.
