Rail Accident Report

**Road vehicle incursion onto the railway at
Aspatria, Cumbria
26 October 2013**

Report 14/2014
June 2014

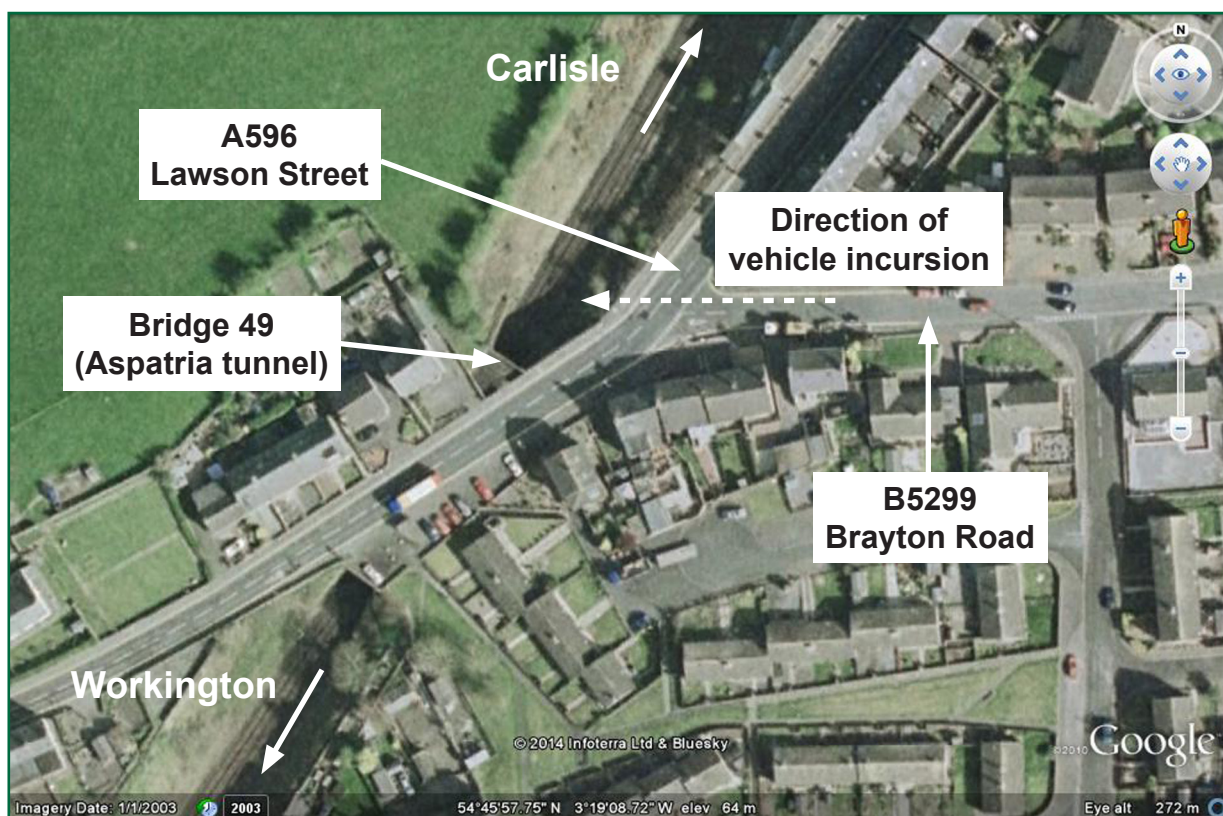
Figure 3: Site location, Aspatria

- 15 Bridge 49 carries the A596 road over the railway at a significant skew resulting in the width of the bridge between the *parapets* being 51.2 metres (56 yards). The A596 road runs from Thursby, just outside Carlisle, to Maryport and Workington and approaches the bridge from the north-east running broadly parallel to the railway until it crosses over it. It was classified as a *trunk road* until it was formally *detrunked* on 1 April 2003. Just before the road crosses the railway, there is a junction with the B5299 Brayton Road, approaching from the east (figure 3).

- 16 Brayton Road approaches the junction with the A596 on a downward gradient of about 3% (1 in 33) and directly opposite the junction the railway boundary is protected by a wooden fence. Beyond the fence, the railway lies in a cutting immediately before bridge 49. Between the end of the wooden fence and the bridge parapet there is a section of parapet laid on top of the cutting's *retaining wall* (figures 4a, 4b, 5a and 5b).
