**REPUBLIC OF BULGARIA**  
**NATIONAL AIR, MARITIME AND RAILWAY TRANSPORT, ACCIDENTS**  
**INVESTIGATION BOARD (NAMRTAIB)**

**FINAL REPORT**  
**from**

**investigation of railway accident – fire in fast train № 2613 during motion between the stations**  
**Kaspitchan and Provadiya on 03.11.2022**

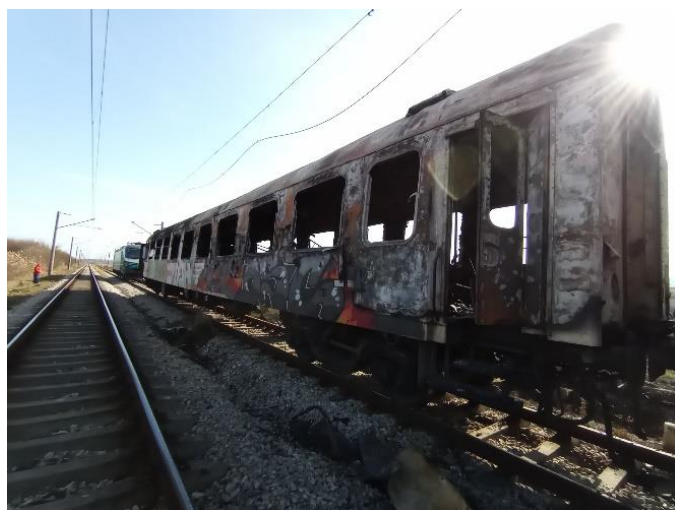
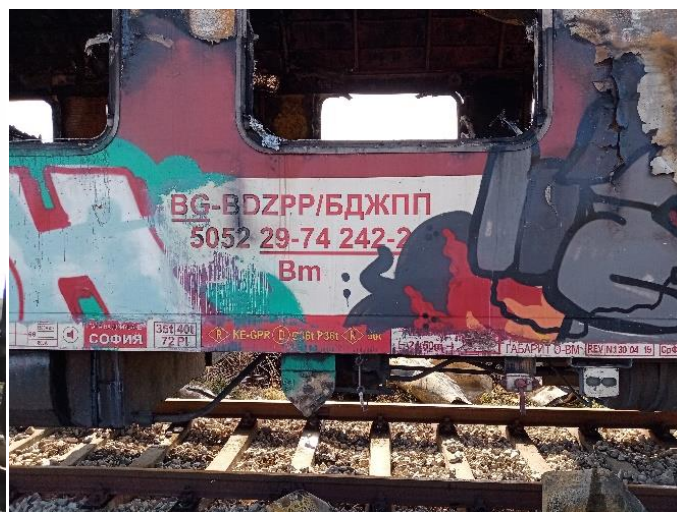
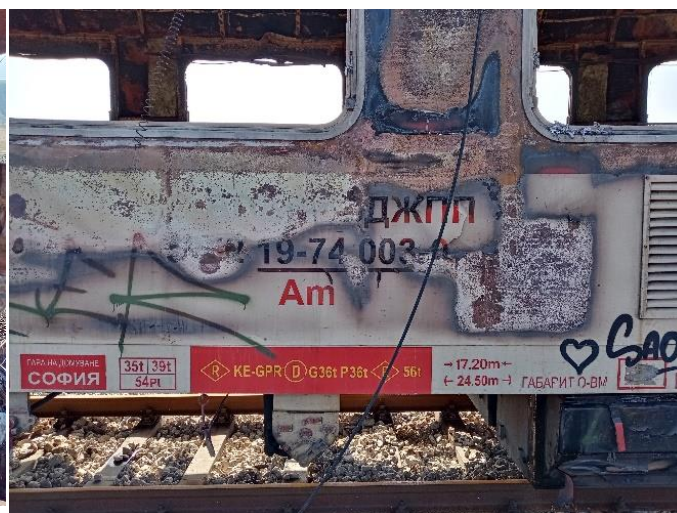
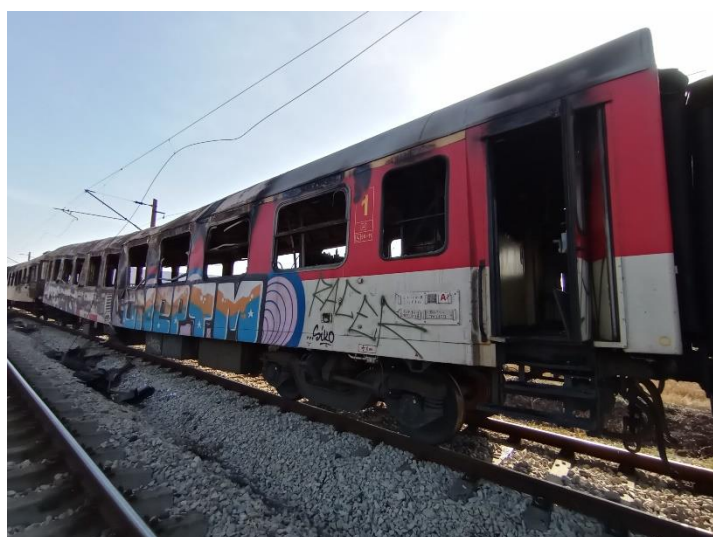
**Fig. 1.3.**

The transport crew that serviced the train (train master and conductor) provided assistance to the passengers in removing them with their personal luggage from the train. No passengers or staff were injured in the fire. Damage was caused to the catenary (overhead contact network, to the first two burned passenger coaches of FT No. 2613: No. 50522974242-2 B4 (fig. 1.3, 1.4, 1.5) and No. 50521974003-0 A4 (fig. 1.6, 1.7, 1.8). The fire did not affect the third and fourth coaches of the train.

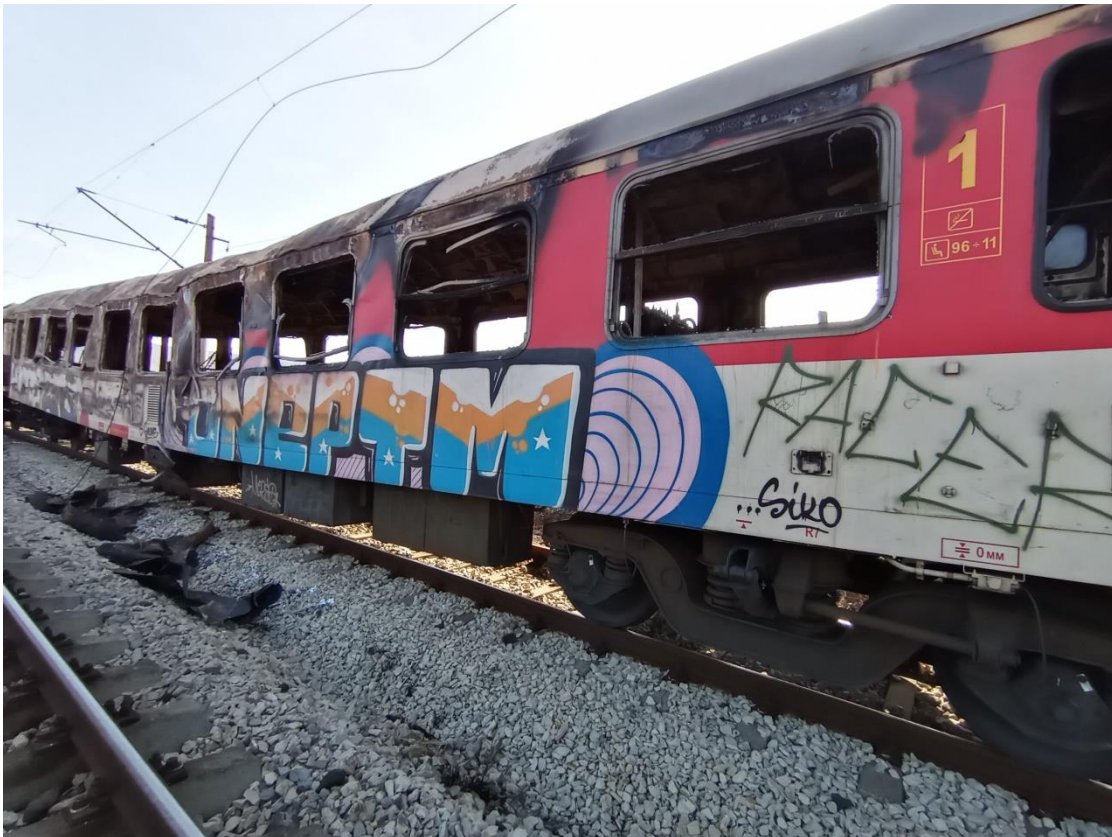
**Fig. 4.8.**

The Investigation Commission carried out several inspections of the burning coaches both at the place of the accident along Kaspitchan - Provadiya interstation at km 462+000 (fig. 4.8) and at the Gorna Oryahovitsa wagon depot, where they were settled in a garage (fig. 4.9 and 4.10 ).

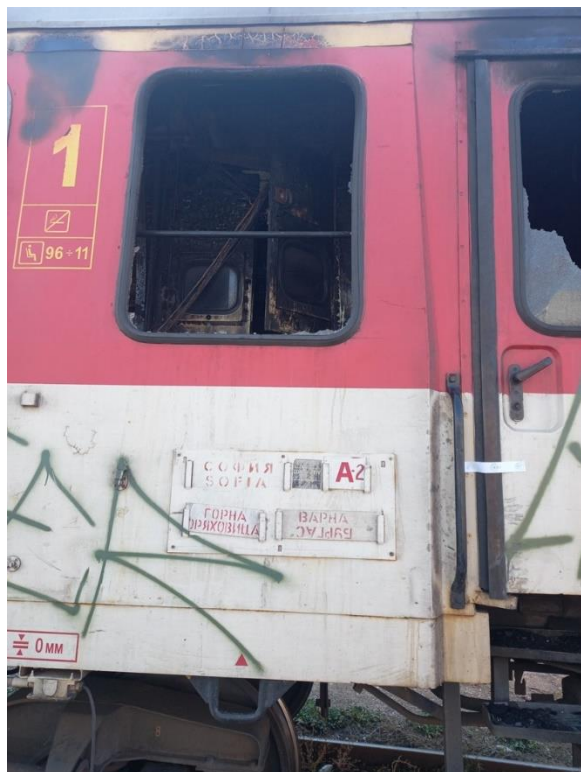
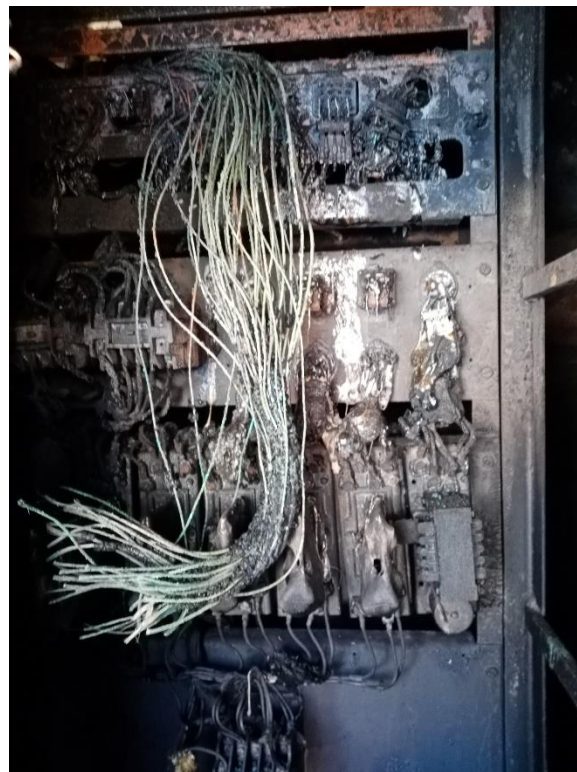
**Fig. 4.12.**

- **Apparatus cabinet** –the apparatus cabinet was burnt, but all indications were that it was due to smoke saturation and the burns caused by an elevated outside temperature, with all the fuses on, i.e. the possibility that it triggered one of the protections of the electrical system was ruled out, especially since the apparatus cabinet was located at the opposite end of the coach (fig. 4.12 and 4.13);

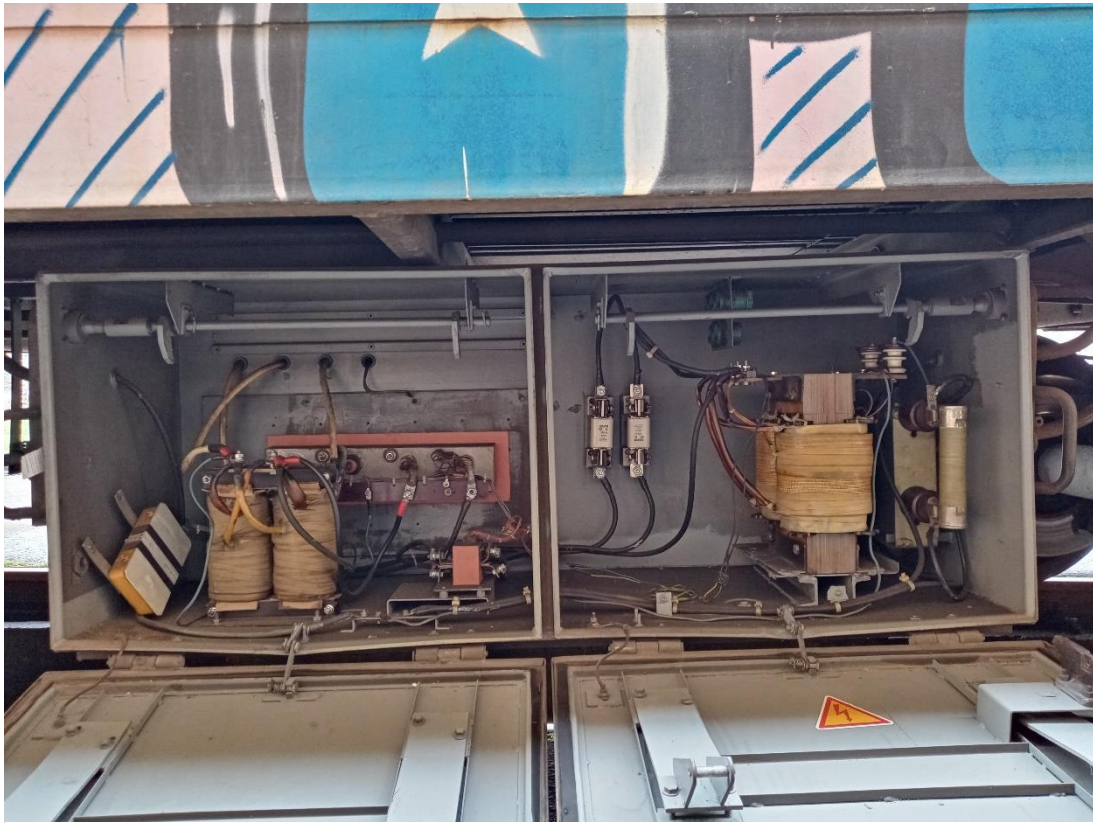
Fig. 4.15.

- **High voltage charge of the coach** – these cabinets are located under the frame of the coach, and are designed to provide primary power for the electrical system of the coach: for heating 1500 V and for lighting 24 V. During the inspections, it was found that the batteries providing power in the absence of external voltage were clean, were in working order and were not affected by the fire (Fig. 4.14). It was also found that the apparatus cabinet, which housed the apparatus for powering the electrical system of the coach, was in working order, clean and not affected by the fire (Fig. 4.15)

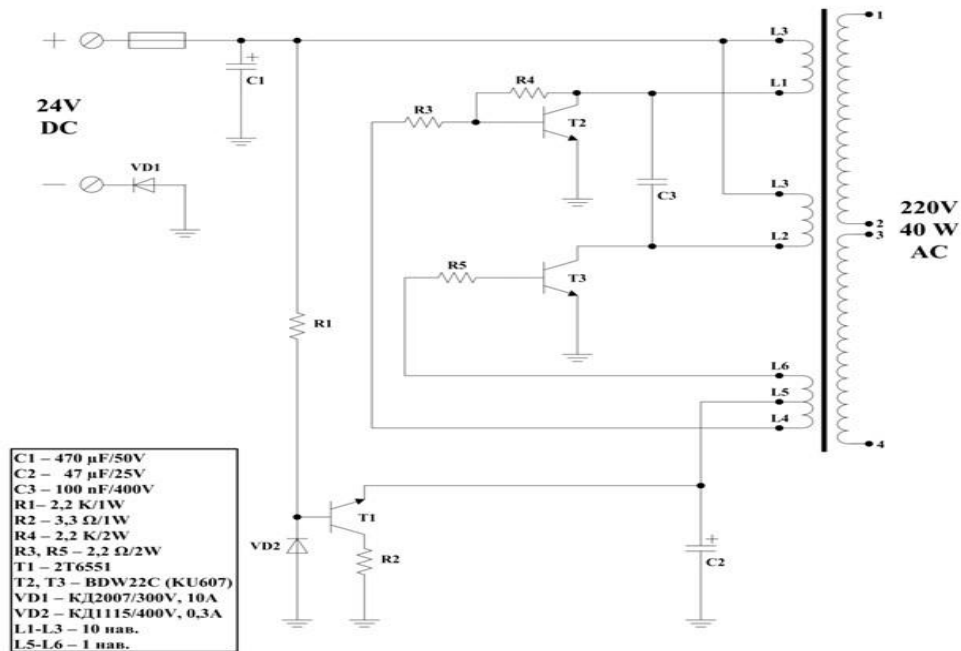
**Fig. 4.21. Electronic chart of the inverter, which powers the lighting fixtures.**

A determining factor for the accident occurrence was the unsatisfactory technical condition of the power module of the lighting fixtures (inverter), installed in the fixtures in the corridor next to the coach exit. The inverter has a design defect between the circuit board and the power wires.

the basis of existing bodies of identical coaches (Fig. 4.21). During the inspection of the power modules of the lighting fixtures, the following features were found.
