REPUBLIC OF BULGARIA
NATIONAL AIR, MARITIME AND RAILWAY TRANSPORT, ACCIDENTS
INVESTIGATION BOARD (NAMRTAIB)

FINAL REPORT
from

Investigation of railway accident – derailment of wagons of the IDFT № 40832 in Banya station
on 26.02.2023

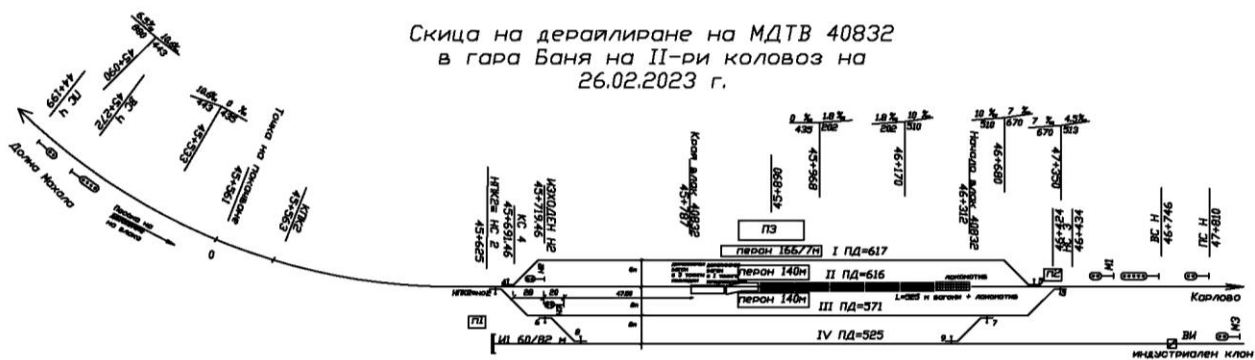
Fig. 1.3.

The event occurred at Banya station at km 45+561, 289 m after the entrance semaphore at 00:41 a.m. on 26.02.2023. The derailment area of the wagon is in a left curve with radius $R=350$ m, elevation $H=135$ mm and profile= 0 ‰. In the area of derailment of the wagon, the rail track is jointed with rails type S 49, reinforced concrete sleepers' type ST-4 and fasteners type PAK-68 (fig. 1.3).

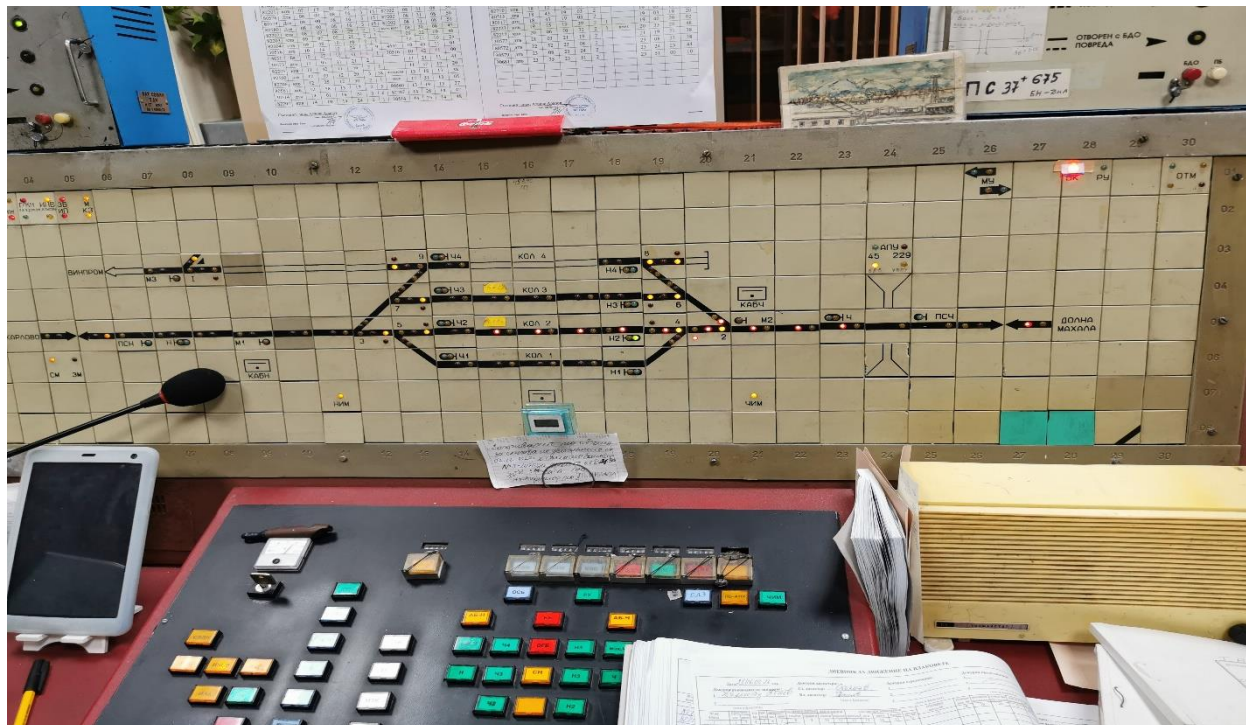
Fig. 3.5.

Banya station is equipped with RRI EC-1 with routed shunting – functioning (fig. 3.5);

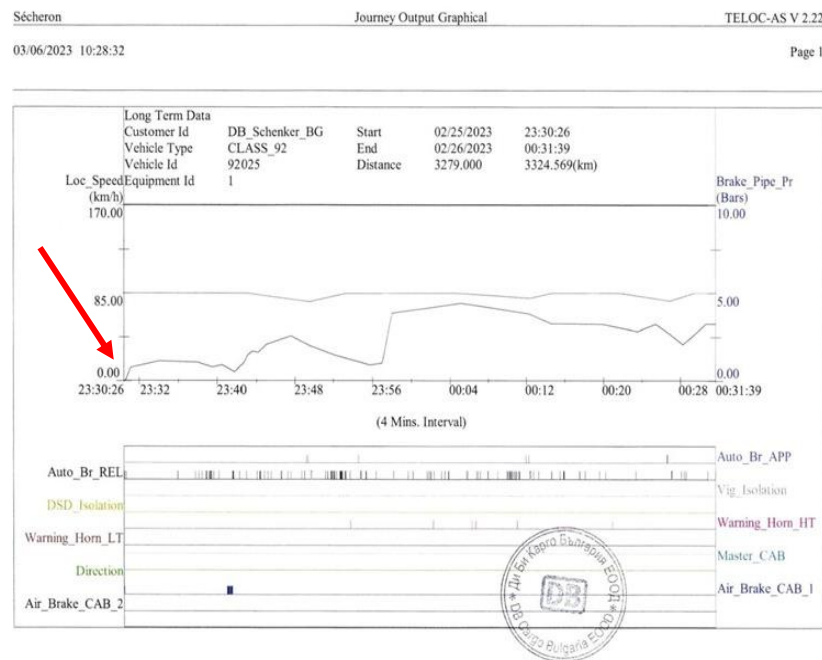
Fig. 4.1.

On fig. 4.1 and fig. 4.2 in the upper part of the image, the graphs V(S) and pressure in MAD (S) are shown for locomotive No. 91521688025-1 and reflect the recorded data from the electronic speedometer installation of the locomotive during the movement of IDFT No. 40832 after departure from Plovdiv station at 23 :30 p.m. to the scene (indicated in the figures by arrows). Figures represent a graphical screen from the locomotive manufacturer's data analysis processor (TELOC-AS V 2.22).

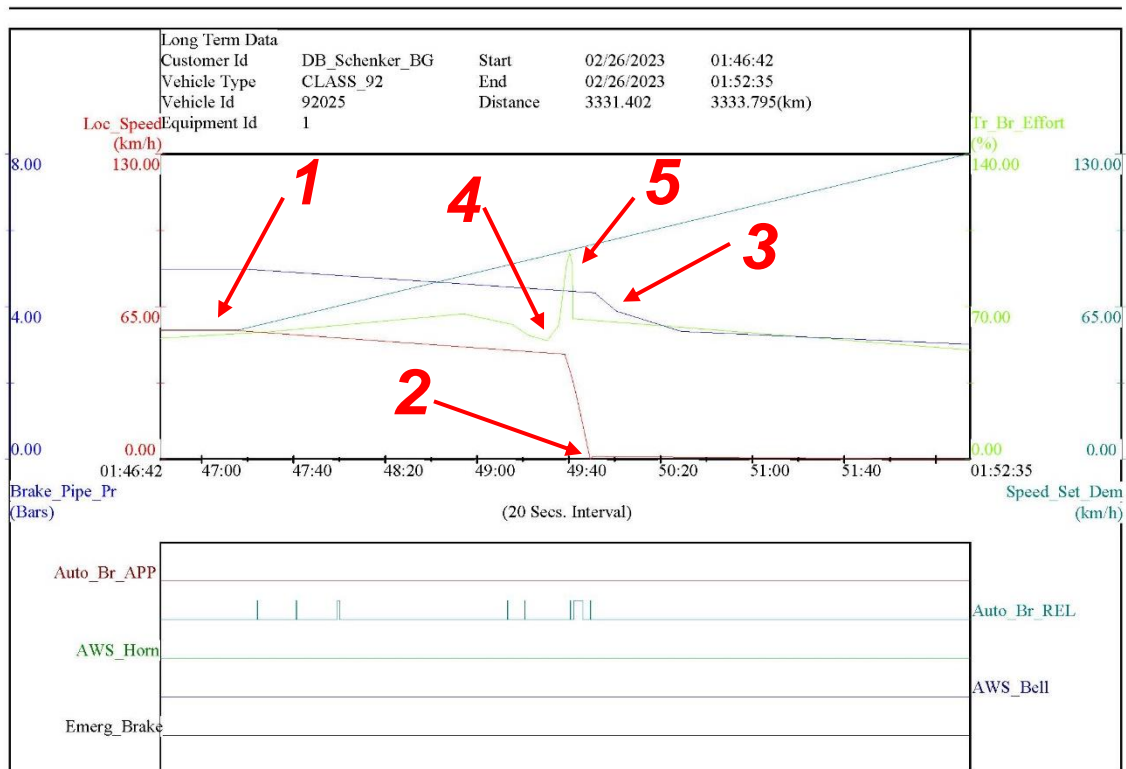
Fig. 4.9. Diagram of train movement under time.

IDFT No. 40832 enters in Banya station at a speed of 55 km/h (fig. 4.9, item 1). At 01:49:37 a.m. the speed started to decrease and at 01:49:51 a.m. it was already 0 km/h (Fig. 4.9, item 2). The pressure in the main air duct also began to decrease and at 01:50:09 a.m. it was below 3.5 bar, indicating that a quick hold with the autobrake had taken place. The fact that the brake applied after the start of the deceleration means that the brake was applied due to a violation of the integrity of the main air duct (Fig. 4.9, item 3). At the initial moment, there was a pullback due to the ploughing of the derailed wagons into the ballast prism (Fig. 4.9, pos. 4), after which the front wagons pulled forward and that led to the appearance of acceleration in the direction of train movement (Fig. 4.9, item 5)

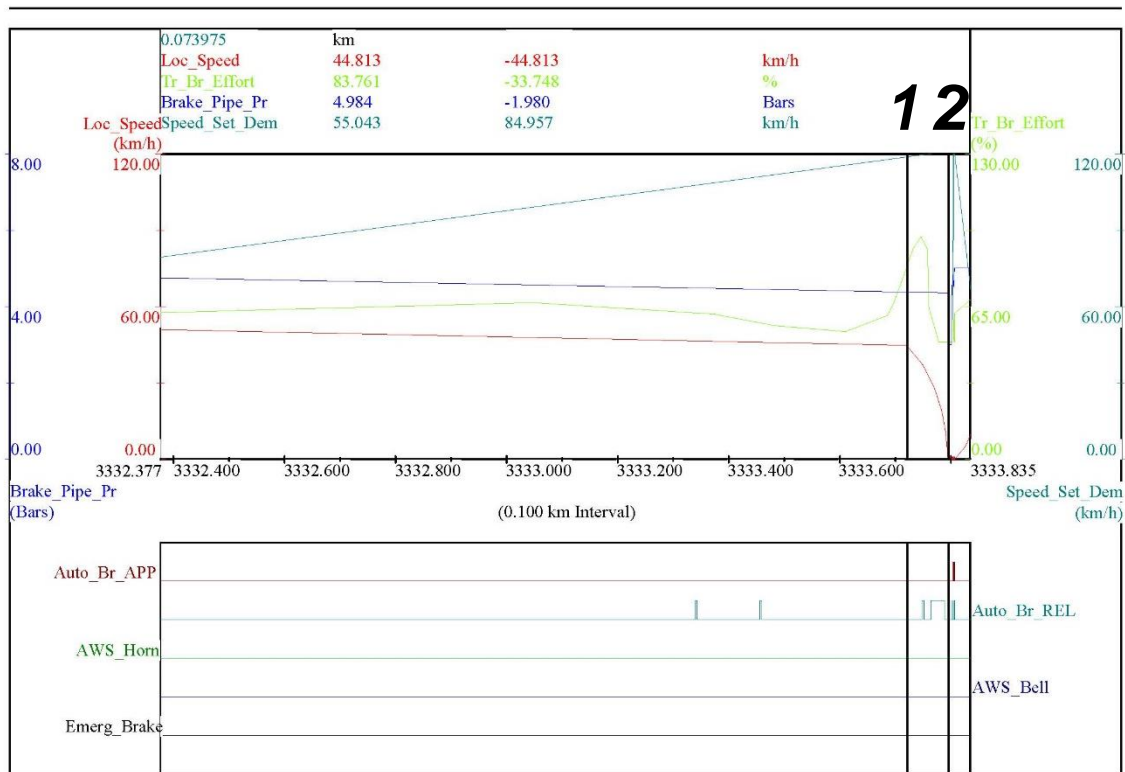
Fig. 4.10. Diagram of the train movement under passed track.

had passed 74 meters (fig. 4.10, the distance between marker 1 and marker 2).

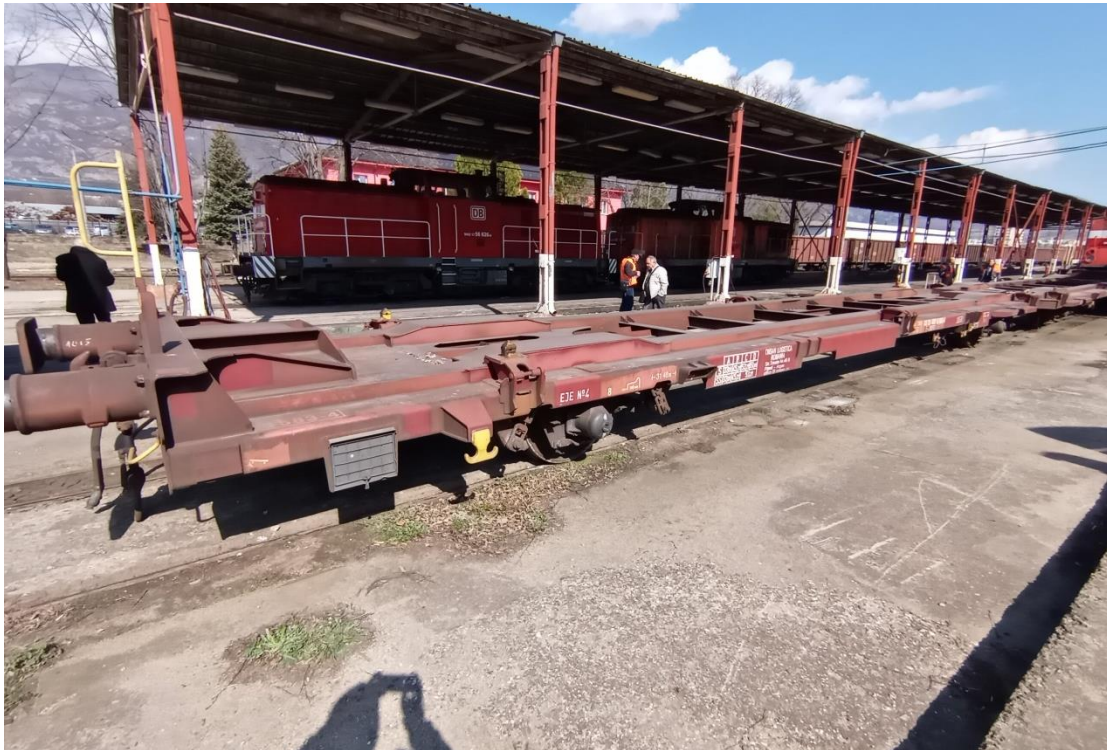
- The derailed wagon No. 43714378583-4, the last of the train, is a two-platform, 4-axle, bogie less (fig. 4.11). The two platforms are connected to each other with an elastic connection, which consists of taller-free buffers - one on each platform, and a coupling (Fig. 4.12);

Fig. 4.11. General appearance of wagon № 43714378583-4.

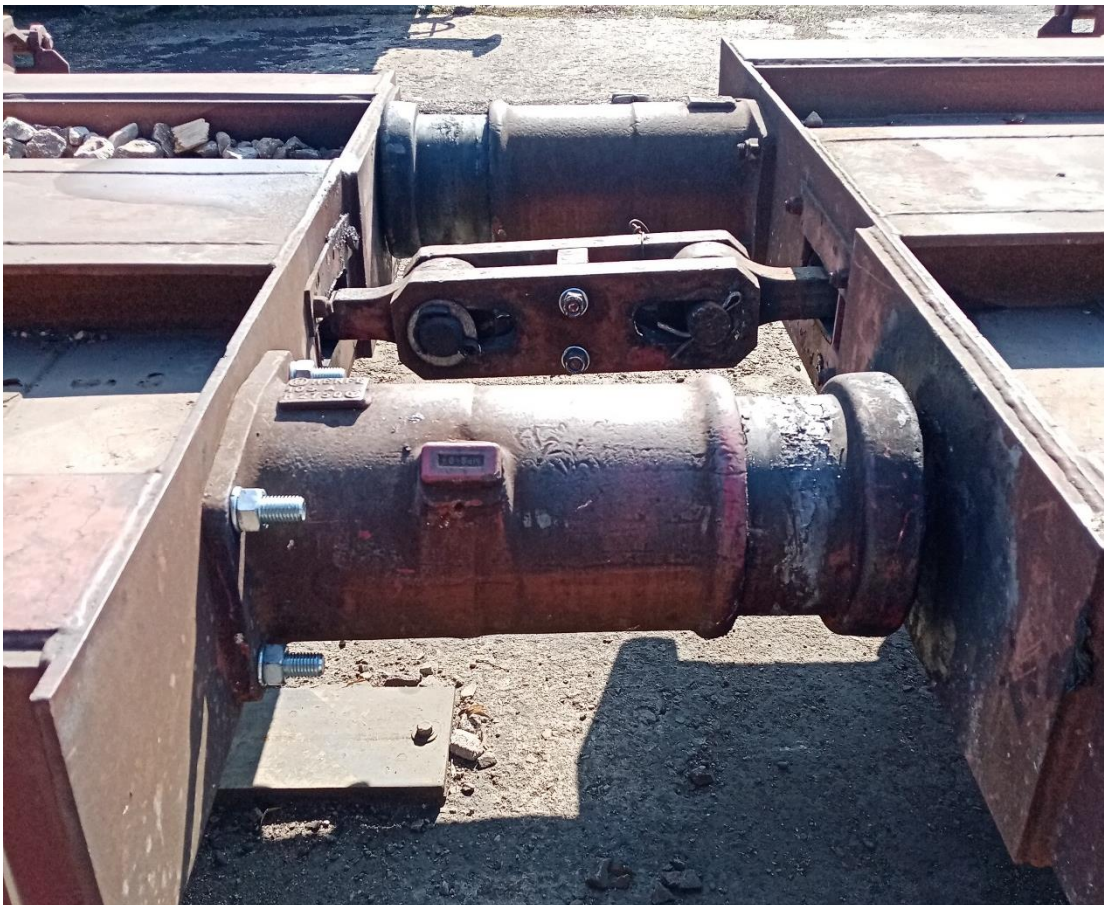
Fig. 4.12. Appearance of the device connecting the two platforms of wagon № 43714378583-4.

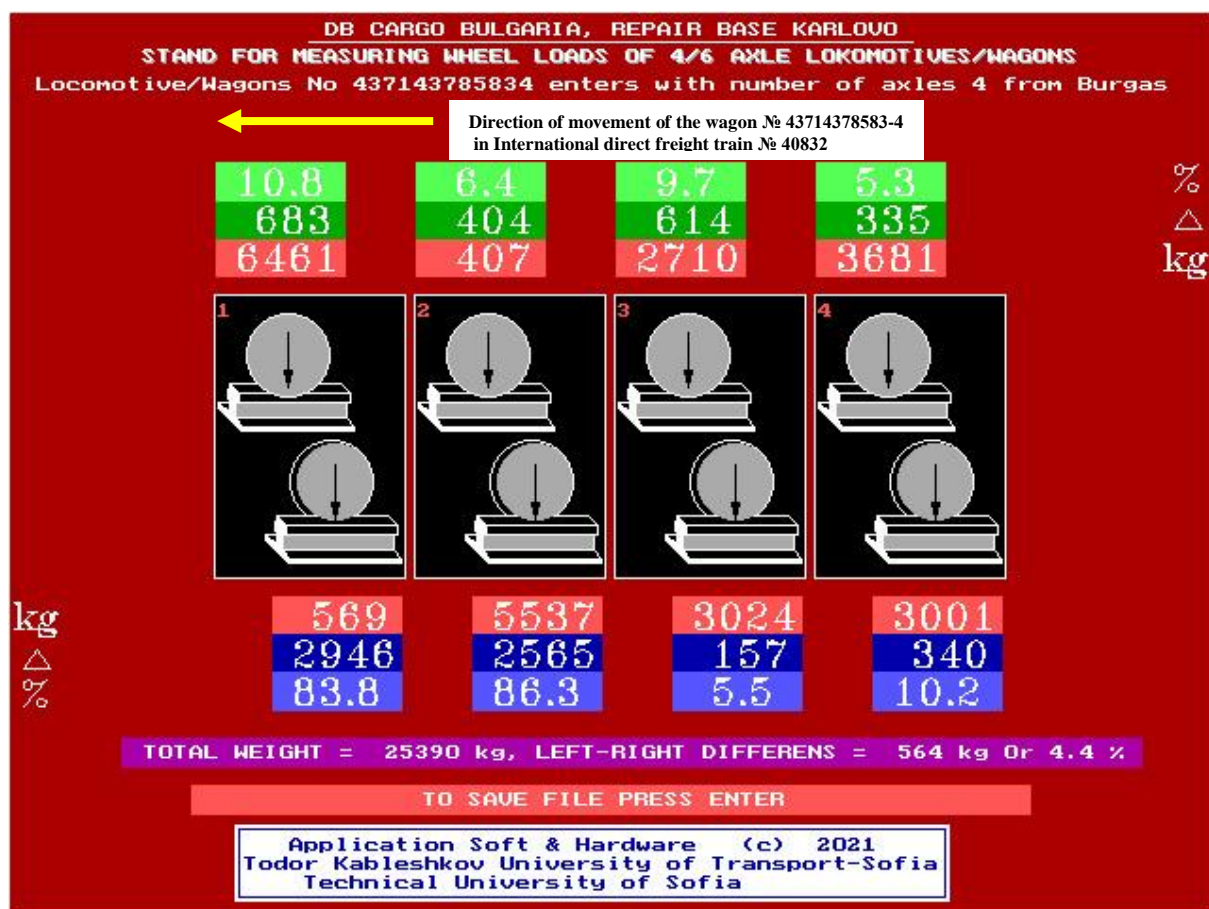
Fig. 4.20.

The facts established during the inspections gave the investigation commission a reason to measure the static load on the individual wheels of wagon No. 43714378583-4, where the following results were obtained (Fig. 4.20):
