Rail Accident Report

**Partial failure of a structure inside Balcombe
Tunnel, West Sussex
23 September 2011**

Partial failure of a structure inside Balcombe Tunnel, West Sussex, 23 September 2011

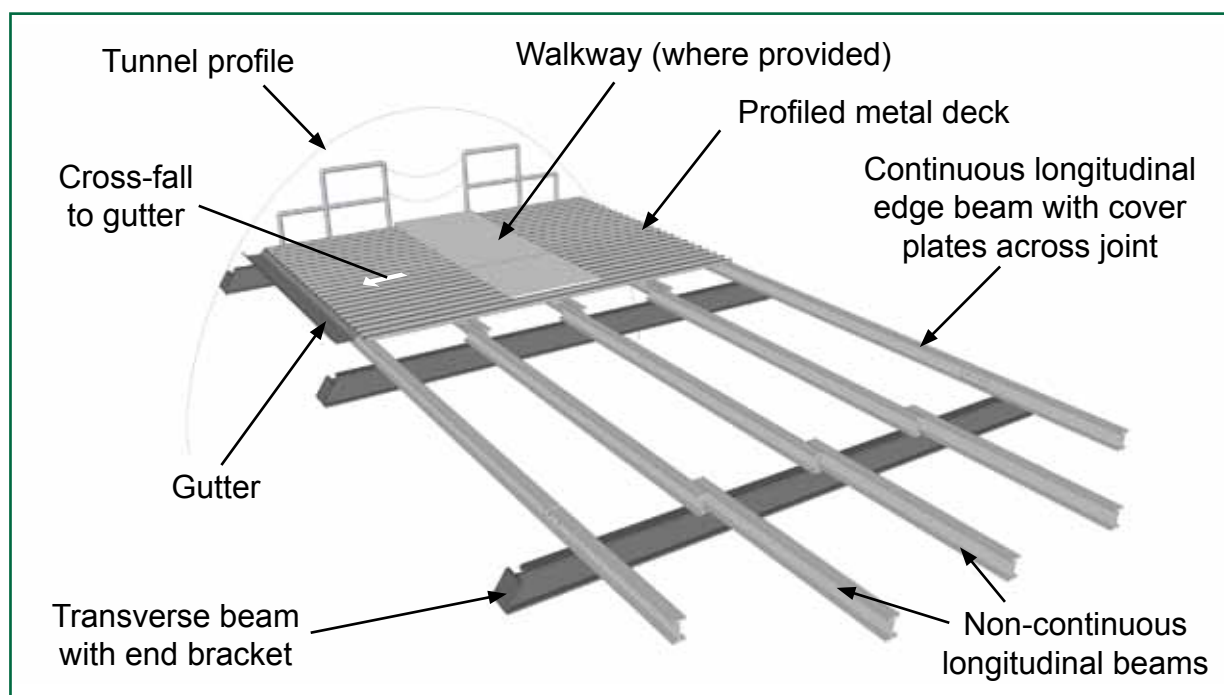
Figure 4: Diagram of water catchment tray structure

- 28 The trays, as designed by Scott Wilson, comprised a profiled metal deck supported by five longitudinal beams (ie parallel with the track) which in turn rested on transverse beams. The three central longitudinal beams spanned between transverse beams and were not continuous (ie a separate section of steel was used for each span, figure 4). The two outer longitudinal beams (ie one on each side) were continuous, with cover plates bolted across each joint. The transverse beams were approximately six metres long and spanned across the tunnel at four metre intervals (figures 3 and 4). The trays were inclined at a gradient of 1 in 40 so as to shed water towards a gutter above the down line. The design drawings showed that the trays were to be installed a minimum of 4.69 m above rail level.

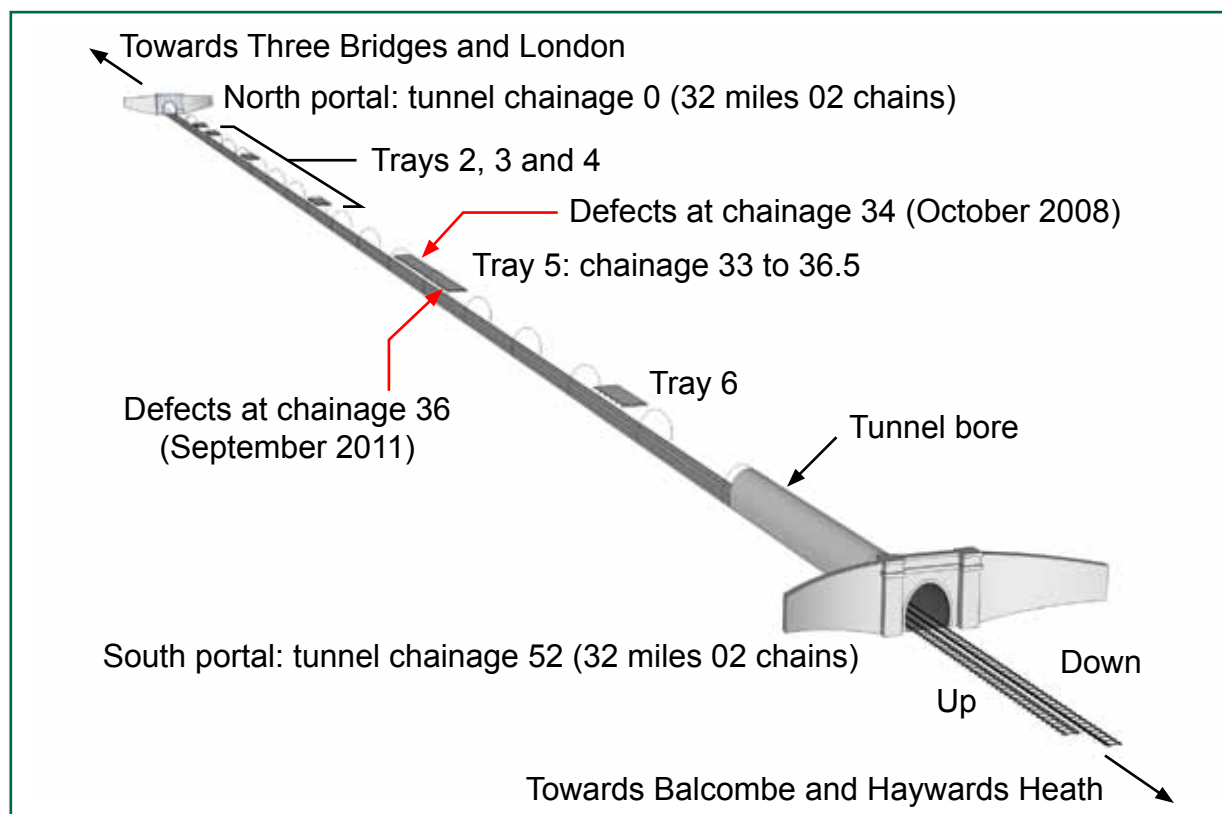
Figure 5: Diagram of Balcombe tunnel showing location of water catchment trays and defects

- 29 Four of the five trays (2, 3, 4 and 6) are 20 metres long, each supported by six transverse beams. Tray 5 is similar, but before being shortened following the incident, was 72 metres long and supported by 19 transverse beams, covering the area beneath shaft 4 (figure 5). The beams supporting tray 5 are numbered from 1 (at the north end) to 19.

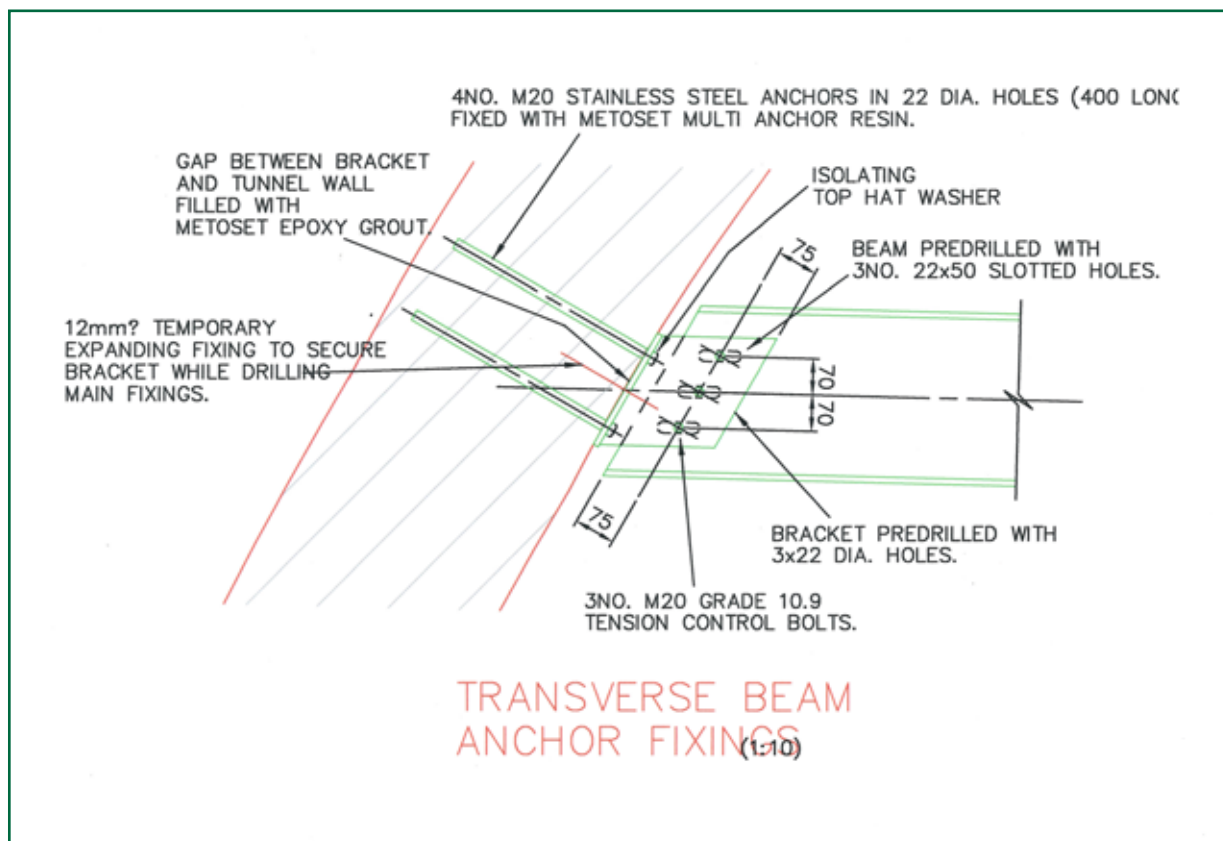
Figure 6: Scott Wilson's design drawing showing transverse beam end fixing

- 30 Atkins' outline design showed the ends of the transverse beams being inserted into holes cut in the tunnel lining and being directly supported by the brickwork. Scott Wilson's design did not adopt this arrangement, but instead the beams were connected to brackets which were attached to the tunnel lining by four 20 mm diameter threaded stainless steel rods (studs), two each side of the beam end. The studs were anchored into 22 mm diameter holes drilled into the tunnel brickwork at an angle of approximately 30° to the horizontal (figures 6 and 7) with a proprietary resin (Metoset multi-anchor resin is specified on Scott Wilson drawings). Once the bracket was in position, a washer and two nuts were added to each stud to secure it (figure 8).
