The derailments at Amsterdam Central Station on 6 and 10 June 2005

The Hague, 30 November (project numbers M2005RV0606-04 en M2005RV0610-02)

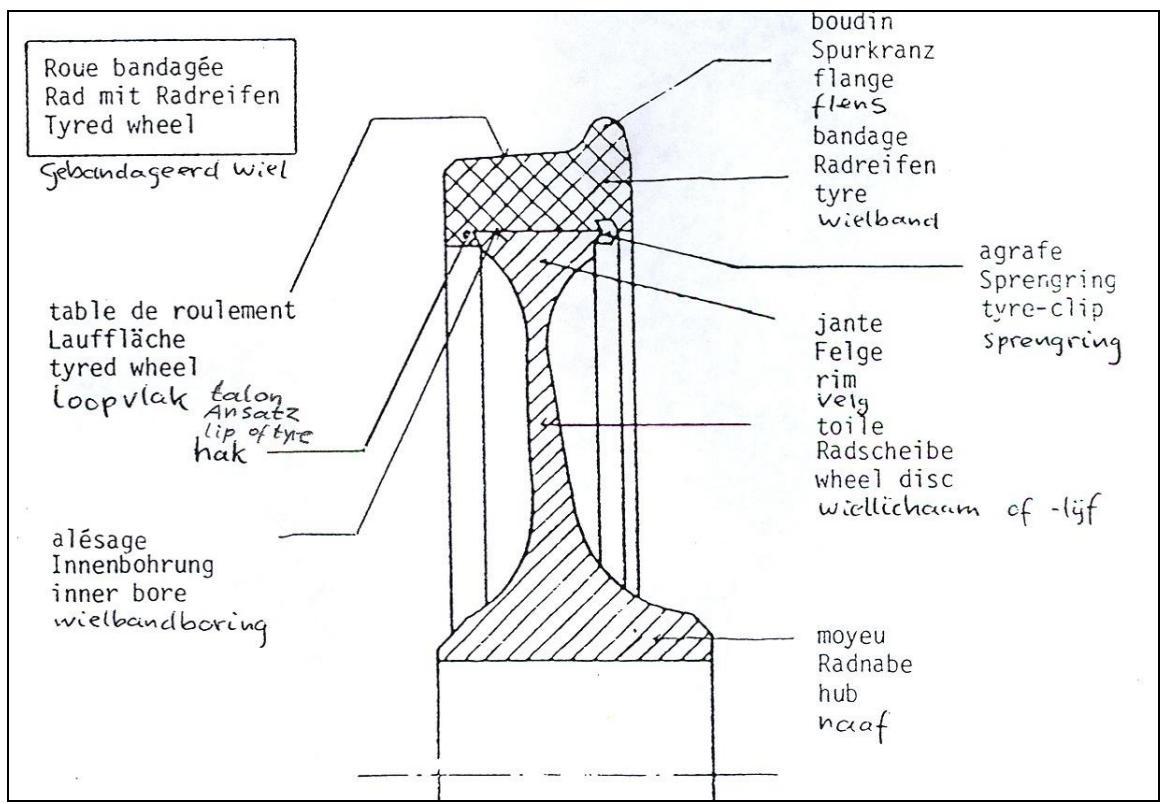
A second safeguard against the tyre coming loose, and which specifically prevents the tyre sliding sideways, is the tyre clip. The tyre clip is rolled onto the inside of the wheel, after which the lip of the tyre (which partially hangs over the inner wheel) is pressed against the tyre clip. The tyre clip cannot prevent the tyre from coming loose from a wheel but does provide an extra safeguard should the clamping tension no longer be sufficient to prevent the tyre from coming loose from the inner wheel. In other words, the tyre clip ensures that the tyre does not slide sideways.

Illustration 5 Structure of the tyre - inner wheel and tyre clip system (source photo: Inspectorate for Transport, Public Works and Water Management)

In general terms, a tyre can start to come loose as a result of a combination of factors, namely the wheel load, a thin tyre and a considerable increase in temperature caused by the contact between the brakes and the tyre.
