Rail Accident Report

Uncontrolled evacuation of a London Underground train at Holland Park station 25 August 2013

This report is published by the Rail Accident Investigation Branch, Department for Transport.

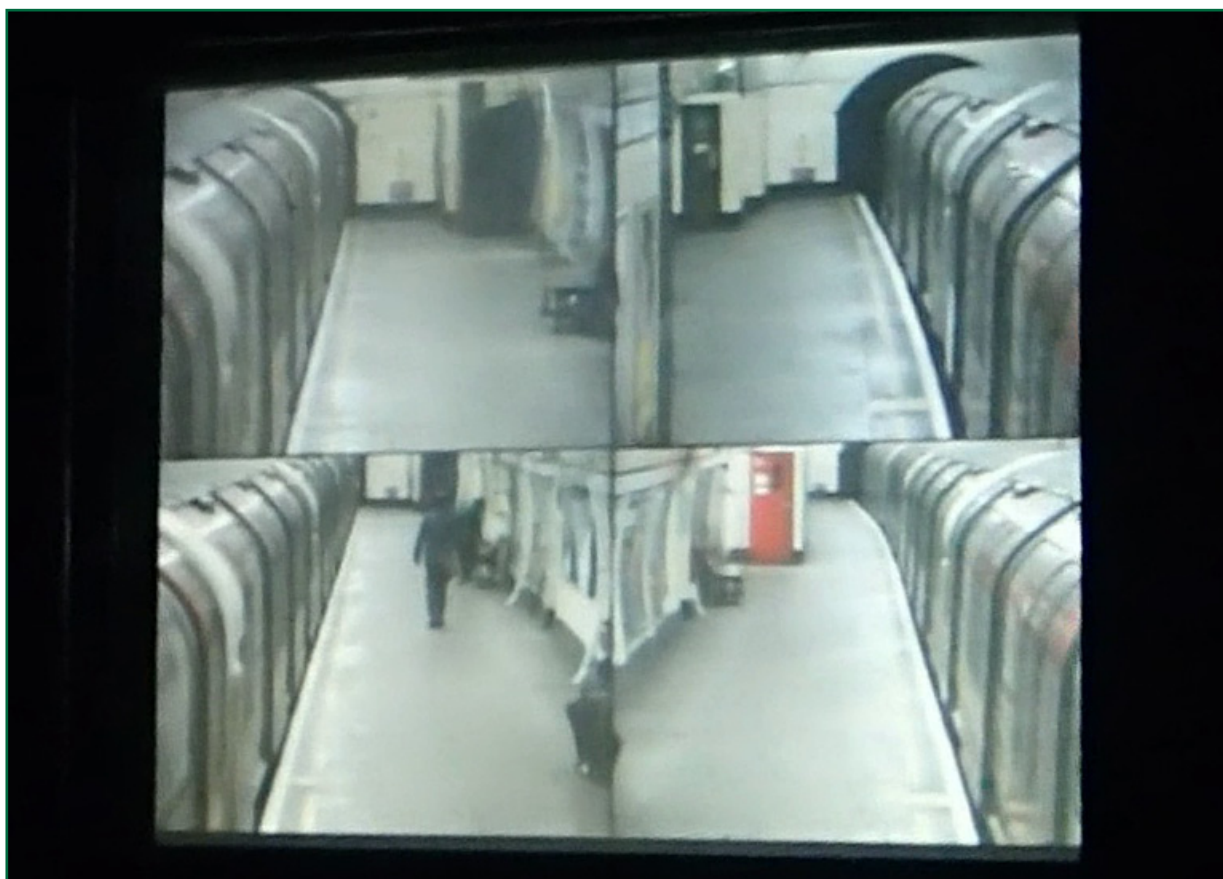
Figure 6: An example of CCTV images of the platform-train interface displayed in the cab of a Central Line train at Holland Park station

- 43 At Holland Park station passengers got on and off the train as normal but CCTV footage shows some alighting passengers turning to look in the direction of car 6. The train operator was unaware of the burning smell and could not see the smoke on his in-cab CCTV. After all waiting passengers had boarded the train, and in the few seconds before the train operator closed and locked the train doors for departure, passengers were observed on CCTV footage to begin getting out of car 6.

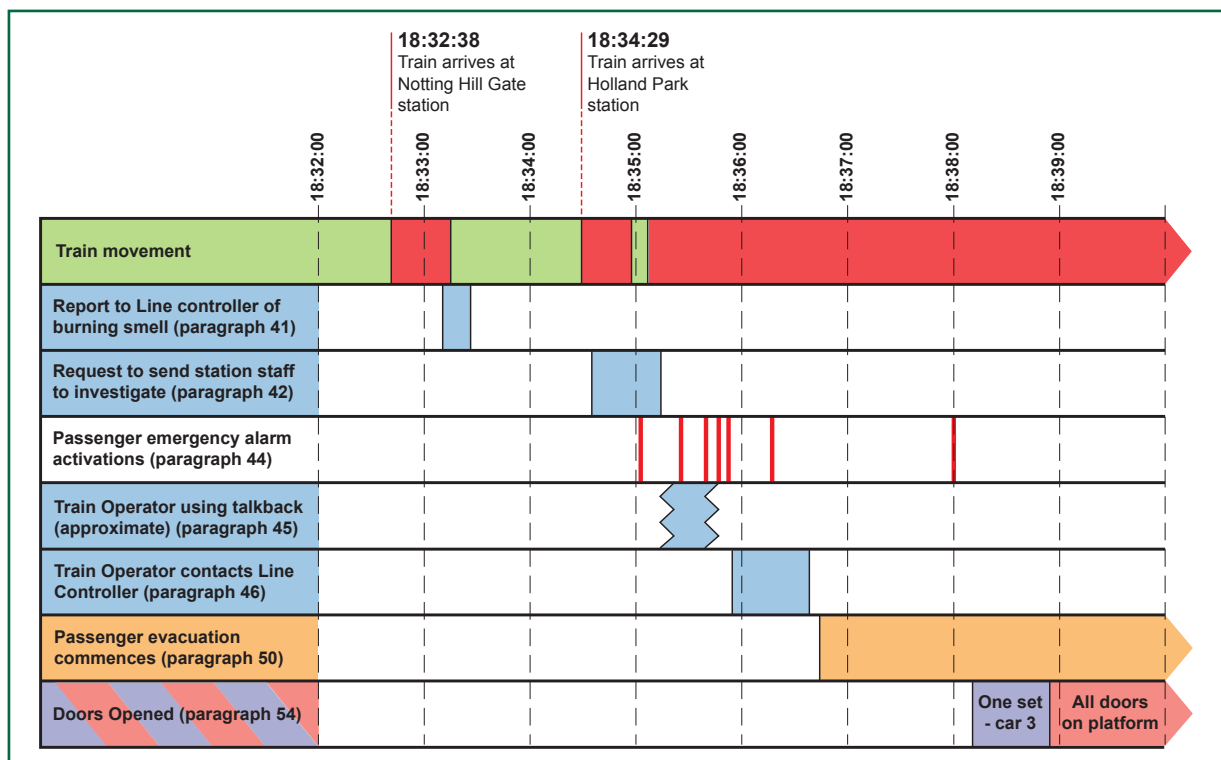
Figure 8: Timeline of key events

- 41 Just over 20 minutes later, when the train was at Notting Hill Gate station (the station before Holland Park), platform staff reported to the station controller that there was a burning smell coming from the train. There is a voice recording of the station controller passing on this report to line controller 2 as train 003 departed for Holland Park station. Figure 8 shows the timeline of the incident from this point onwards.
