Rail Accident Report

Derailment at Liverpool Street station, London 23 January 2013

Report 27/2014
December 2014

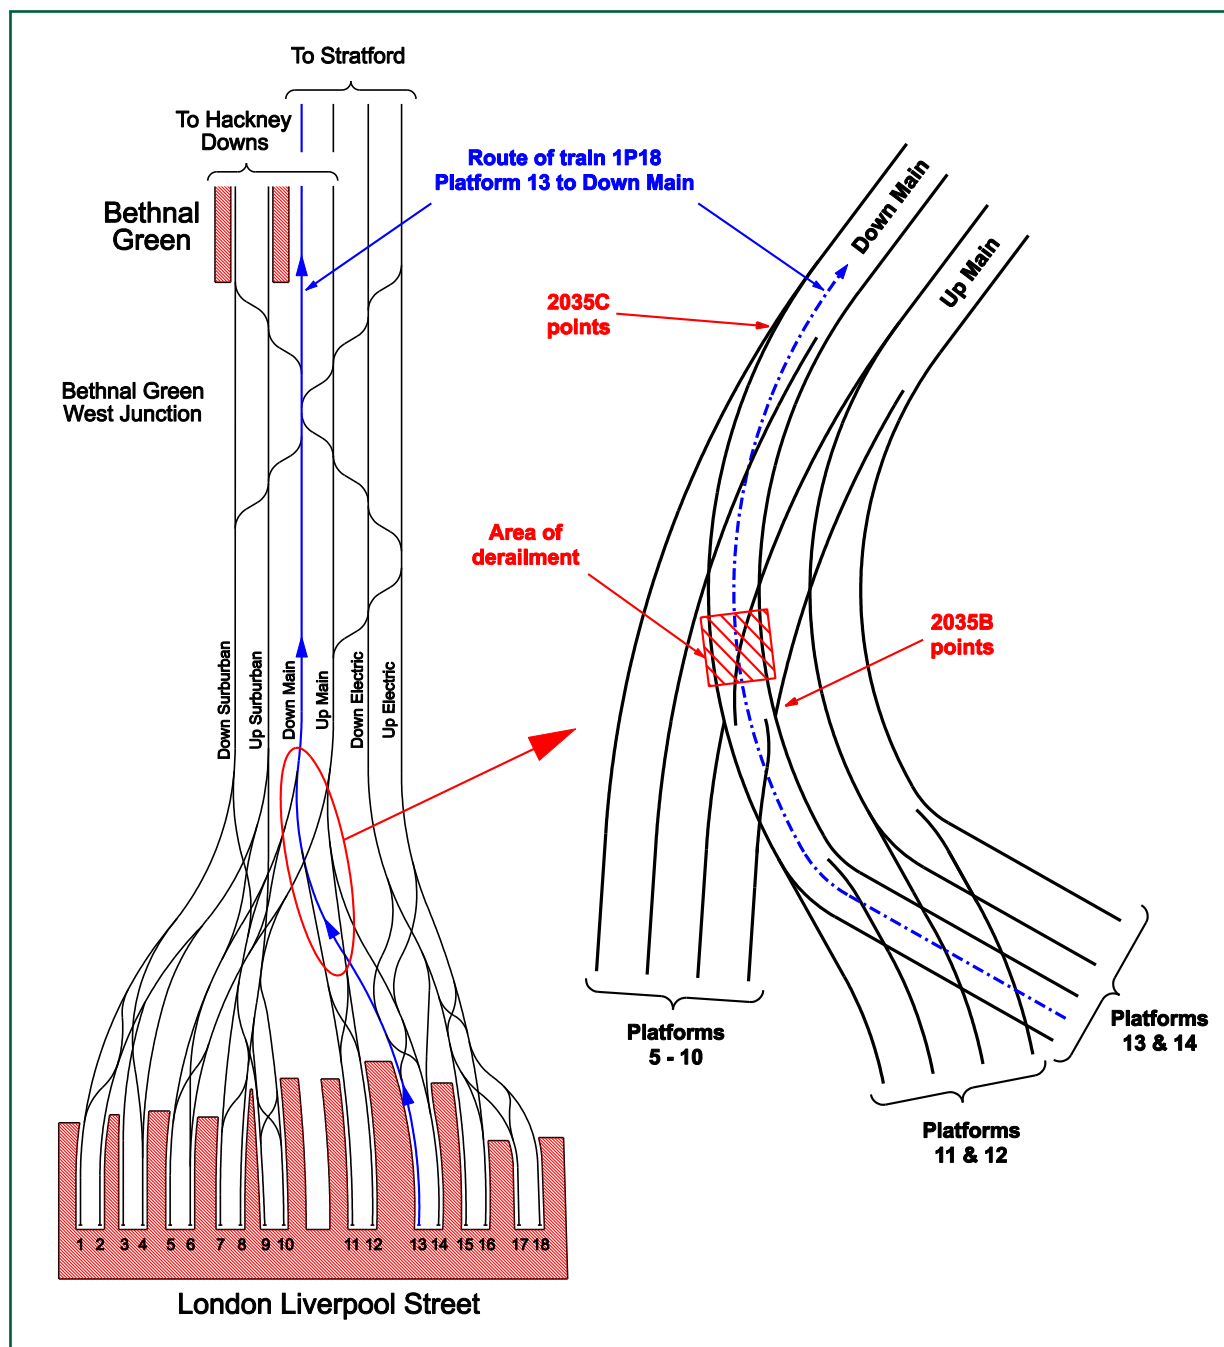
Figure 3: Liverpool Street station and detail of derailment area

- 27 At approximately 10:00 hrs on Wednesday 23 January 2013, train 1P18 departed from platform 13. As the train was passing over 2035B points, and approaching 2035C points (figure 3), on a right-hand curved section of track about 260 metres from the platform end, 19 wheels of the train derailed (figure 5). Of these, 15 wheels were re-railed within 5 metres. The remaining four wheels were on a bogie which travelled in a derailed state for approximately 40 metres (around 6 seconds running time), before forcing its way through (*running through*) the converging rails of 2035C points and re-railing (paragraph 66)).

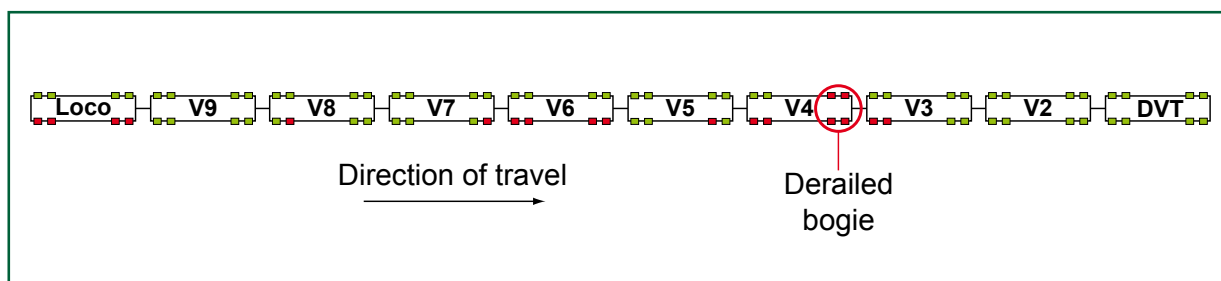
Figure 5: Train 1P18 (derailed wheels shown in red)

- 64 The first of the wheelsets exhibiting wheel face damage were on the *trailing bogie* of vehicle 3 (figure 5). Damage to the track fixings of the right-hand rail (figure 9) and the absence of damage on the left-hand wheels of this bogie show that these wheelsets continued with the right-hand wheels dropped inside the right-hand *running rail* while the left-hand wheels remained on the rail. Damage to the track fixings indicate that these wheels ran derailed for about 4.5 metres before encountering a *fishplate* forming part of a rail *joint*. As they struck the fishplate, the wheels were raised back up to rail level and guided back on to the running rail (figures 10 and 11).

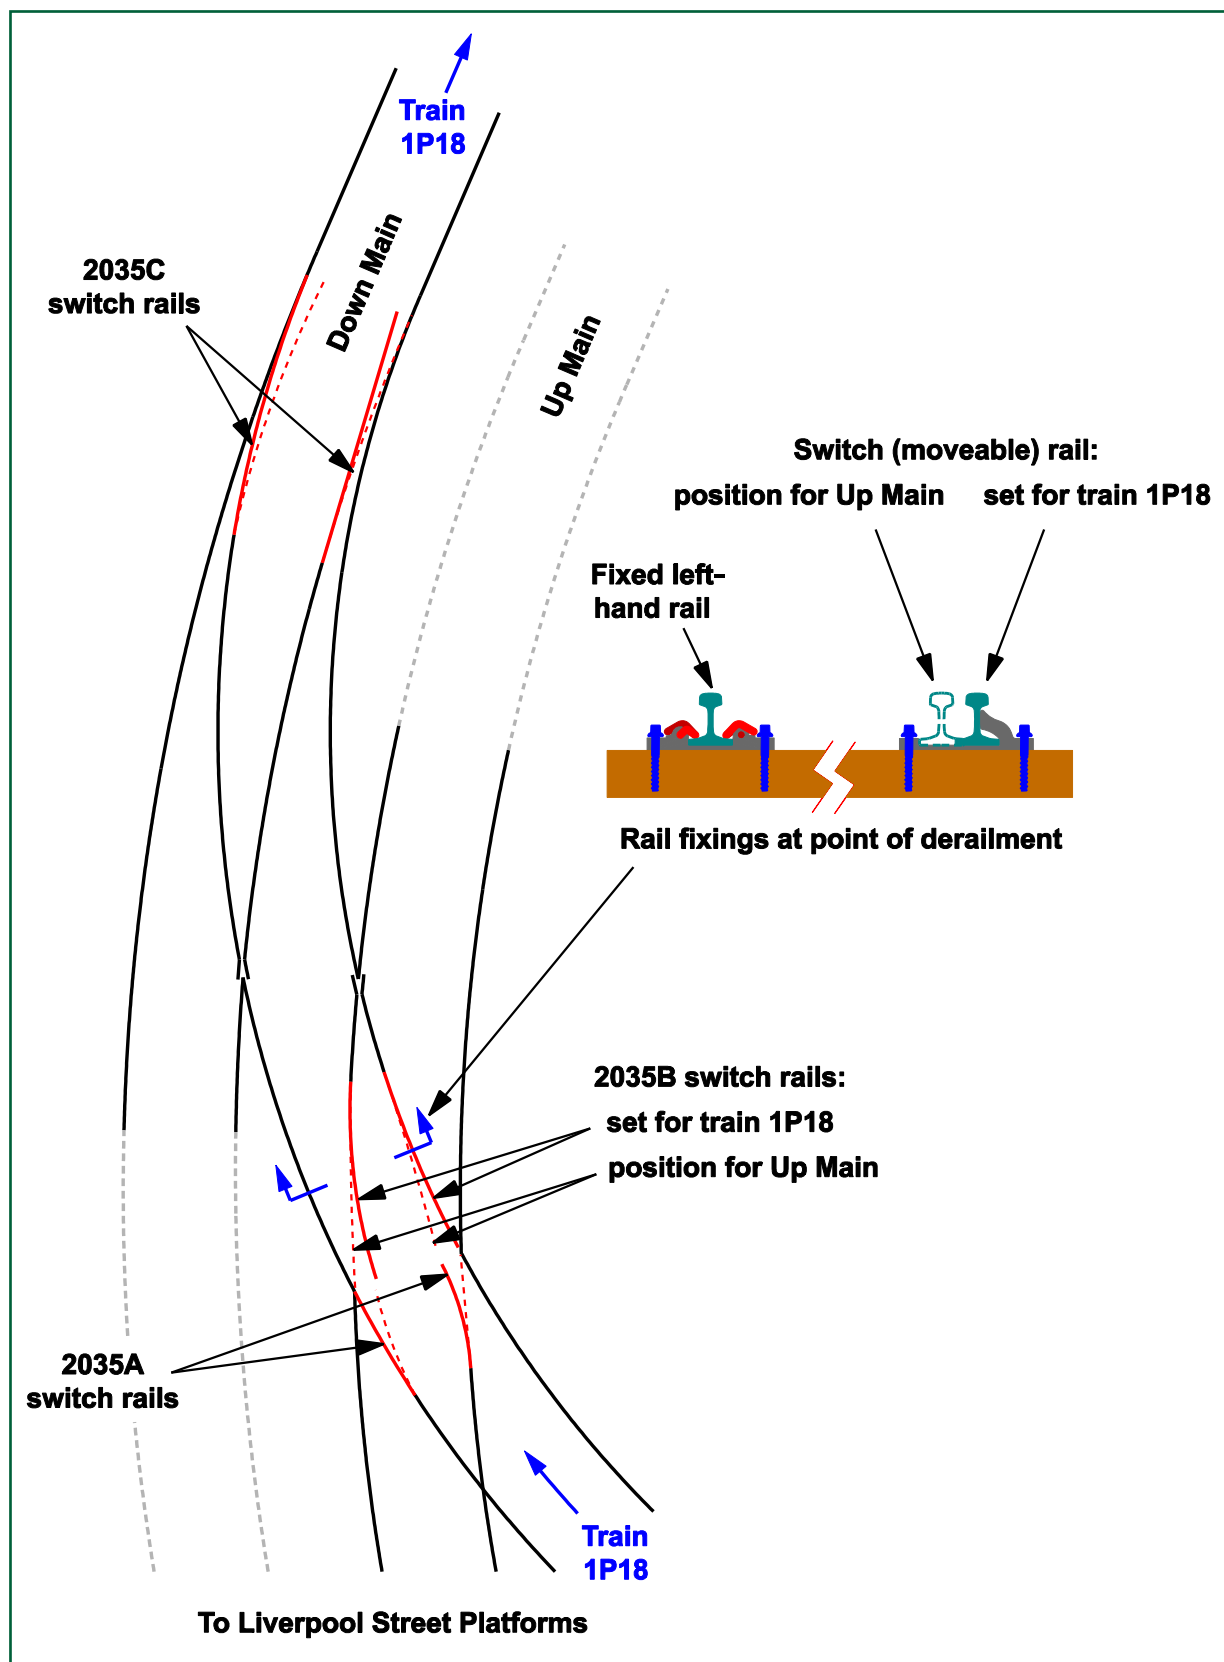
Figure 7: Track layout at incident site

- 62 These points, together with 2035A points, formed the switch diamond crossing illustrated in figure 7. A description of a switch diamond crossing is included at appendix D.

- 97 The right-hand switch rail is intended to move laterally according to the direction in which 2035B points are set (figure 7). The rail support system allowing this movement does not prevent the top of the right-hand rail moving outwards due to rotation at the foot of the rail. The right-hand rail is not normally subjected to sufficient gauge spreading force (paragraph 69) to cause movement of this type. However, in this instance, it is likely that the displaced position of the left-hand rail meant that the outer edges of the right-hand wheels were running on the inner edge of the switch rail. In this position, the downward load from the wheels, the angled shape of the wheels and the curved rail head combining with the gauge spreading force would result in the top of the switch rail being pushed outwards (figure 20, inset).

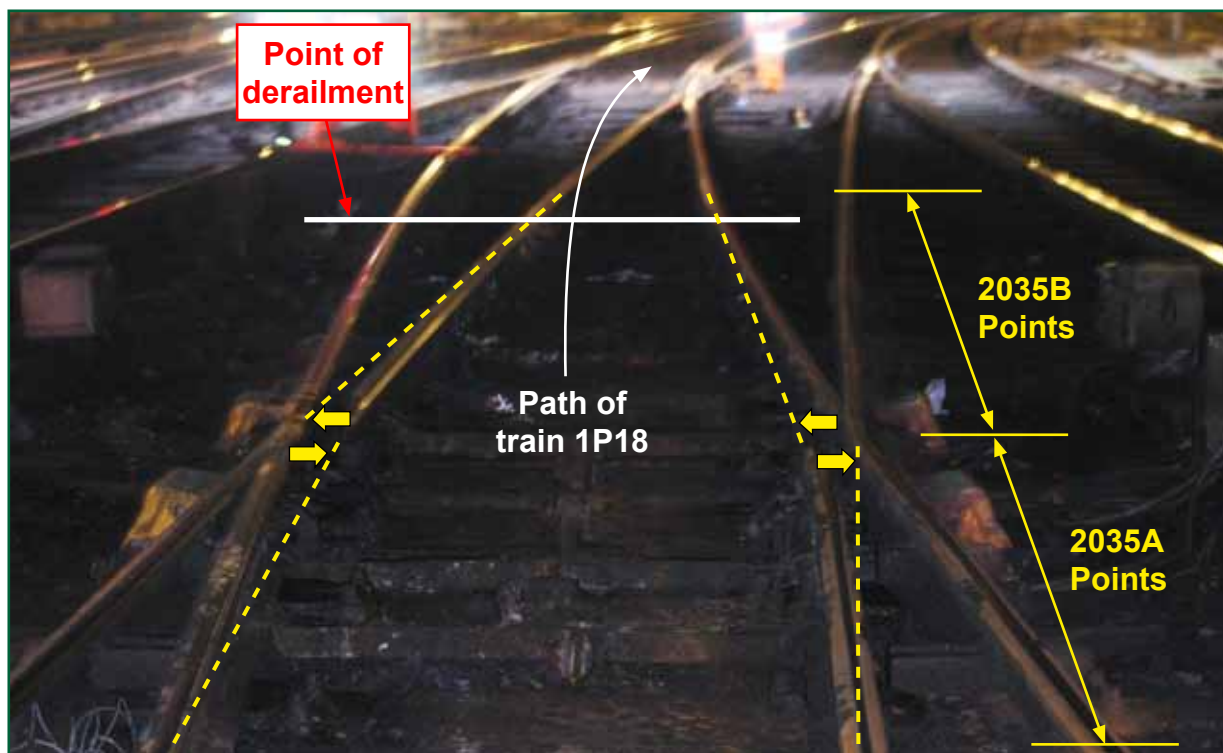
Figure 8: Incident site showing switch rails set for train 1P18 (alternative route shown in yellow)

- 63 The derailment evidence comprised closely spaced marks on the right-hand rail indicating that all the derailed right-hand wheels of the train had dropped inside this rail approximately five metres beyond the *tip* of the moveable rail (figures 8 and 9). The RAIB has concluded from the wheel face (the outside face) damage on the train, and a lack of derailment marks elsewhere on the right-hand rail, that the 17 right-hand train wheels derailed in turn as they reached this location. At the point of initial derailment the track is on a right-hand curve and the left-hand wheels were running along a section of rail that should be fixed.

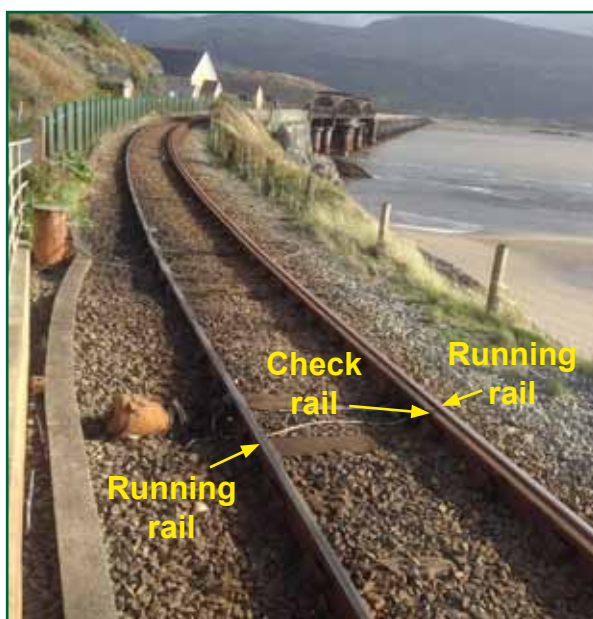
Figure 13: Typical check rail

- 71 Current Railway Group standard GC/RT5021 normally requires a check rail on curves less than 200 m radius. However, the standard reflects Network Rail's view that this is not viable on movable rails such as the right-hand rail at this site.

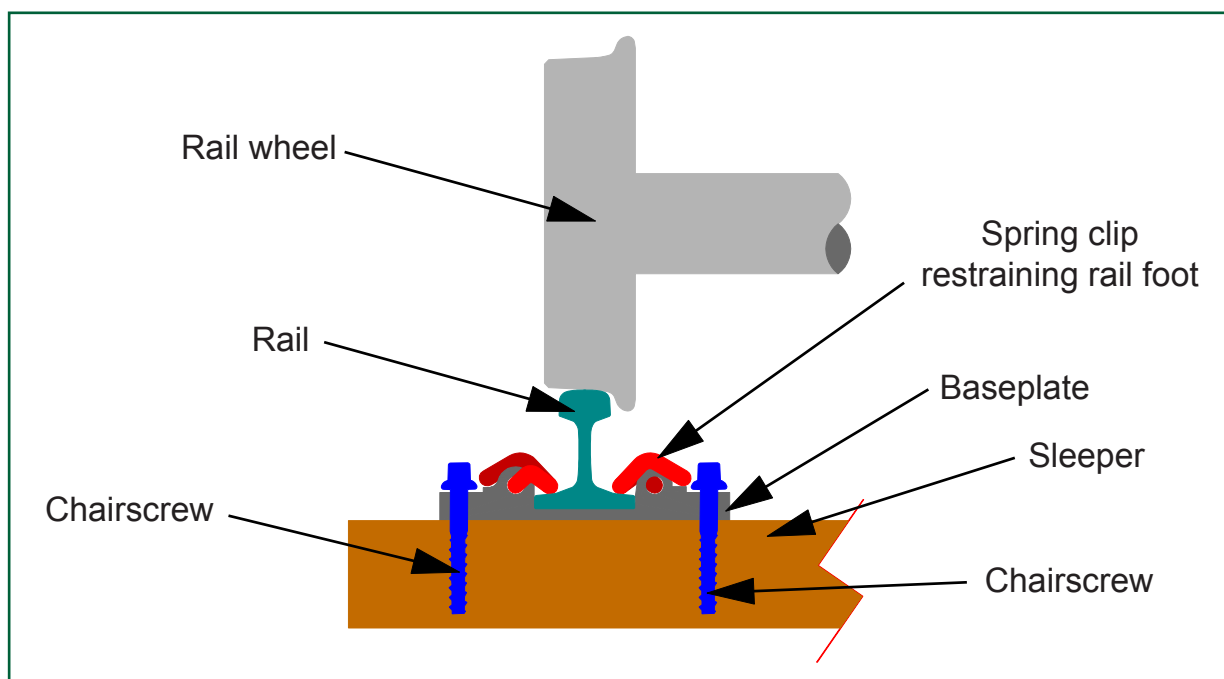
Figure 14: Rail fixing system

- 76 Most rails at Liverpool Street, except switch rails, are fixed to wooden sleepers using a retaining system consisting of a *baseplate* which is screwed to the sleeper using *chair screws* and *spring clips* which clamp the *foot* of the rail to the baseplate (figure 14). This type of fixing is intended to resist the forces imposed on the rail by train movement.

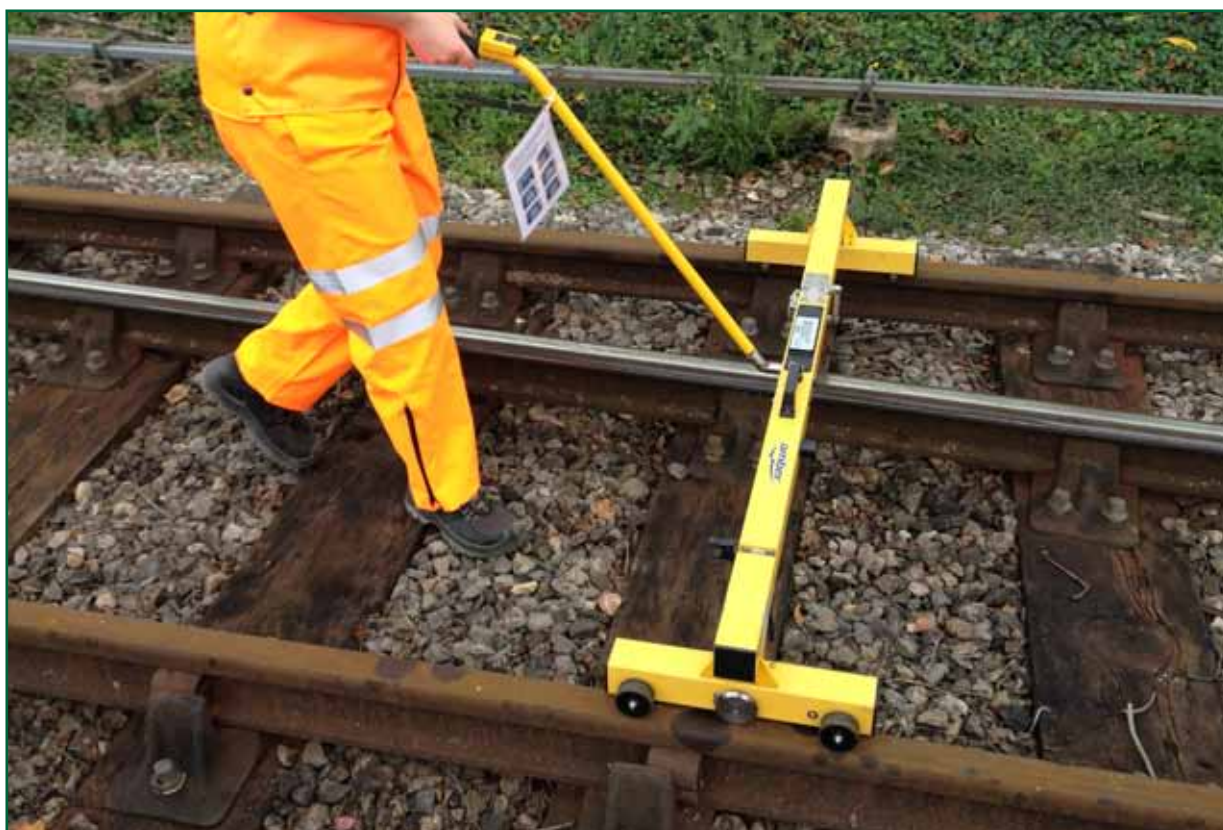
Figure 21: Amber trolley in use (not at accident site)

- 119 At Liverpool Street the static gauge was recorded using a manual recording device known as an Amber trolley (figure 21). The trolley is lightweight to allow handling by a single person and only applies a small load to the rails. This load is not sufficient to replicate the dynamic movement caused by train loads and so the trolley cannot be used alone to measure dynamic gauge.

- 120 The trolley measures and records track gauge, and other track geometry characteristics, while it is pushed along the track. It alerts the operator when pre-set track geometry intervention limits, including those for dynamic gauge, have been exceeded. Although the intervention limit relates to dynamic gauge, the trolley is only measuring static gauge.

- 121 The use of the Amber trolley at Liverpool Street was first implemented in 2008 by the previous assistant track maintenance engineer, he supervised the members of the TME's technical team undertaking the task. The lengths of track to be measured in each shift were provided on task lists generated by Ellipse (paragraph 111). These lists omitted some areas of track at Liverpool Street, but did include the derailment site. The last Amber trolley measurements at the derailment site were made in March 2012, about ten months before the derailment. This was within the 52 weeks maximum interval required by Network Rail standards (paragraph 116).
