DUTCH SAFETY BOARD

# Collision between a passenger train and a man lift at Dalfsen

The Hague, December 2016 The reports issued by the Dutch Safety Board are open to the public. All reports are also available on the Safety Board's website www.safetyboard.nl

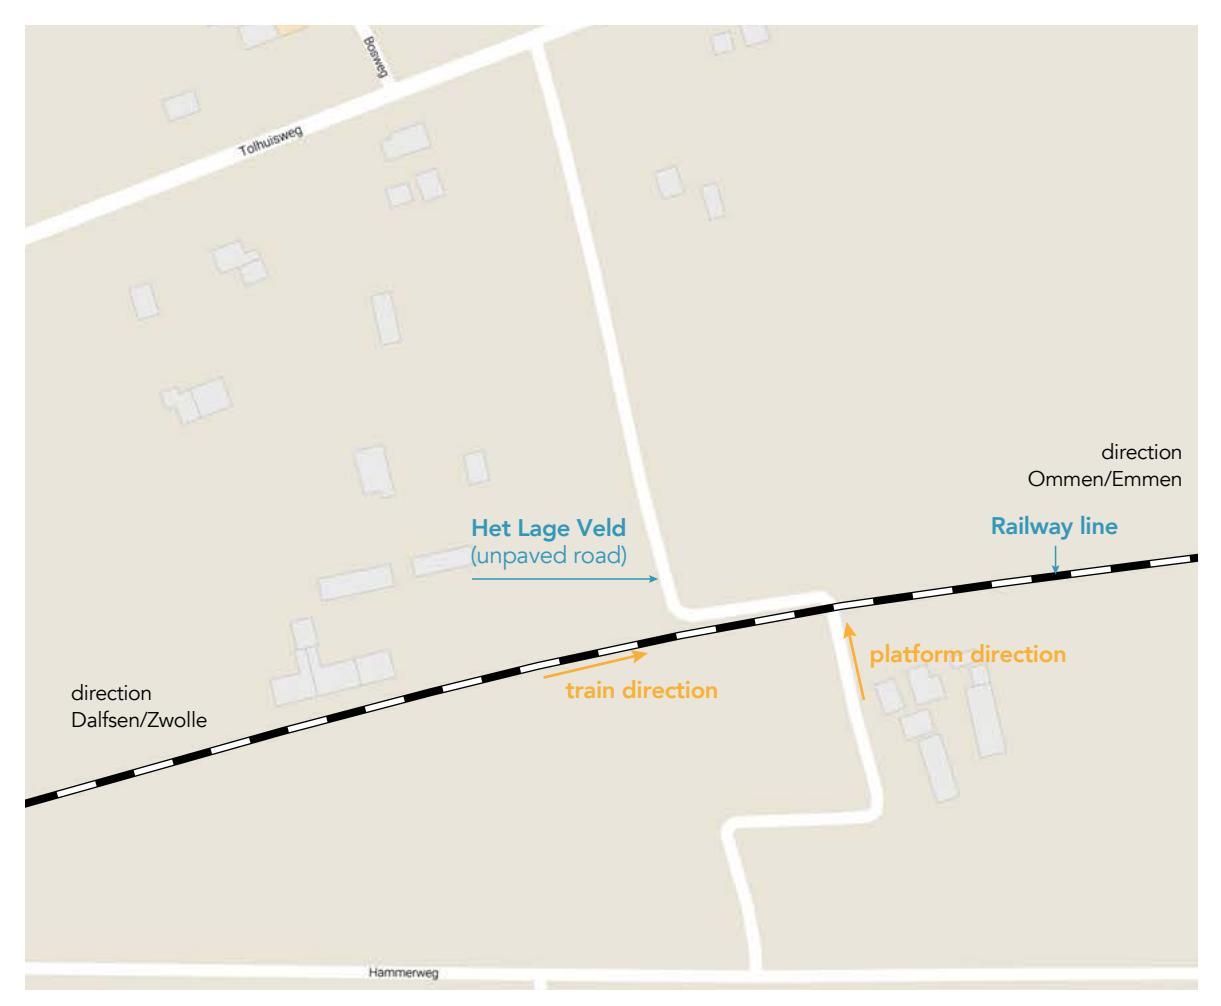
Figure 2: Location of Het Lage Veld level crossing.

Het Lage Veld is a largely unpaved road that connects two paved roads to each other (*Tolhuisweg* and *Hammerweg*) (figure 2). There are three addresses on the road: to the north of the level crossing there is a farm and a camping site, to the south of the level crossing there is a single house. There are a number of sharp bends on the quite narrow road (approx. five metres wide), one of which connects directly to the level crossing.

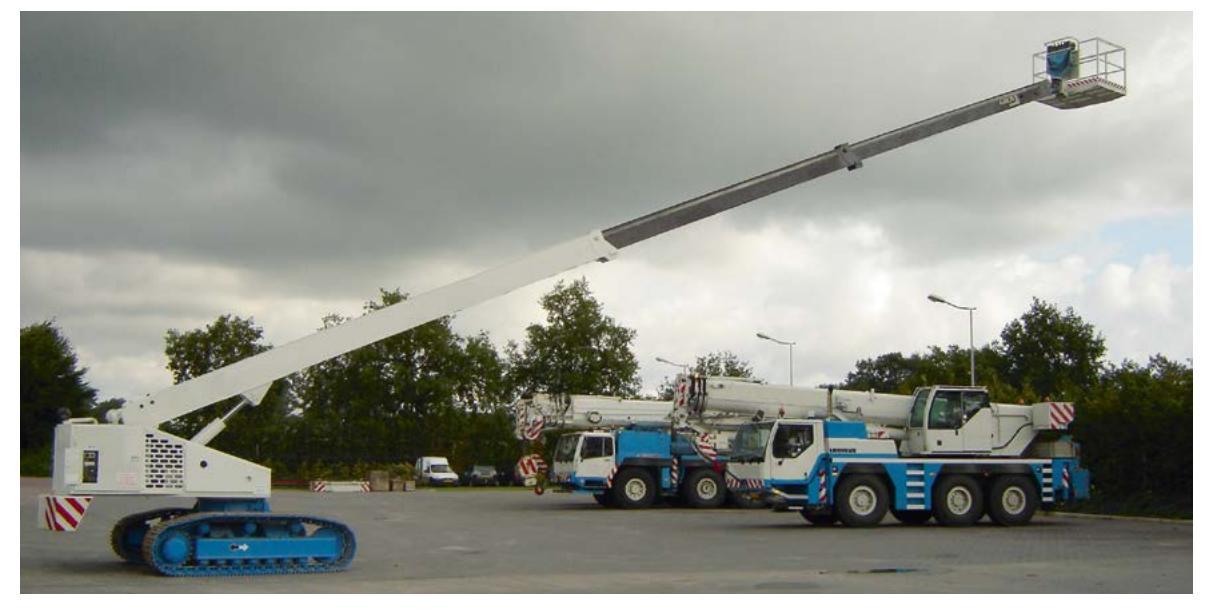
Figure 3: The man lift. Photo: Man lift rental company

The man lift was a Grove MZ 90 CR. This is a relatively large man lift with caterpillar tracks and a maximum working height of 27 metres, see figure 3. The total mass is approximately 20 tonnes.

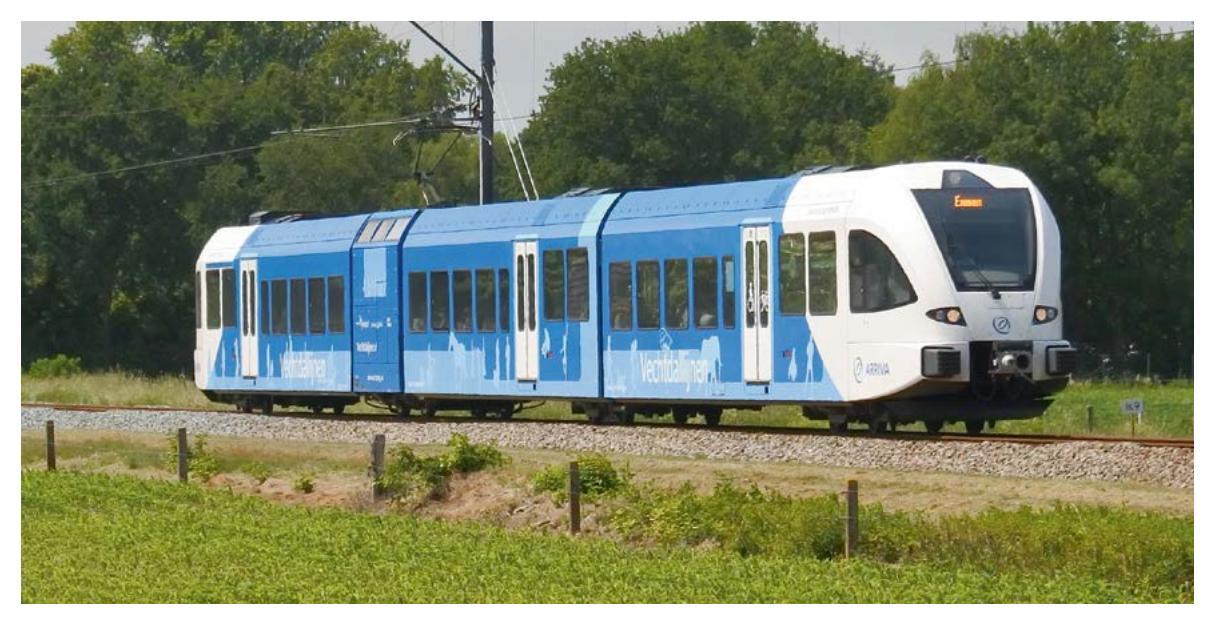
Figure 4: The photo shows a train of the same type as the train involved in the accident. Photo: Dutch Safety Board

This was a four-part train of the GTW 2/8 type made by the Swiss manufacturer Stadler. This type of train comprises three passenger carriages and a short middle section housing the drive (figure 4).<sup>6</sup> The mass is 85 tonnes and the maximum speed is 140 km/hour.

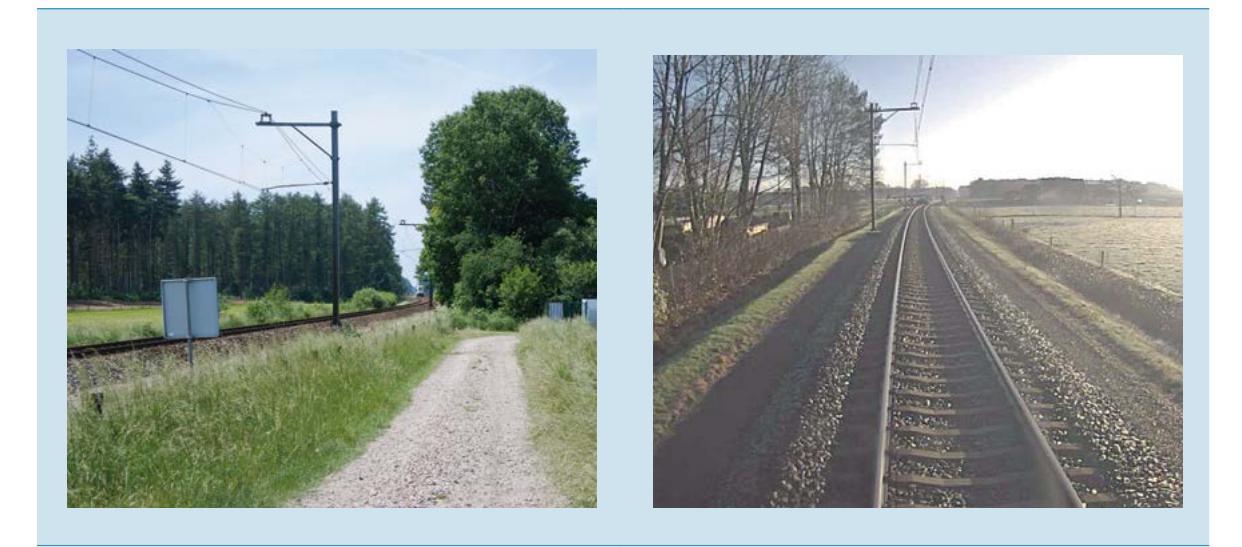
During the crossing, the operator saw a train approaching from the direction of Dalfsen. At that time, he himself was already past the track and as a result he could see a straight section of track that lies beyond the curve (see the photo on the left in figure 4). The train was then at such a distance from the level that the level crossing system had not yet been activated. The employee tried to clear the level crossing in time by continuing to operate the drive buttons. In addition, he waved his arms to warn the train driver. The level crossing system activated approximately 30 seconds before the collision occurred. At that moment, the train had approached to a distance of approximately one kilometre. The operator jumped out of the man basket a couple of seconds before the collision.

Figure 5: The photo on the left shows the view of the straight length of track beyond the curve, seen from the bend in the road on the north side of the level crossing. The photo was taken in June 2016. The photo on the right shows the view that the driver of the train in the accident had when entering the curve; the distance to the level crossing at that time was still approximately 150 metres. Photos: Dutch Safety Board (left), Arriva front camera (right)

Because of the curve in the track, the train driver only had a view of the level crossing when he had approached to within approximately 350 to 400 metres. The train driver, once hen he had a line of sight to the level crossing, had to look into the light while having driven in shade shortly before this. The sun was low and at one o'clock for the train driver (see the right-hand photo in figure 5).

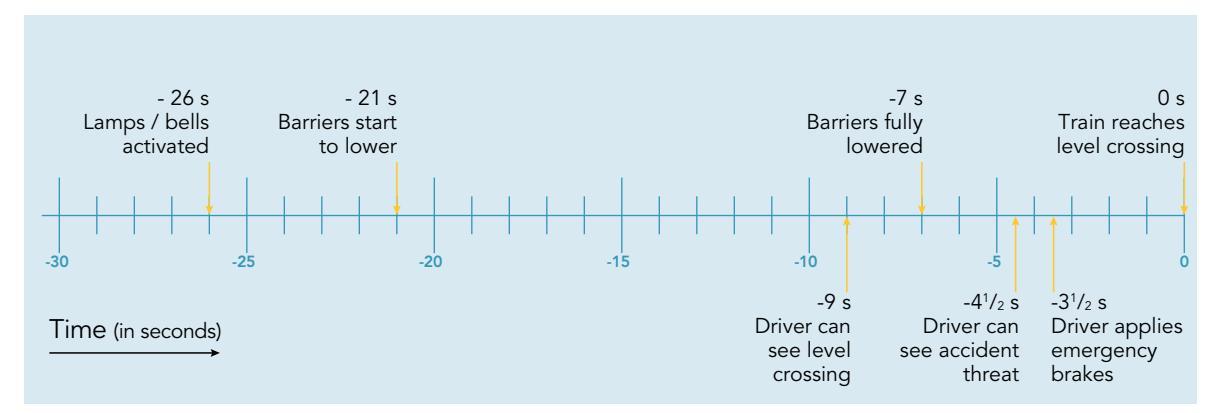
It is not known exactly at what location the train driver realised that the man lift was engaged in crossing the level crossing, and that this manoeuvre would not be completed in time. Because of the curve in the track the Dutch Safety Board considers it unlikely that the train driver was able to determine this at a distance of more than 175 metres (see Section 4.4). The data from the train event recorder ('black box') on the train shows that, three seconds before the collision, the train driver deployed the emergency brakes. At that point, the train was still approximately 130 metres from the level crossing, and the train speed was reduced from approximately 140 km/hour to approximately 130 km/ hour.<sup>7</sup>

Figure 6: Time line of relevant moments shortly before the accident.

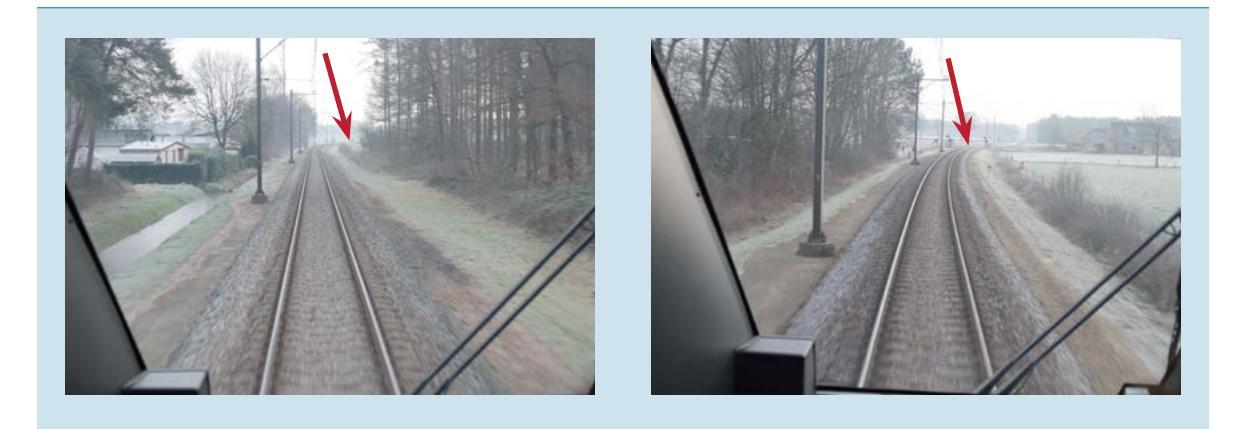
In the accident in Dalfsen, the train driver, because of the curve in the track, only gained sight of the level crossing when the train was approximately 350 metres away from it (see photo on the left in figure 13). The accident threat would not, however, have been immediately apparent when the train driver caught sight of the level crossing. This is because there is a curve in the intervening track section, as a result of which it was not, initially, perceptible that (part of) the man lift was still on the level crossing, and that it would probably not clear the level crossing in time. When that too had become reasonably perceptible, the distance from the train to the level crossing had already decreased to approximately 175 metres (see photo on the right in figure 13). The analysis of the trip data (see Appendix C1) reveals that the remaining distance was covered in four to five seconds. This means that the period available for an escape manoeuvre was less than the time reasonably required for it. In the accident in Dalfsen, the train driver did not have the opportunity to make a timely escape from his cab into the passenger compartment.

Figure 13: View from the cab on approaching the Het Lage Veld level crossing. The left-hand photo is the moment at which the level crossing becomes visible; the distance is a good 350 metres. The right-hand photo is the stage at which it was reasonably possible for the train driver to assess the situation on the level crossing (including any accident threat); the distance had then decreased to approximately 175 m. These pictures were recorded during a train journey on a similar train on 01 March 2016.<sup>21</sup> Photos: Police

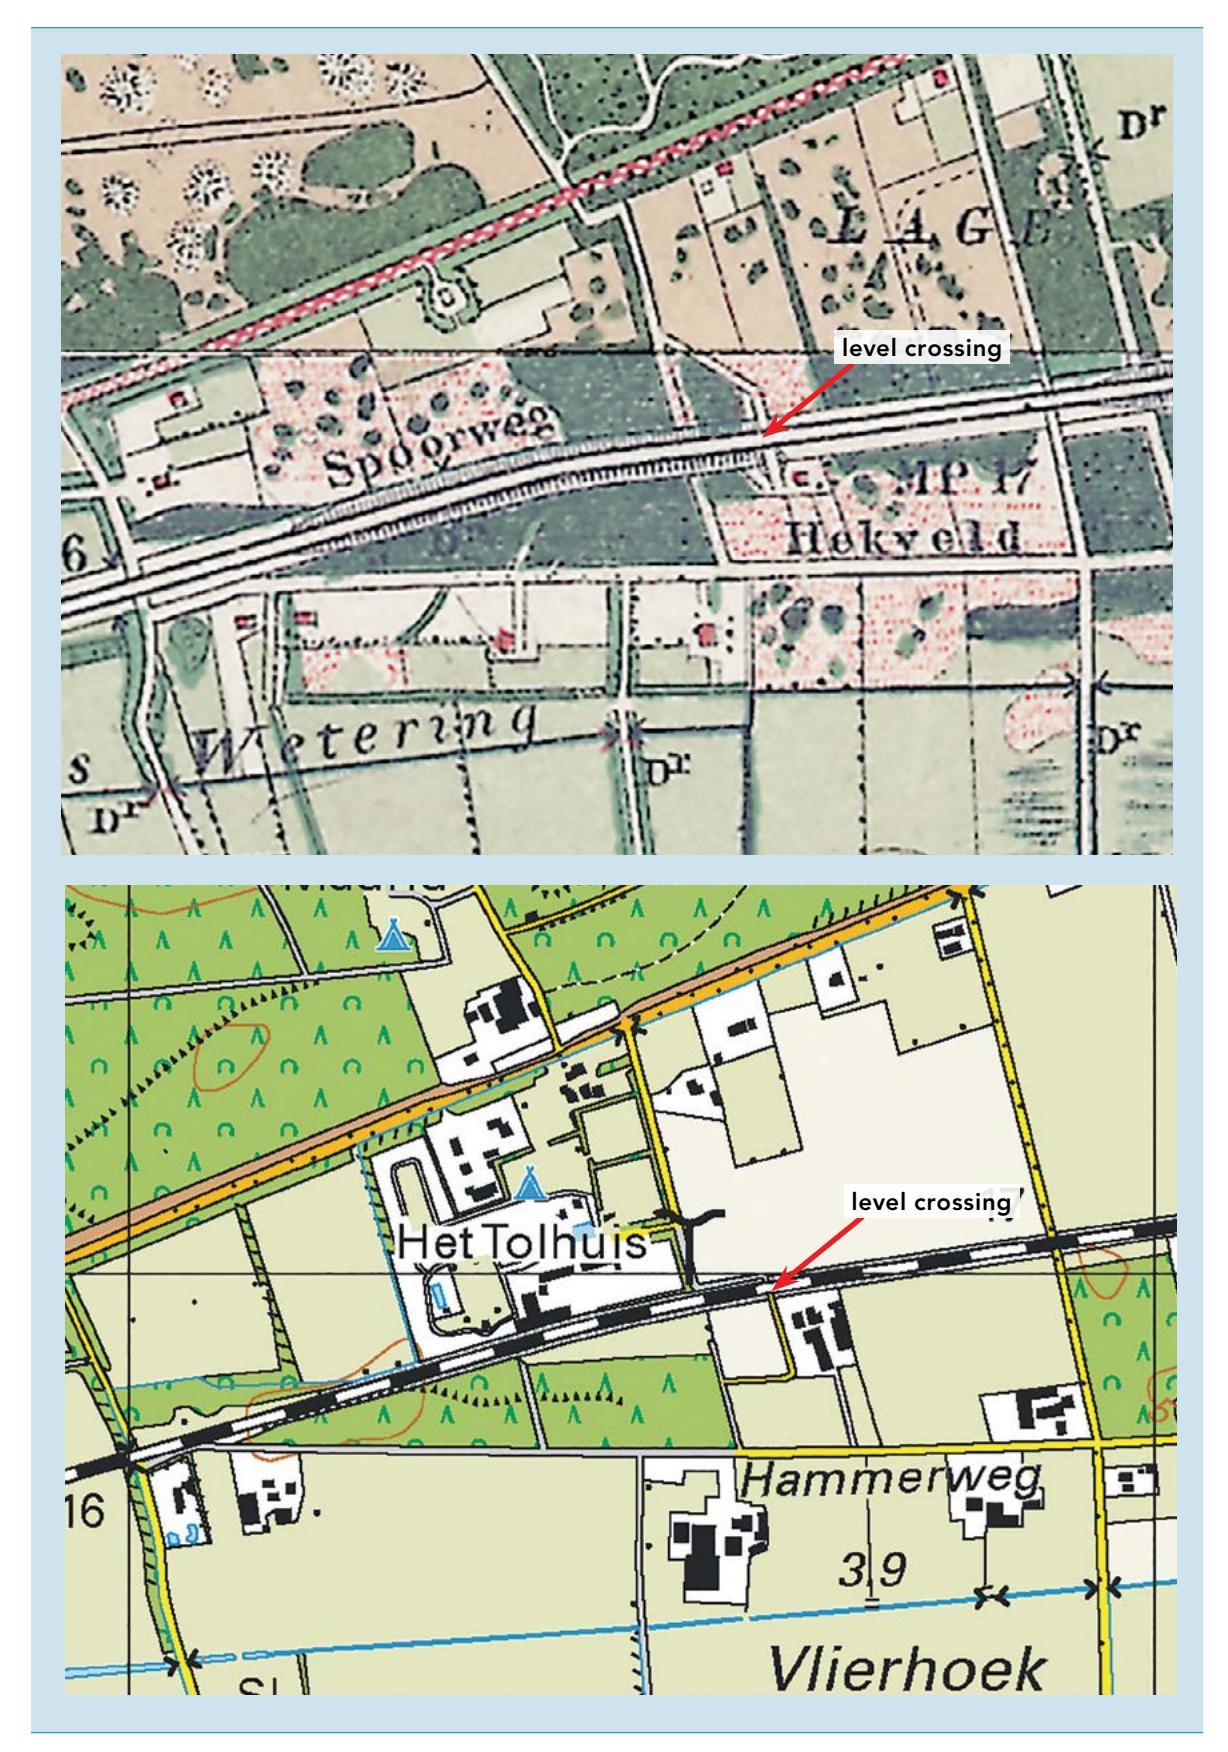
Historical maps show that the road ran straight on before the railway line was built; when the railway line was built (around 1900), the road situation changed and there is now a level crossing at the current location (figure 16). The situation of the road changed once again since then and this probably happened between 1910 and 1935. The road situation, which is not ideal by current standards because of the bend in the road shortly before the level crossing and the inability for low loaders to use the level crossing, was established long ago and has not changed substantially since then.

Figure 16: Het Lage Veld level crossing, maps dated 1908/1911 (upper) and map dated 2015 (lower). Source: Kadaster

Although the nearby Vlierhoekweg level crossing is less hazardous with regard to crossing heavy vehicles - because of the straight and flat road layout, the probability of problems during the crossing is smaller; because of the distance to the curve in the track, the probability of a serious outcome also is smaller - the normal processes of the road manager and rail network manager have never considered removing the Het Lage Veld level crossing or restricting its use by long or heavy vehicles.<sup>36</sup>

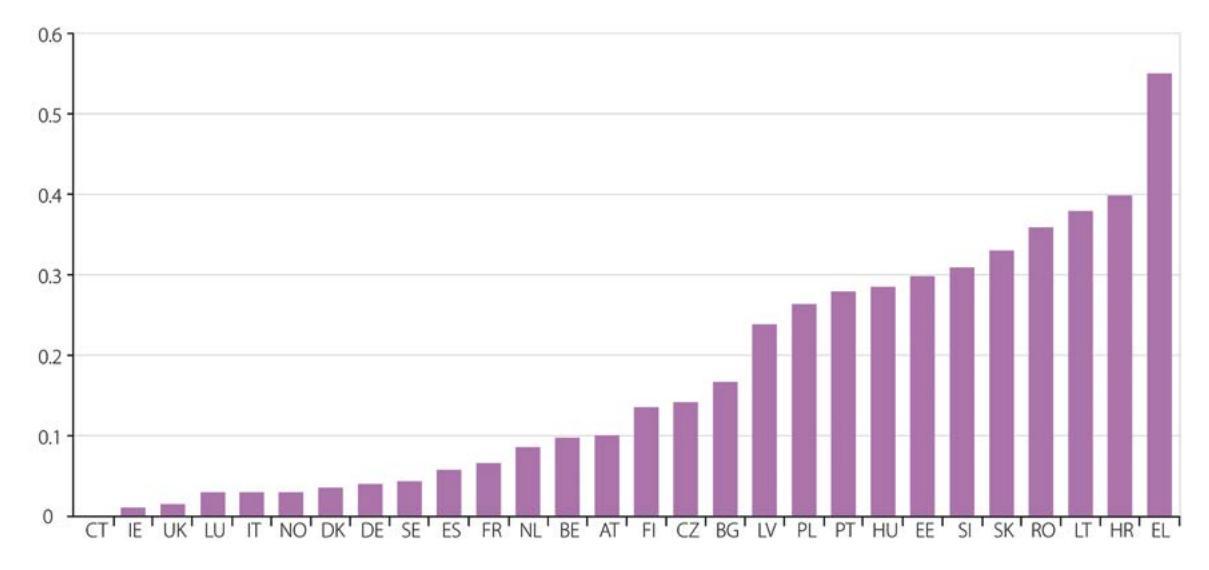
To allow the Dutch level crossing safety performance to be considered in perspective, Table 3 and Figure 17 summarise a number of key figures where the Netherlands is compared with other West-European countries.<sup>44</sup> This reveals that there is a relatively large number of level crossings in the Netherlands and that, proportionally, there are many casualties (both per time unit and per train kilometre travelled).

Figure 17: Number of level crossing fatalities per million train kilometres (2010 - 2012). Source: ERA

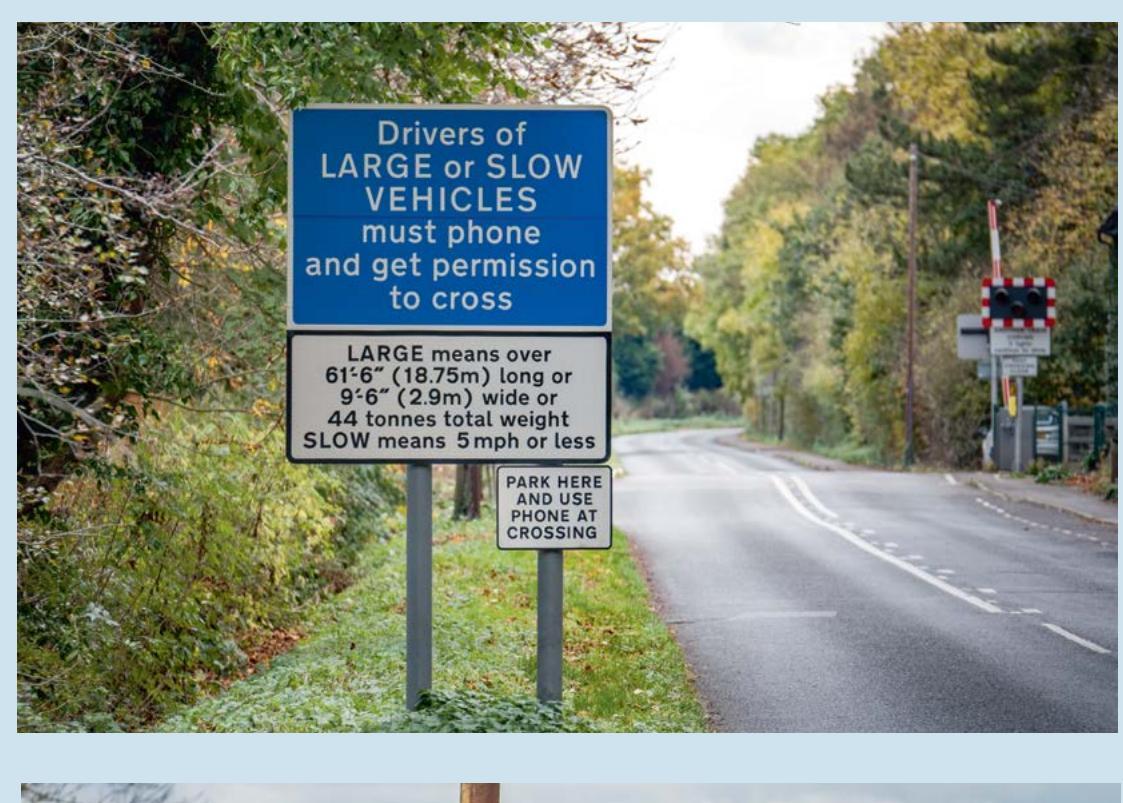
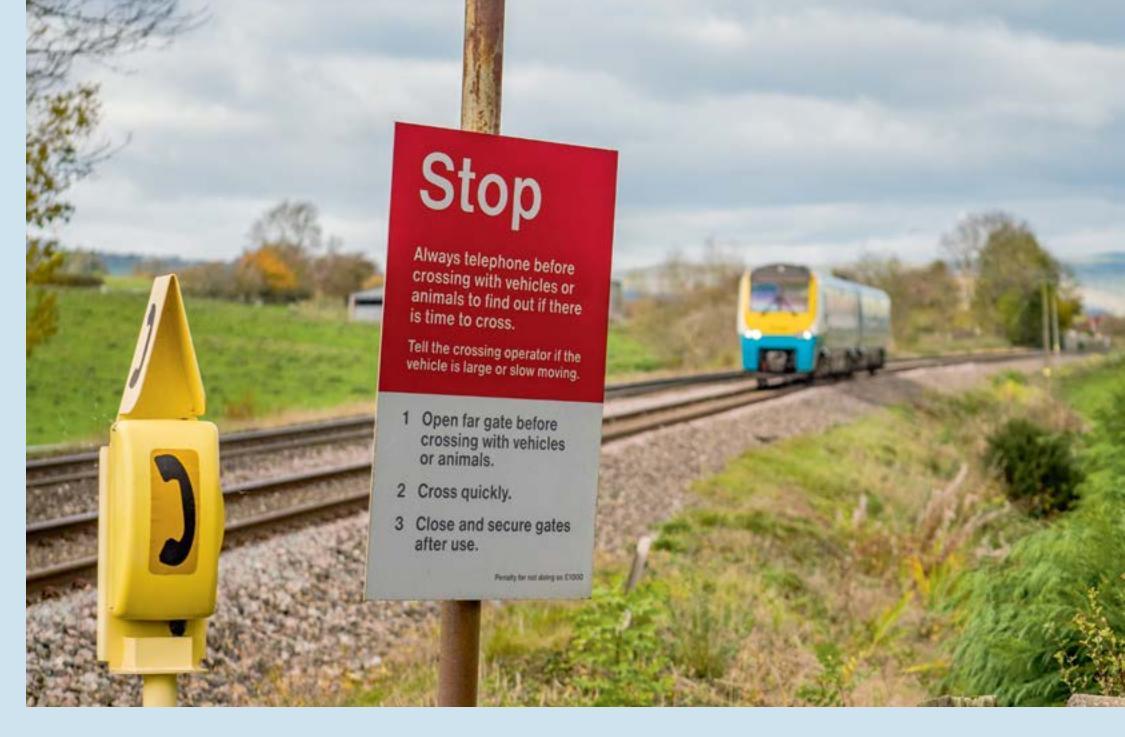
In the United Kingdom, level crossings with automatic half barriers have signs explicitly stating that drivers of heavy, long or slow vehicles must stop and request permission to cross the railway (figure 18). Apart from drivers being explicitly informed of circumstances in which crossing is hazardous, they are obliged to contact rail traffic control and are provided with the capability to do so.

Figure 18: United Kingdom: warning signs for drivers of heavy and slow vehicles with the capability to contact rail traffic control. Photos: Dutch Safety Board

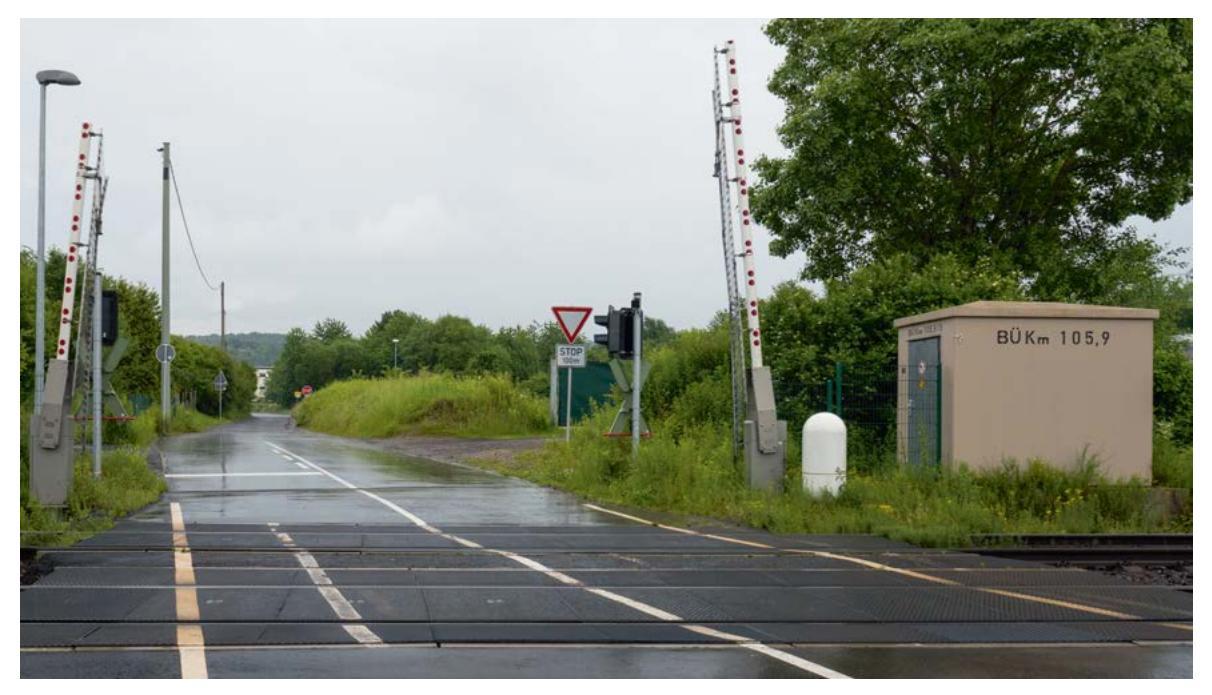
In Germany, obstacle detection is a requirement in certain cases, either visually by the level crossing operator or using technical aids such as mirrors, cameras and/or radar systems. Figure 19 shows an example of radar detection. In these cases, train traffic is only allowed onto the crossing after it has been confirmed that the crossing is actually clear. The level crossing must be closed and reported clear when the train is still approximately 1500 metres away if train traffic is not to be disrupted. This means longer waiting times for the road traffic than at level crossings with half barriers; the duration of the closure for a single train is approximately three minutes, compared to approximately one minute for half barriers.

Figure 19: Germany: level crossing with radar system that monitors whether or not the intersection is actually clear. Photo: Dutch Safety Board

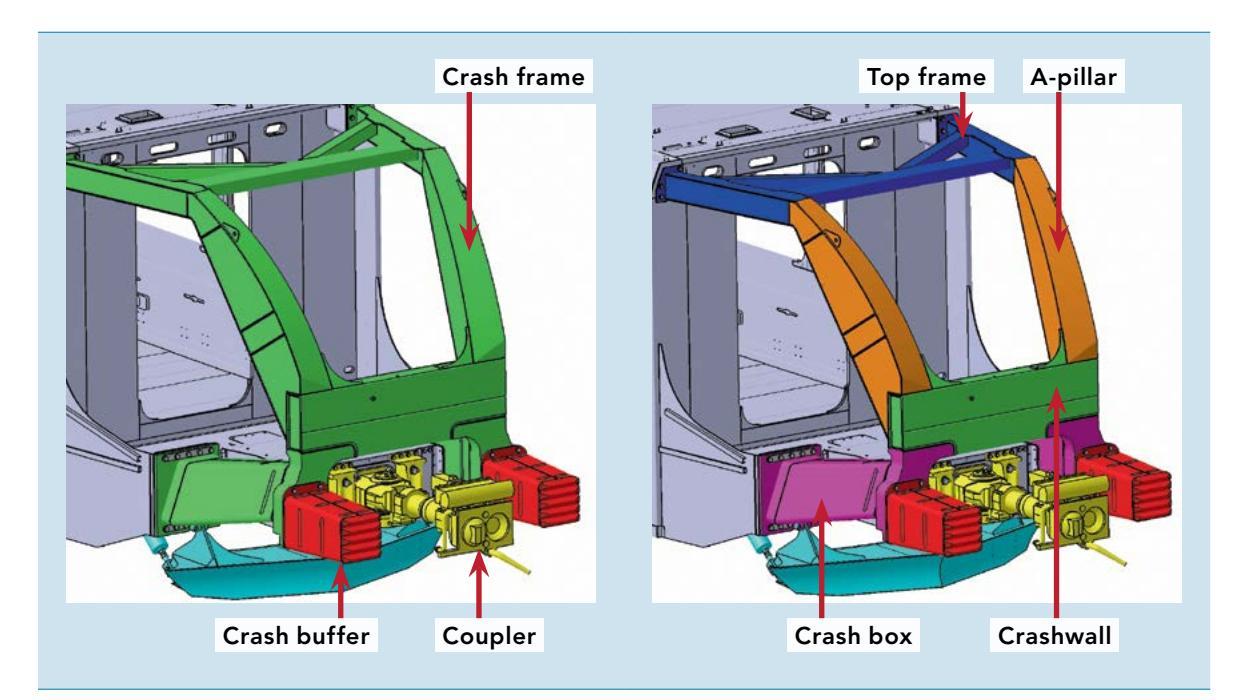
Figure 25: The construction of the crash structure. Source: Stadler

The cabs of GTW trains are equipped with a crash structure, comprising a crash fame, two crash buffers and a coupler (see the left-hand drawing in figure 24). In its turn, the crash frame comprises a top frame, two A-pillars, a crash wall and two crash-boxes (see the right-hand drawing in figure 24).

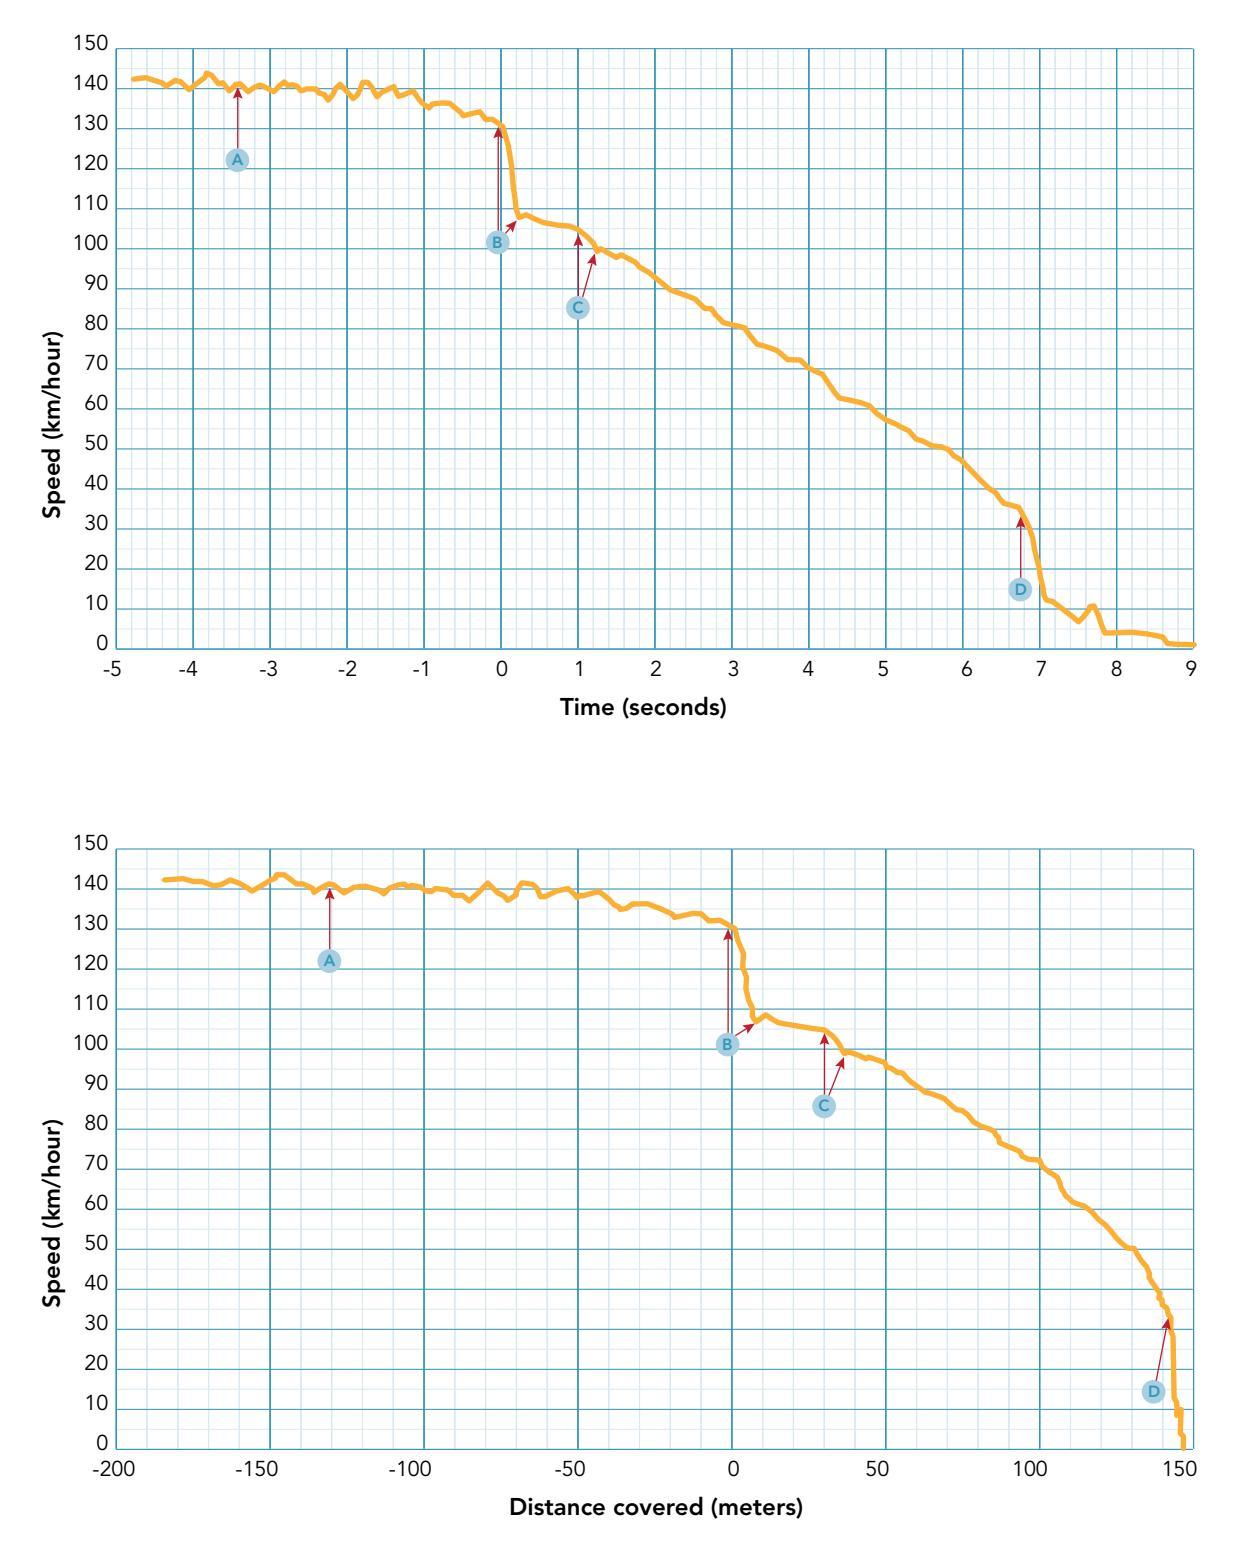
Figure 33: The train's speed profile as a function of the time (top graph) and distance covered (bottom graph) respectively. Source: Dutch Safety Board

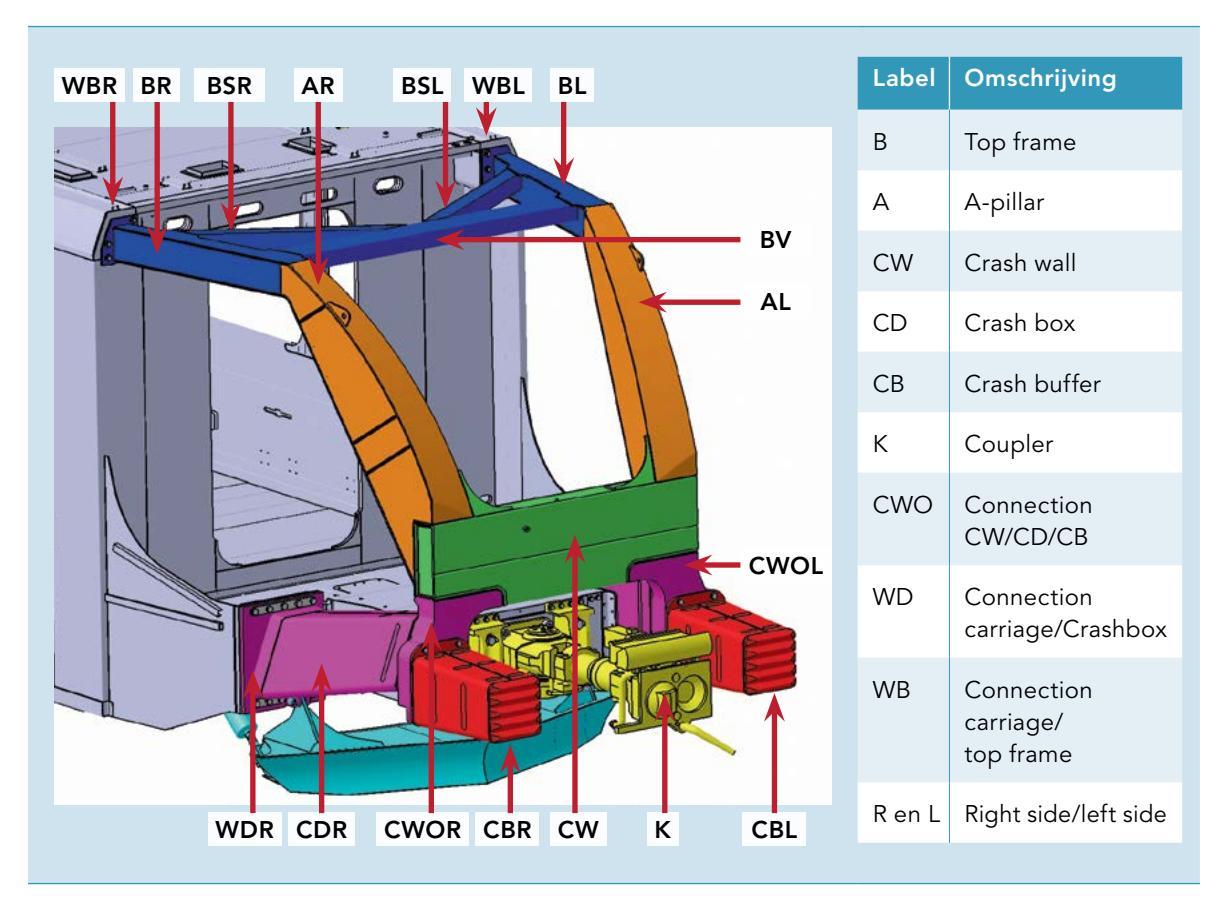
The fractures created in the main components of the crash frame were analysed to gain insight into the way in which the front of the train collapsed. When doing so, the labels shown in figure 34 were used for the documentation.

Figure 34: Summary of the labels used in the documentation of the fractures and deformations. Source: Stadler

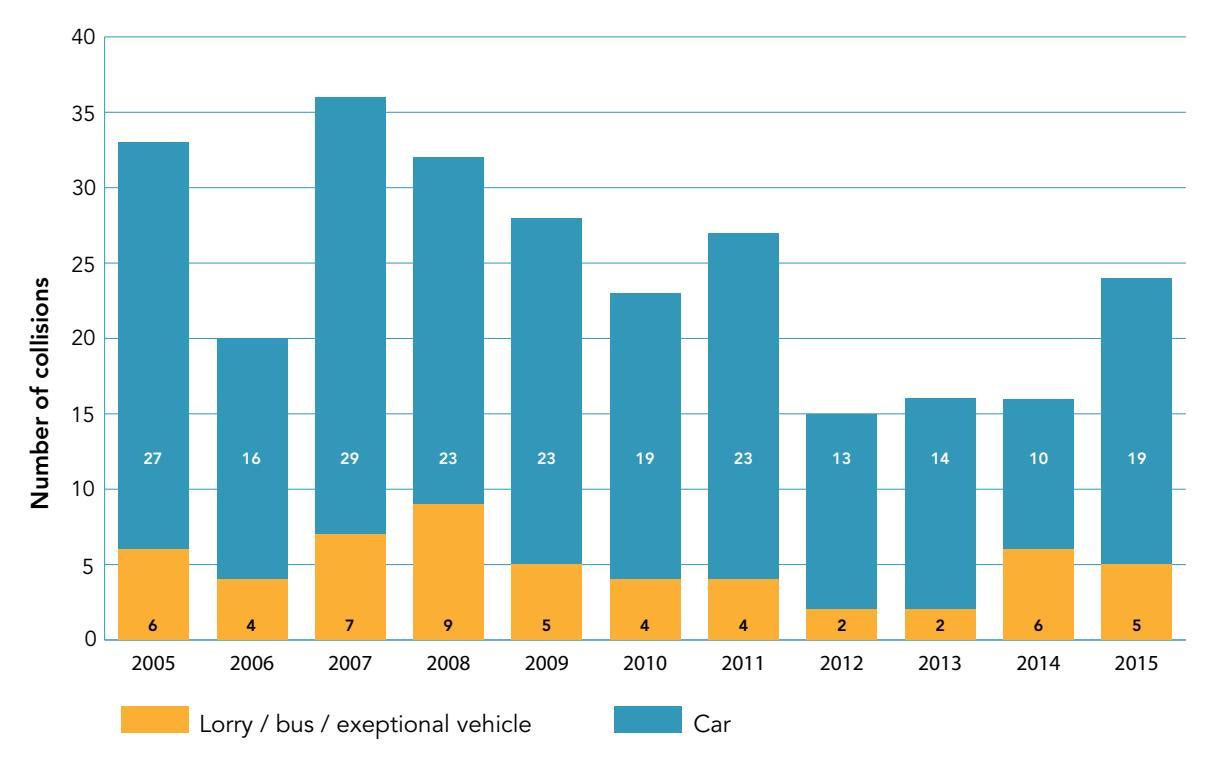
In the said period of just over 11 years, there were 277 accidents between passenger trains and motor vehicles, which works out as an average of 25 accidents per year. It is worth mentioning that while the annual total does fluctuate, no rising or falling trend is demonstrated (figure 41). The total of 277 accidents involved 55 collisions with heavy motor vehicles (20%) and 222 with passenger cars (80%). The collisions with heavy road vehicles mainly involved trucks and tractors (sometimes with a trailer); occasionally a bus or another type of vehicle was involved (figure 42).

Figure 41: Number of level crossing collisions with heavy road vehicles and passenger cars per year.

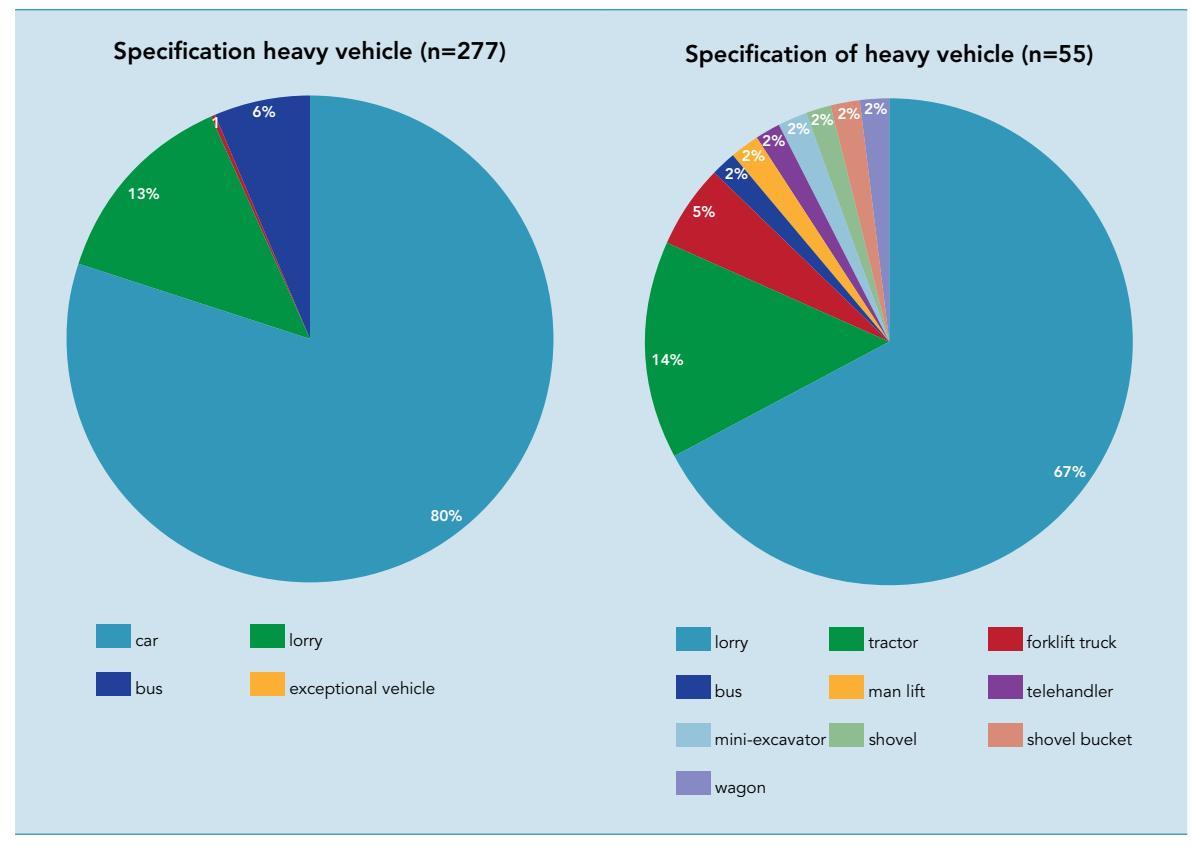
Figure 42: Accident distribution by type of vehicle.

Apart from the accident in Dalfsen, there was only one involving a somewhat comparable vehicle (digger). In all other cases, the dimensions and mass of the obstacle more closely resembled that of a passenger car or truck.<sup>56</sup>

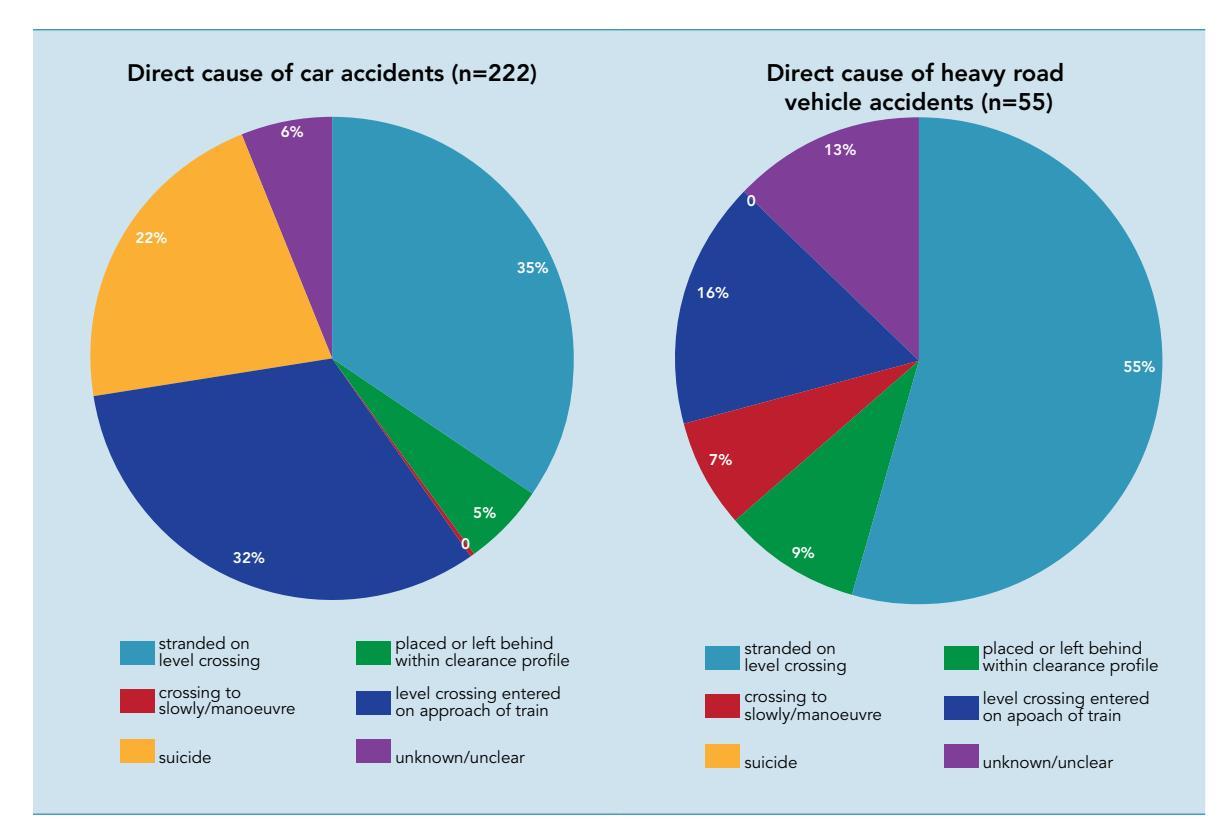
Clearly, heavy vehicles often spend more time on the level crossing, as a result of stranding, low speed or the need to manoeuvre on the level crossing, for instance (figure 43). In comparison with collisions involving passenger cars, collisions involving heavy motor vehicles occur more often on level crossings protected by barriers (figure 44).

Figure 43: Causes of level crossing collisions involving passenger cars and heavy road vehicles.

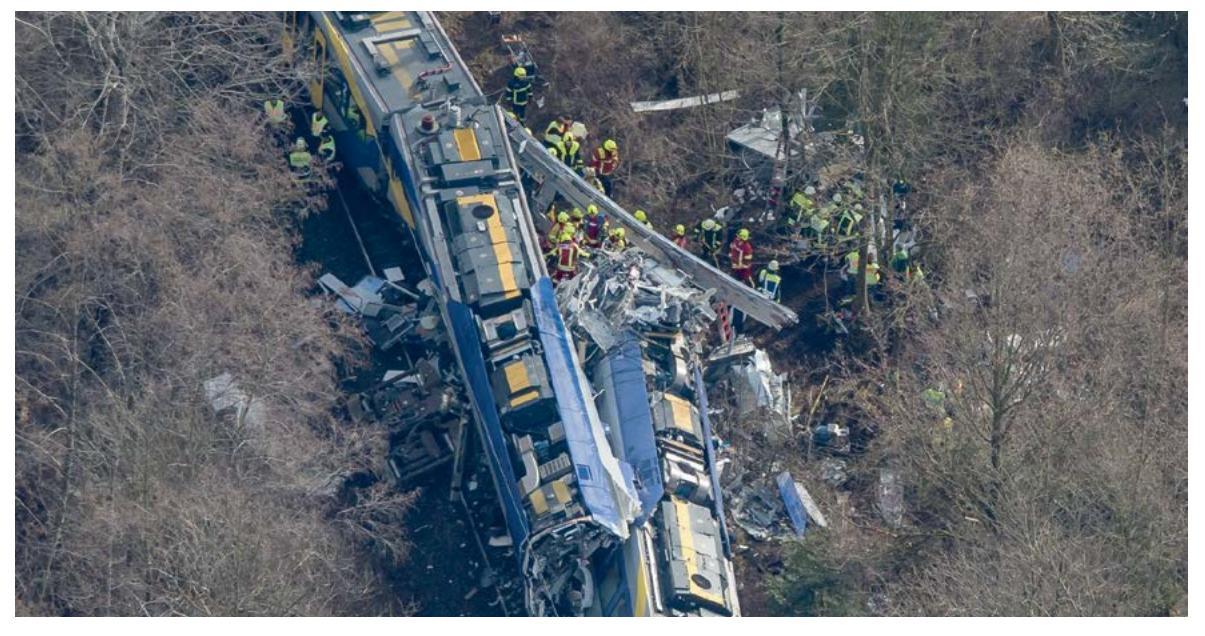
Figure 45: On 09 February 2016, two Stadler FLIRT-3 type trains were involved in a frontal collision at Bad Aibling (Germany). Photo: ANP

Both trains were of the FLIRT-3 type. The speed limit at the accident location was 100 km/ hour. It is probable that both trains had braked relatively little prior to the collision.

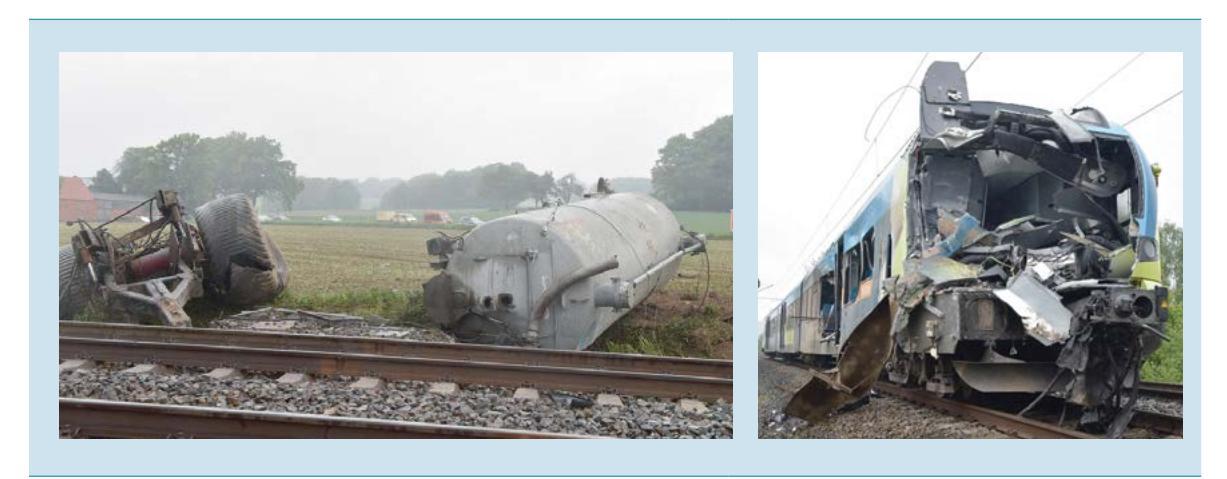
The train was of the FLIRT-1 type, a type which does not have a crash structure in the cab and which does not yet comply with the crashworthiness requirements in EN-15227. The agricultural vehicle involved in the collision was a manure spreader hitched to a tractor, but it broke free while crossing the level crossing and was left behind.

Figure 46: On 16 May 2015, a train of the Stadler FLIRT-1 type collided with a manure spreader that was stranded on a level crossing at Ibbenbüren (Germany). These photos show the end situation. Photos: Tobias Vieth, ivz-aktuell.de

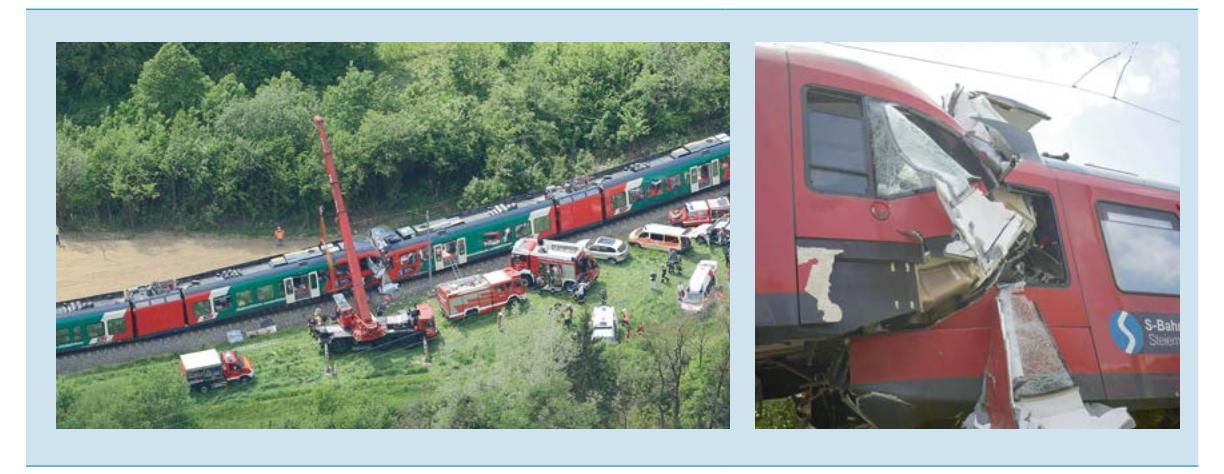
Both trains were of the same type as the train involved in the accident in Dalfsen (Stadler GTW). Both trains were also from the series where the crash frames have weld defects.

The maximum speed at the scene of the collision was 50 km/hour in one direction and 60 km/hour in the other direction. The collision occurred at a relatively short distance, less than 200 metres, from a station and therefore one train was still pulling away and the other was already braking. The collision speed (sum of both speeds) was approximately 70 km/hour. In the collision, the front of one train - having 'climbed up' - penetrated the cab of the other train.

Figure 47: On 06 May 2015, two Stadler GTW type trains were involved in a frontal collision at Übelbach (Austria). Photos: ANP
