DUTCH SAFETY BOARD

# Collision between a passenger train and a man lift at Dalfsen

The Hague, December 2016 The reports issued by the Dutch Safety Board are open to the public. All reports are also available on the Safety Board's website www.safetyboard.nl

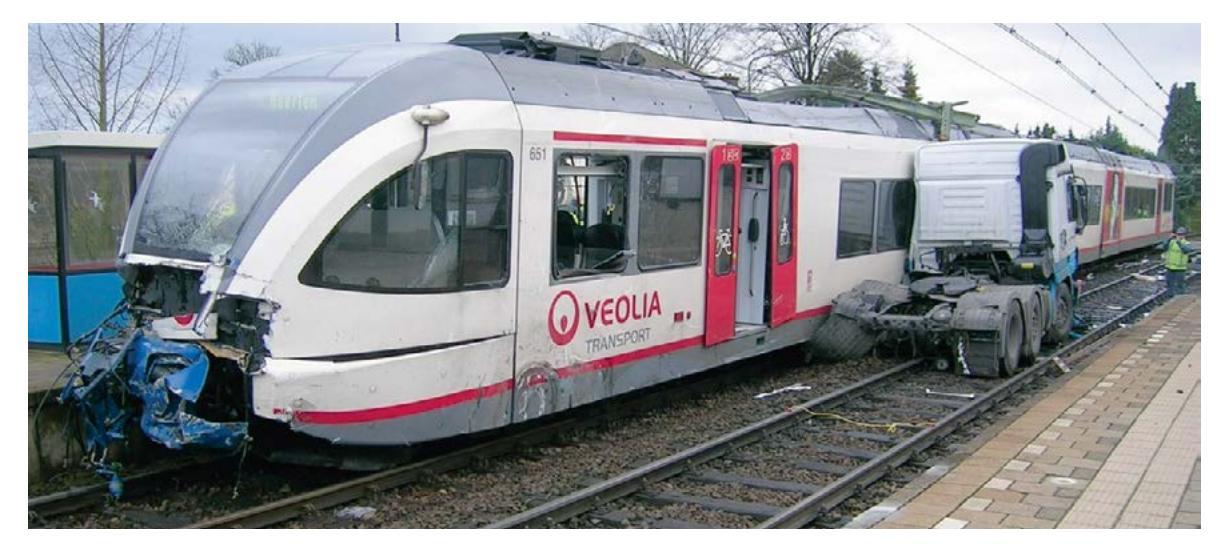
The train was of the same type as the train involved in the accident in Dalfsen (Stadler GTW). The truck, a tractor unit with low-loader which was carrying a load of concrete slabs, became stranded while crossing the level crossing. On the approach to the level crossing, the train was travelling at approximately 100 km/hour and it braked to approximately 65 km/hour before the collision.

The front of the train was damaged, but the cab remained intact. A driver and a driver under instruction were in the driver's cab; both were able to escape from the cab into the adjoining passenger compartment prior to the actual collision.

Figure 48: On 08 December 2009, a train of the Stadler GTW type collided with a truck on a level crossing in Houthem (the Netherlands). These photos show the end situation. Photo: Veolia Transport Limburg/ René Hameleers

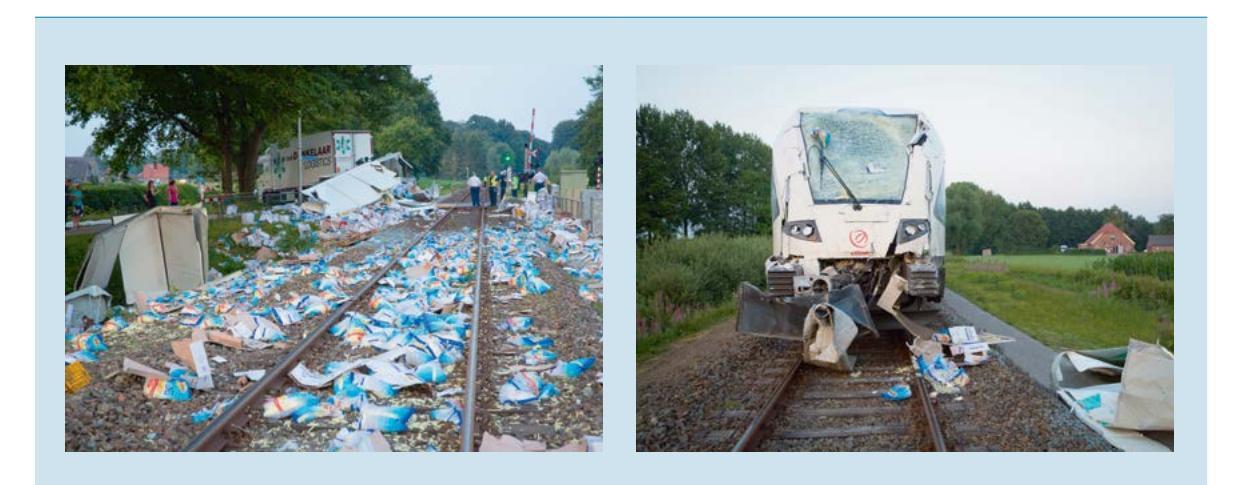
The train was of the same type as the train involved in the accident in Dalfsen (Stadler GTW). It was also from the series where the crash frames have weld defects. The truck, a box-body with trailer, became stranded while crossing the level crossing. The train crashed into the side of the trailer, which was laden. The train's collision speed was approximately 80 km/hour. The collision totally destroyed the trailer and the front of the train was damaged. The driver's cab remained intact.

Figure 49: On 16 July 2014, a train of the Stadler GTW type collided with a truck on a level crossing in Ruurlo (the Netherlands). Photos: Stefan Verkerk
