DUTCH
SAFETY BOARD

Risk management for the transport of dangerous goods by rail

Train collision Tilburg

6 March 2015

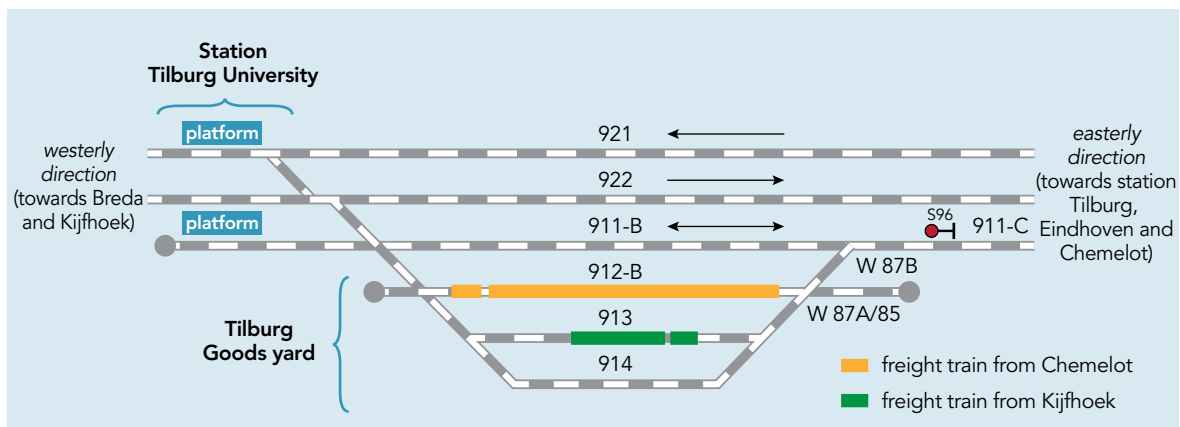
To allow the driver change to take place, both freight trains were guided to the side tracks at the Tilburg-Goods yard (see figure 3). The first to arrive, from a westerly direction, was the freight train that departed from Kijfhoek, which was guided onto track 913. Approximately fifteen minutes later, the freight train that departed from Chemelot arrived from an easterly direction, and was guided onto track 912-B. During its arrival, the freight train passed a switch (W87B) that is also part of the route of the passenger train. The freight train passed the switch several minutes before the passenger train was due to pass the same switch, according to the plan. After the freight train had been placed on the side track, it turned out that the train was several tens of metres too long for the side track in question. As a result, the back end of the train was too close to switch W87A/85, so that in the protection system, that switch retained its 'occupied' status. This meant that the switch for the passenger train (W87B) could not be switched to the correct setting¹⁵ and the accompanying signal (96) remained at red, as the passenger train approached.

Figure 3: Because of the specially scheduled driver change, both freight trains were guided onto side tracks at the Tilburg-Goods yard. Because the train from Chemelot was too long for the side track, signal 96 remained at red.

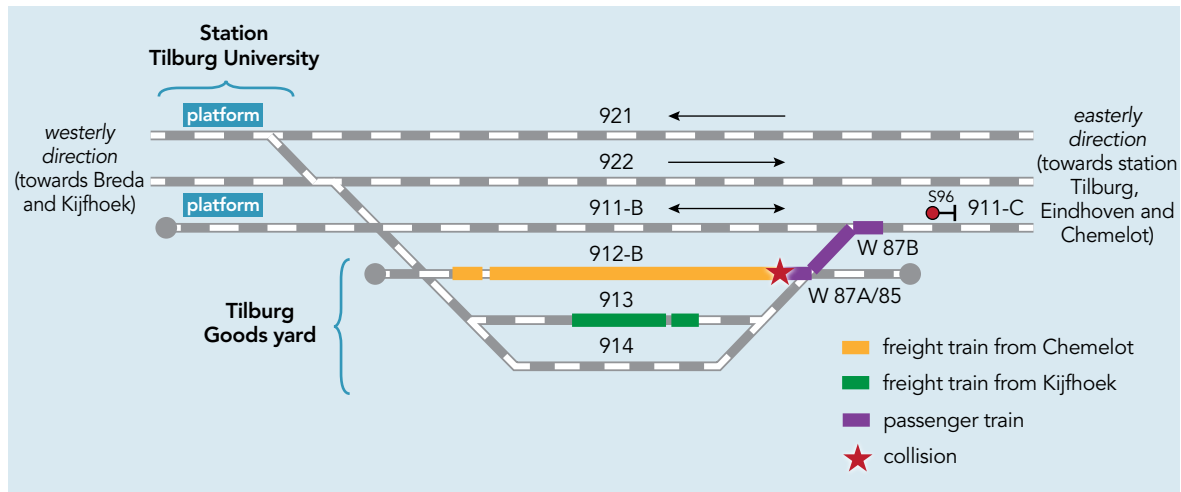
However, the driver of the passenger train did not perceive the signal at red, and as a consequence he failed to brake as he approached the signal. Because the signal is not equipped with an automatic train protection system ATB - Improved Version,¹⁶ no automatic braking was initiated.¹⁷ The eventual consequence was that the passenger train was guided onto the side track on which the freight train was still stationary (see figure 4) via the switch which was still in the diverging position. The driver of the passenger train did start to brake at the last moment, but this had little effect. Because of the limited remaining distance, the speed of the passenger train at the start of the collision was still almost identical to the original approach speed, namely approximately 45 km/hour.¹⁸

Figure 4: The passenger train passed the signal at red and then ran into the back of the freight train which stood on track 912-B.

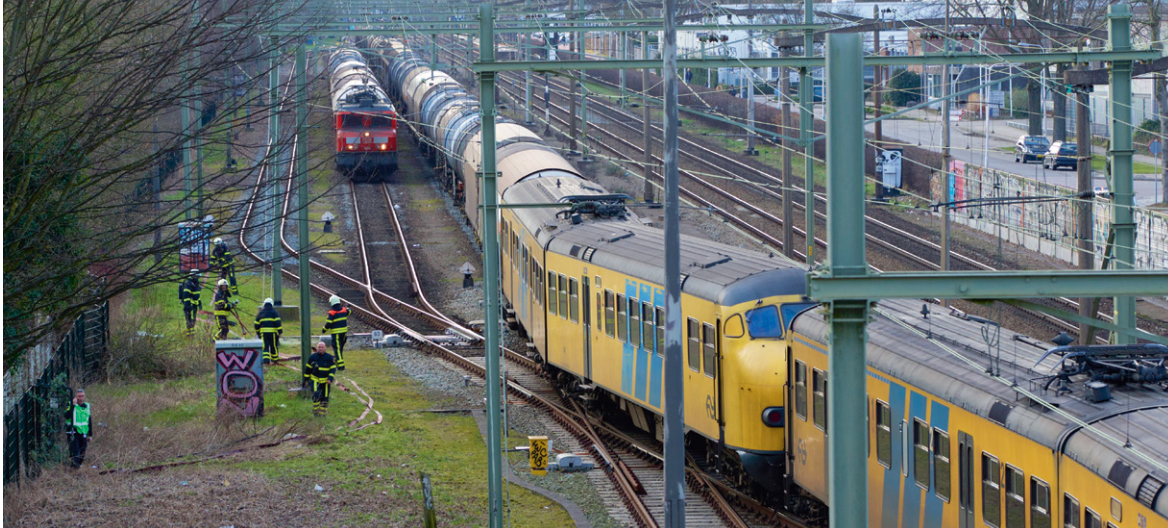
Figure 5: The three trains shortly after the accident. (Photo: ANP / Andy Smulders)

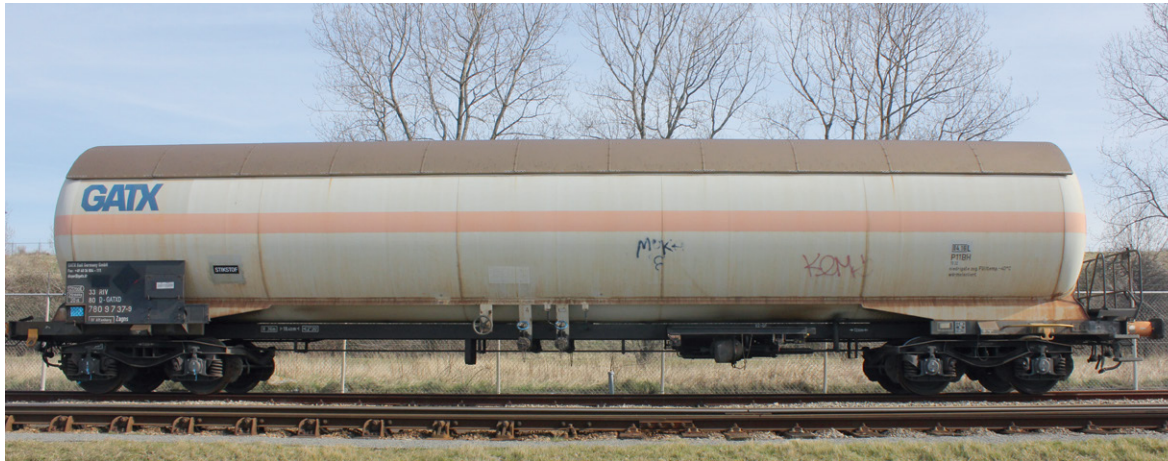
The rearmost wagon was a tank wagon suitable for the transport of (liquefied) gas. The wagon in question was a tank wagon of the type Zagns, built in 2004; the vehicle is the property of GATX and has been hired on a long-term charter by SABIC. The tank wagon was loaded with 52.5 tonnes of 1,3 - butadiene (HIN 239, UN-no. 1010).

Figure 19: The run-into tank wagon. (Photo: Dutch Safety Board)

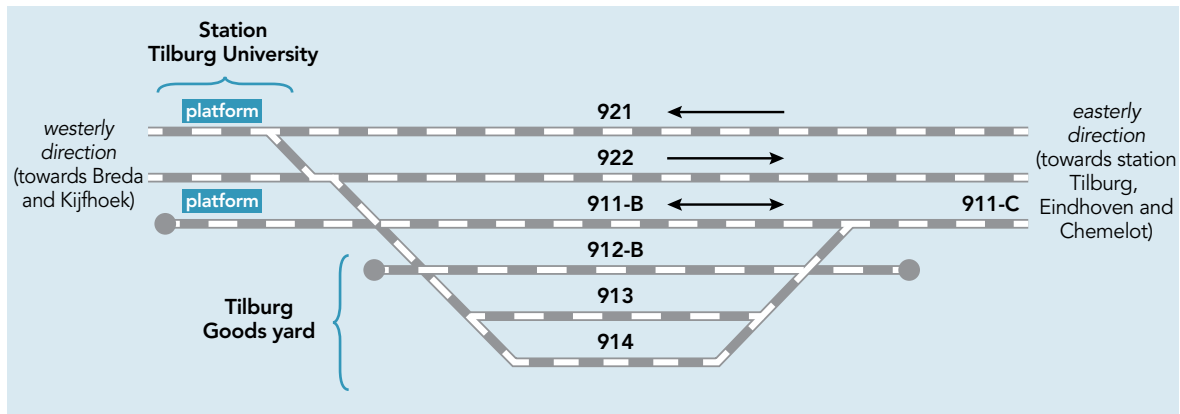
Tilburg-University). The route of the freight train was duly adjusted: the change meant that between the stations Tilburg and Tilburg-University, the freight train would not remain on the through track (921) but would be guided onto one of the side tracks (912-B) at Tilburg-Goods yard (see figure 20). The freight train arrived on that track at 16:34 hours. The other freight train (travelling to Sittard, which had departed early from Kijfhoek) had arrived in Tilburg approximately a quarter of an hour earlier (around 16:17 hours) travelling from the opposite direction, and had been placed on track 913 (see figure 21).

Figure 20: This drawing is a diagrammatic representation of the track layout between the stations Tilburg and Tilburg-University. According to the original timetable, the freight train would have travelled through Tilburg via track 921. In connection with the planned intermediate stop, the train was temporarily placed on track 912-B (via track 911-C).

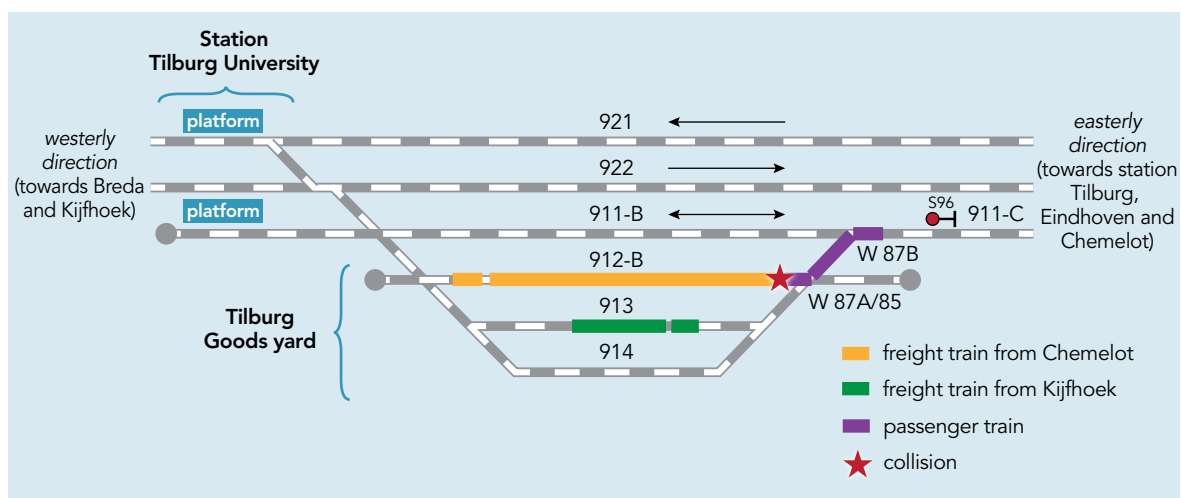
Because the signal was not equipped with the automatic train protection system ATB - Improved Version,⁷⁷ there was no automatic braking intervention. The eventual consequence was that the passenger train, via switch 87B that had not yet been switched to the correct position, and switch 87A/85, was guided onto side track 912-B (see figure 21). As previously explained, that track was occupied by the freight train. The driver of the passenger train activated his brake at the last moment, but because of the limited distance this was not sufficient to avoid a collision with the freight train.

Figure 21: This drawing is a diagrammatic representation of the position of both freight trains and the passenger train at the moment of the collision.

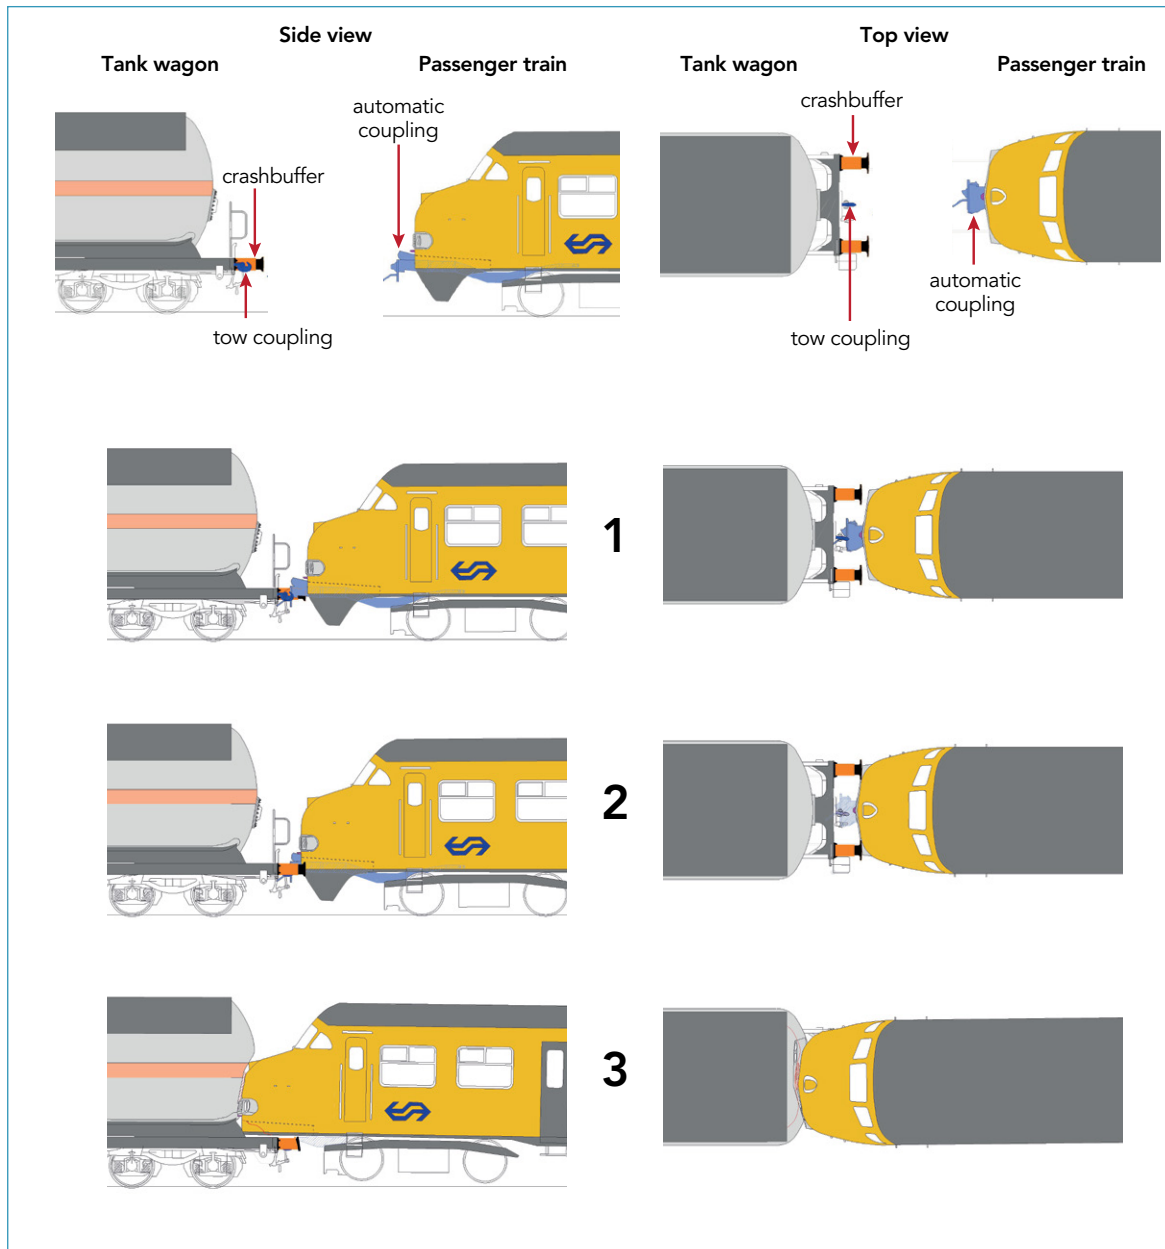
- The first contact took place between the automatic coupler on the front of the passenger train and the tow coupling at the back of the rearmost tank wagon of the freight train.
- As a result of the contact, the automatic coupler of the passenger train was compressed, at which point the front of the cab of the passenger train collided with the buffers of the tank wagon.
- Because only the top section of the buffers was struck, the front section of the passenger train 'climbed up' and over the buffers. The front of the passenger train then collided with the rear wall of the tank.

Figure 22: Broadly speaking, the collision consisted of three phases, whereby the front of the passenger train first collided with the tow coupling (1), then the buffers (2) and finally the tank of the rearmost tank wagon (3).

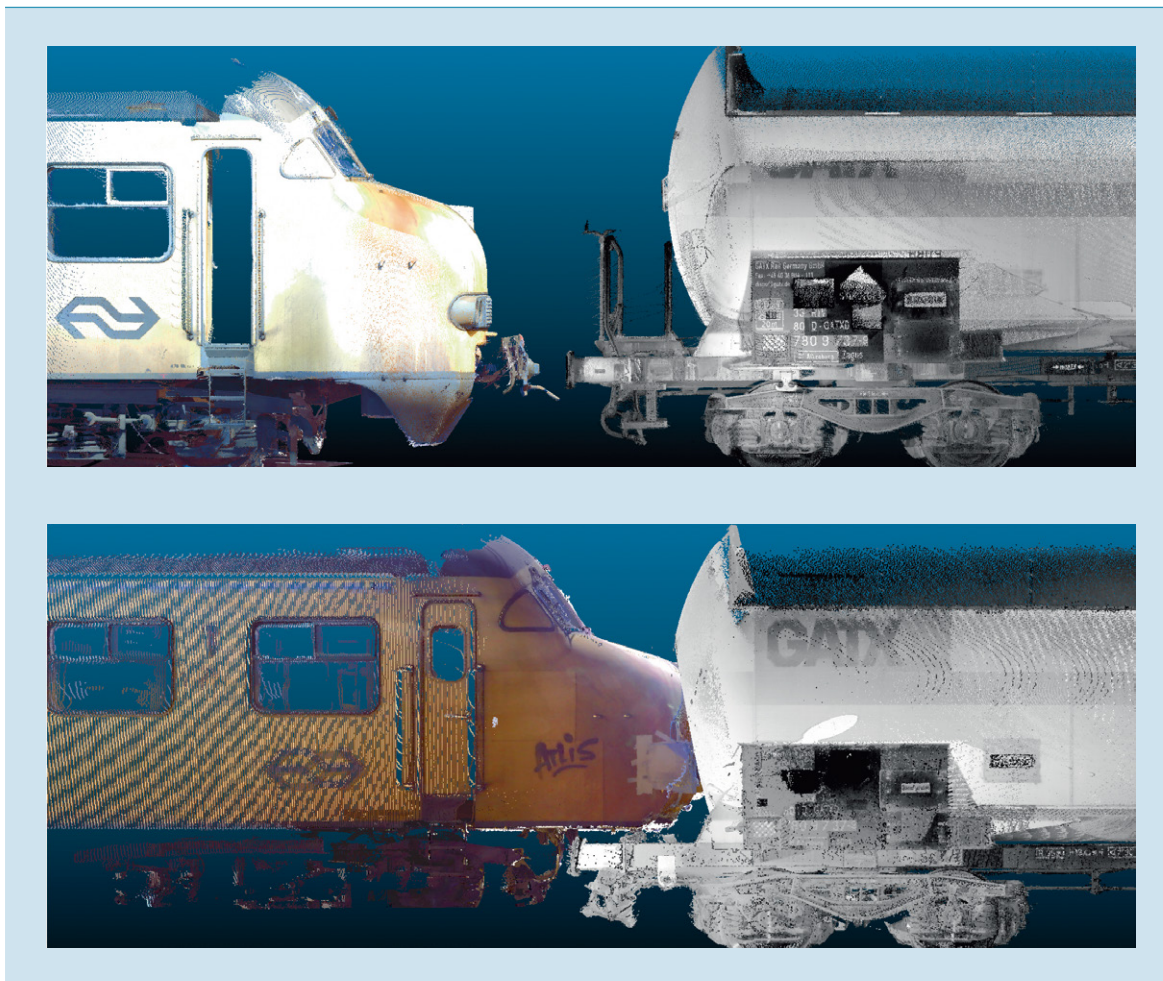
By comparing the 3D scans of the undamaged fronts (see the top picture in figure 35), it became clear that the first contact occurred between the automatic coupler of the passenger train and the tow coupling of the tank wagon, followed by the front of the passenger train making contact with (the top section of) the buffers. By comparing the 3D scans of the damaged fronts (see the bottom photograph in figure 35), it also emerged that in the second part of the collision, the front of the passenger train rose by approximately two decimetres, and subsequently collided against the rear wall of the tank.

Figure 35: These pictures show the side views of the 3D scans of the passenger train and the tank wagon, in respect of one another. The top picture shows the undamaged fronts and the bottom picture the damaged fronts. (Photos: Dutch Safety Board - KLPD)

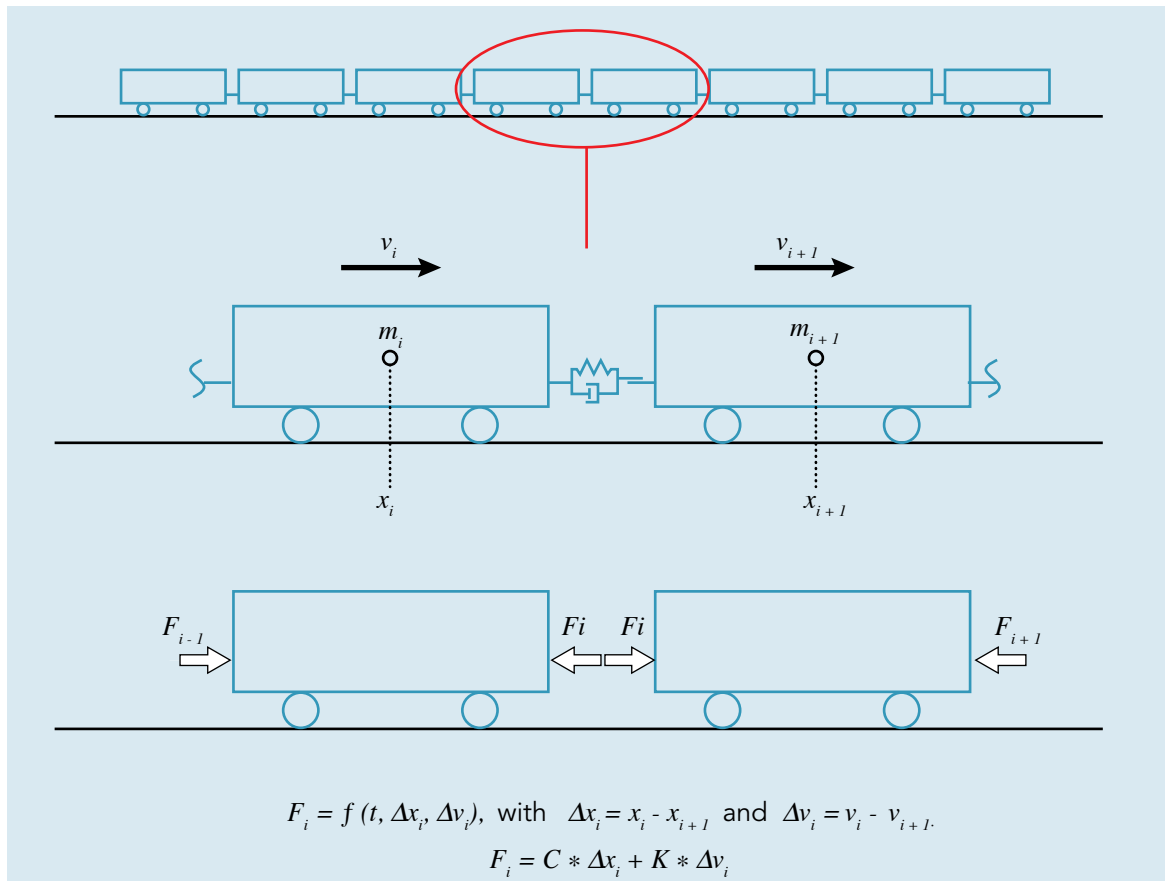
The calculation model used, as reproduced in diagram form in figure 37, consists of a series of coupling masses. The couplings between the masses take the form of elements of force, the force of which (over time) depends on the relative position (Δx) and relative speed (Δv); the elements of force consist of a spring linked in parallel (with the spring constant C) and an attenuator (with the attenuation constant K). The influence of the braking forces is accounted for by indicating for each mass whether or not a braking force was applied. The calculation model was implemented in the BODYSIM computer software (written in MATLAB version 2007b).

Figure 37: This figure is a diagrammatic representation of the calculation model.

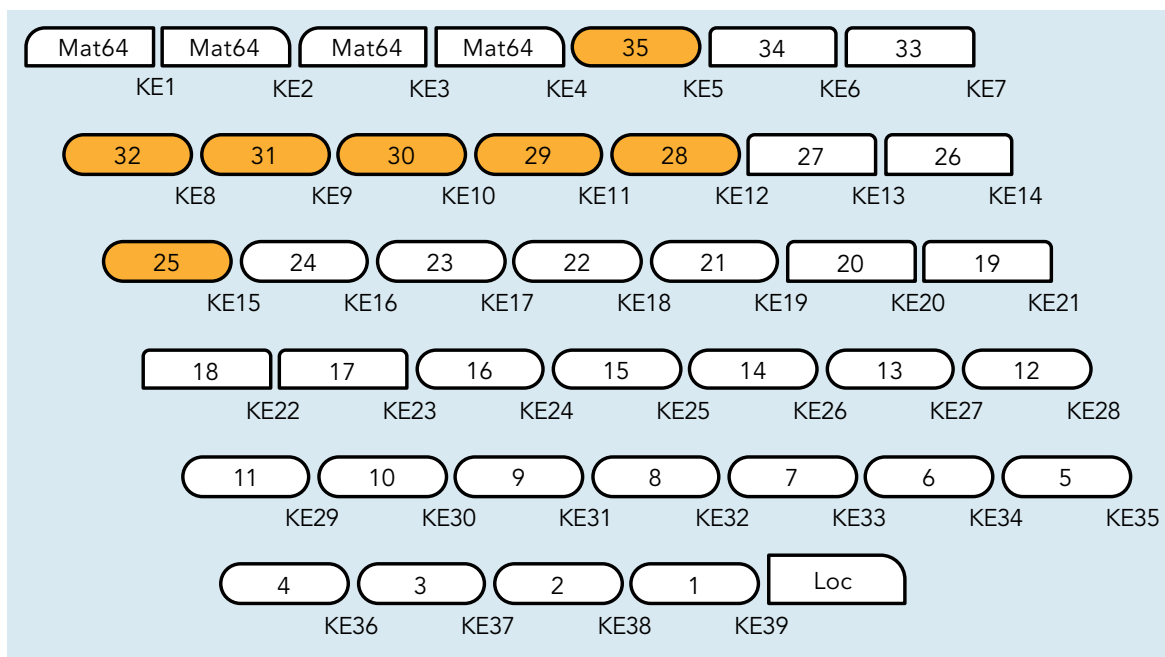
Figure 38 shows a diagrammatic representation of the (40) model elements, and the numbering of the coupling elements (KE).

Figure 38: Diagrammatic overview of the calculation model in which the carriages/wagons are indicated, together with the numbering of the coupling elements (KE). The coloured wagons are loaded, the others are empty

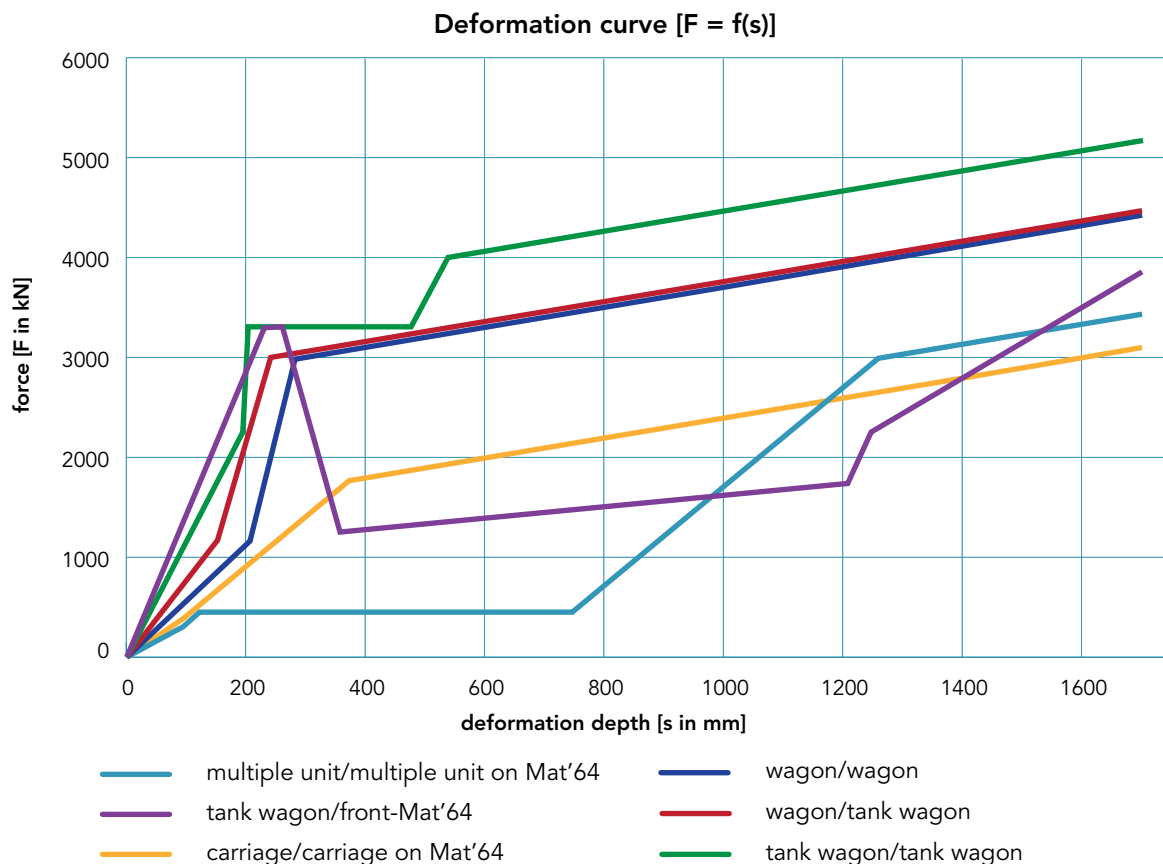
- Figure 39 shows the deformation curves employed for the various coupling elements. The course of the force/path diagrams is derived from the documentation concerning the (crash) buffers and couplings in question, and from deformations which were caused to the passenger train and tank wagon by the collision (as described in appendix B1). In respect of the deformation behaviour of the tank, a force/path development was assumed, such that the permanent deformation of the tank amounted to 0.35 m (in accordance with the measured value).

Figure 39: This graph shows the deformation curves (force/path diagrams) employed in the simulation of the calculation of the movements for the various coupling elements.

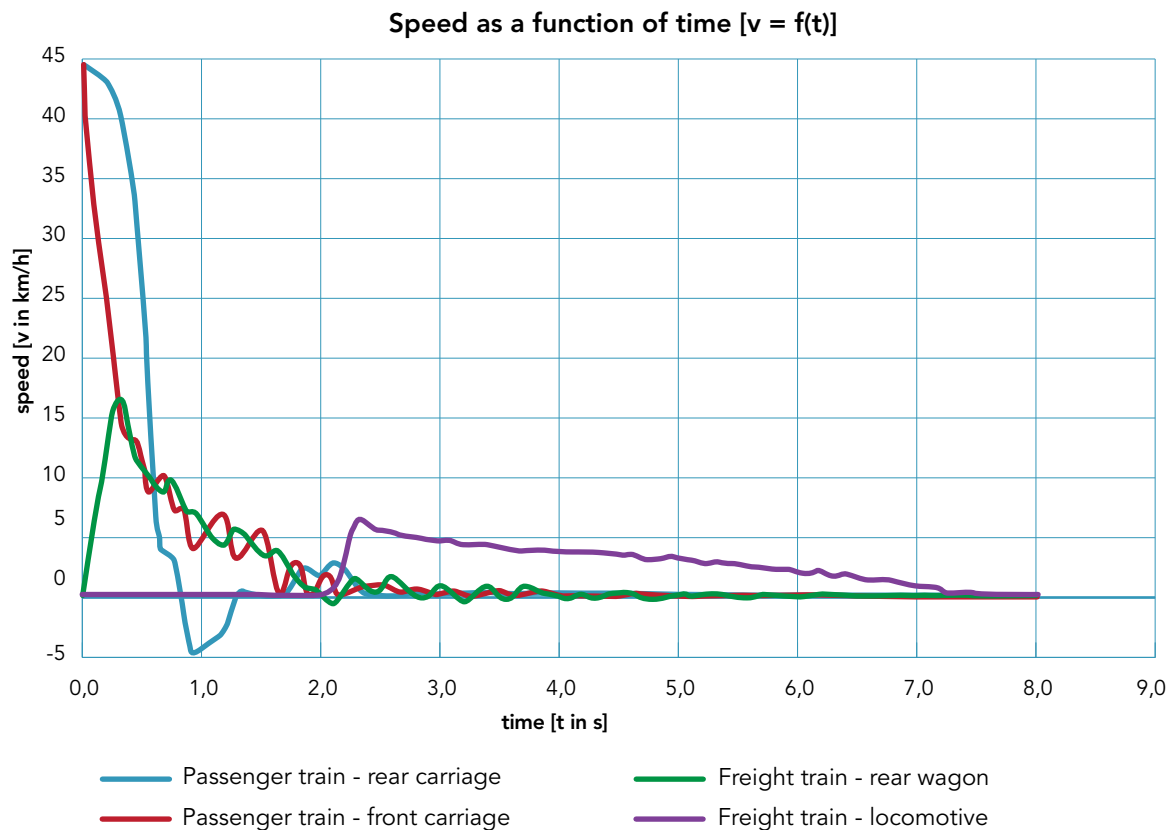
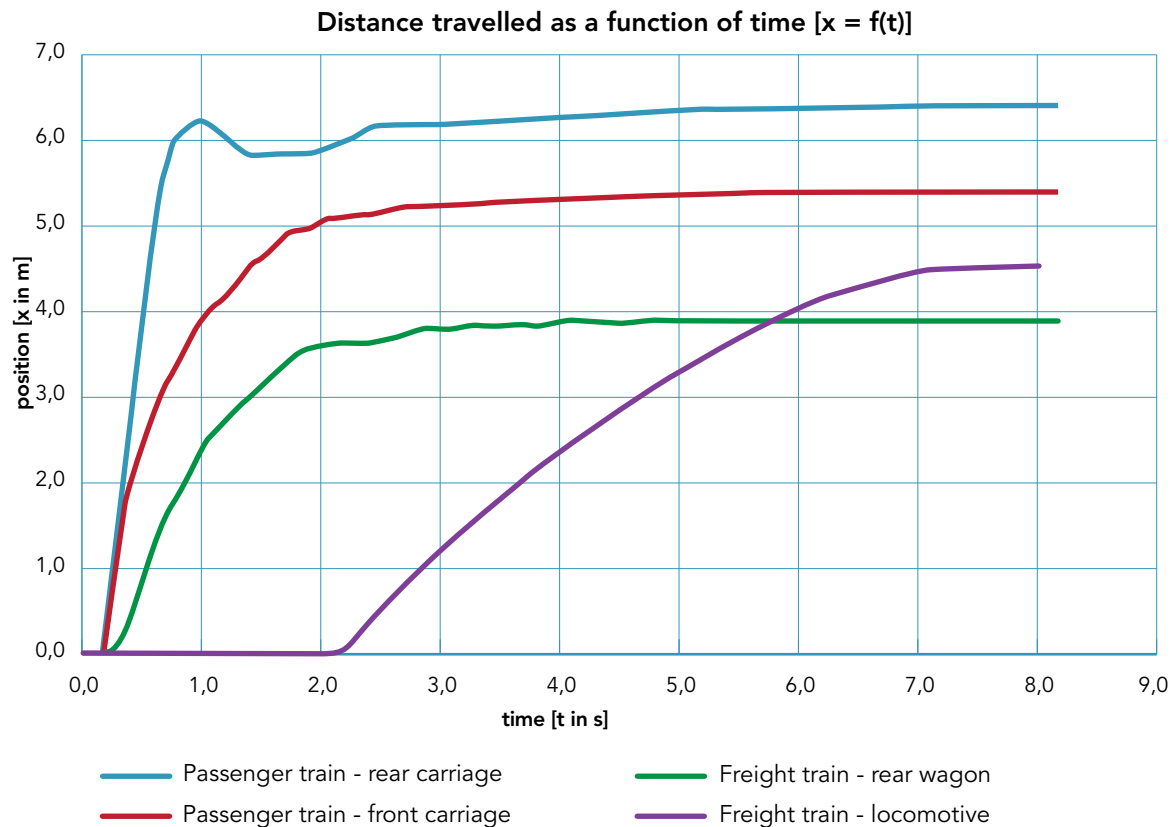
The reconstructed collision (see the graphs in figure 40) broadly speaking amounts to the following:

- The part of the collision period during which permanent deformation (damage) was done to the passenger train and tank wagon lasted approximately 0.4 seconds. In that period, the front of the passenger train was slowed down to approximately 15 km/hour, while the rear tank wagon was accelerated to approximately the same speed.
- It then lasts approximately 4 seconds before the passenger train and the rear tank wagon come to a standstill. The rear tank wagon is pushed forwards by the collision over a distance of approximately 4 metres.
- The displacement of the rear tank wagon is then transmitted through the freight train. Approximately 2 seconds after the start of the collision, the locomotive also starts to move. Approximately 5 seconds later, the locomotive once again comes to a standstill; in the intervening period, that vehicle is moved forwards by more than 4 metres.

Figure 40: These graphs show the reconstructed movement of the two trains during the collision.

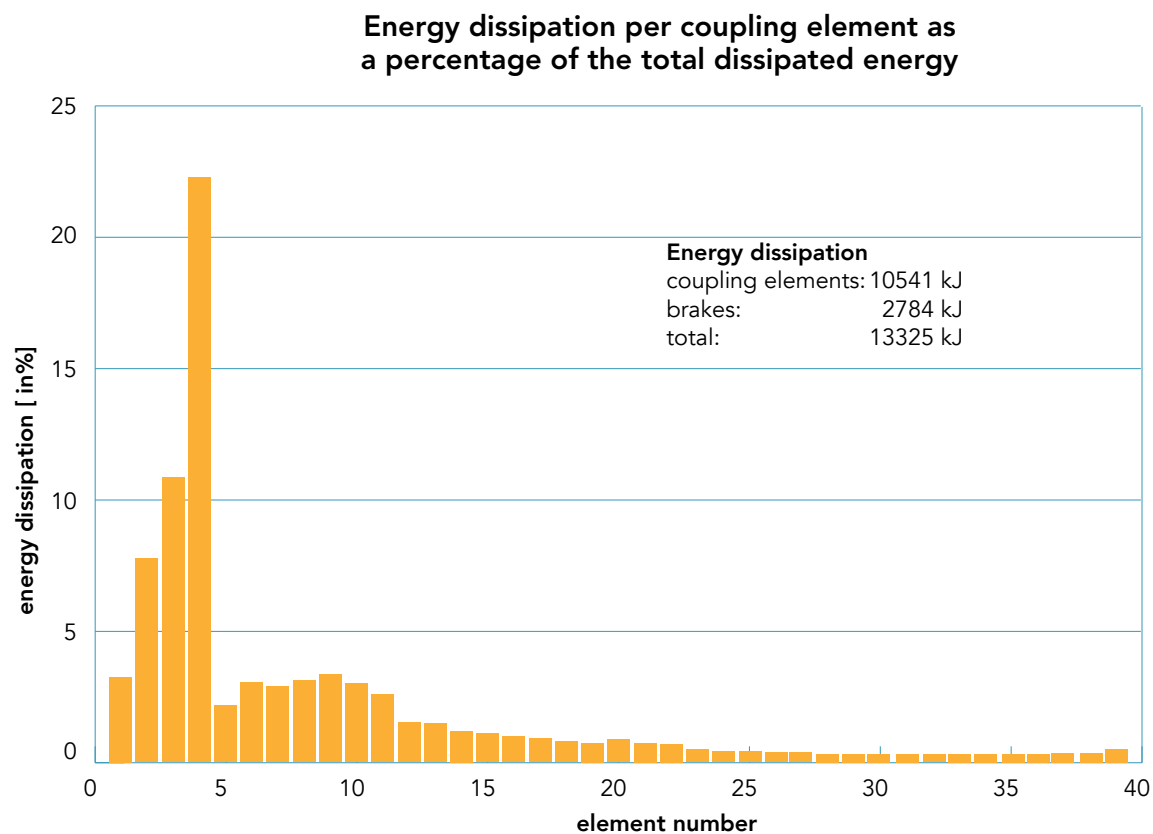
According to the reconstructed movements, the kinetic energy present in the passenger train at the start of the collision was converted as follows into other forms of energy (see figure 41):

- At the start of the collision, the kinetic energy of the passenger train amounted to approximately 13.3 MJ.
- Of that total, during the collision, approximately 5.9 MJ (almost 45%) was converted into permanent deformation (damage) of the passenger train and the rear tank wagon. Approximately half (3 MJ) of this amount related to damage to the front of the passenger train and the rear of the tank wagon; the remainder (also approximately half) related to damage to the connections/couplings between the carriages of the passenger train.

- Approximately 4.6 MJ (almost 35%) of the kinetic energy was absorbed by the extension and contraction of the buffers of the freight train, thanks to the absorption of energy by the inward and outward movement of the (crash) buffers.

- The remainder of the kinetic energy (2.8 MJ or more than 21%) was converted into friction between the braked wheels (of the passenger train and the locomotive) and the rails.

Figure 41: This graph relates to the energy conversion in the reconstructed collision. The graph shows which percentage of the original kinetic energy of the passenger train is absorbed during the collision by the various coupling elements (for numbering see figure 37).

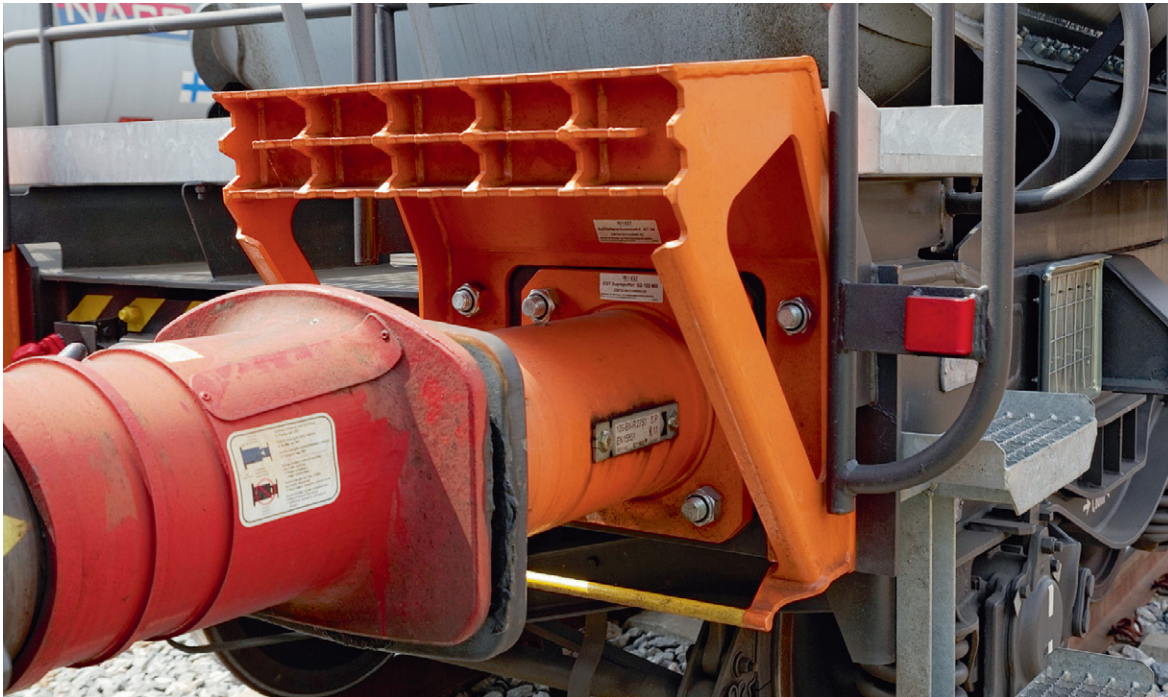
A number of different systems have now been developed. The common feature is that in essence they consist of a catch structure mounted above/below the buffers (see figure 45). The purpose of these catch structures is to halt buffer overriding as it starts.

The RID specifies that the catch structure must be resistant to vertical forces (upwards and downwards) of 150 kN. The structures must also be produced in such a way that they represent no hindrance to the normal use of the wagons (including tight bends), and that the risk of penetrating the base of the tank is not increased, as a result of an impact.

Figure 45: This photograph shows an anti climbing device. (Photo: SABIC)

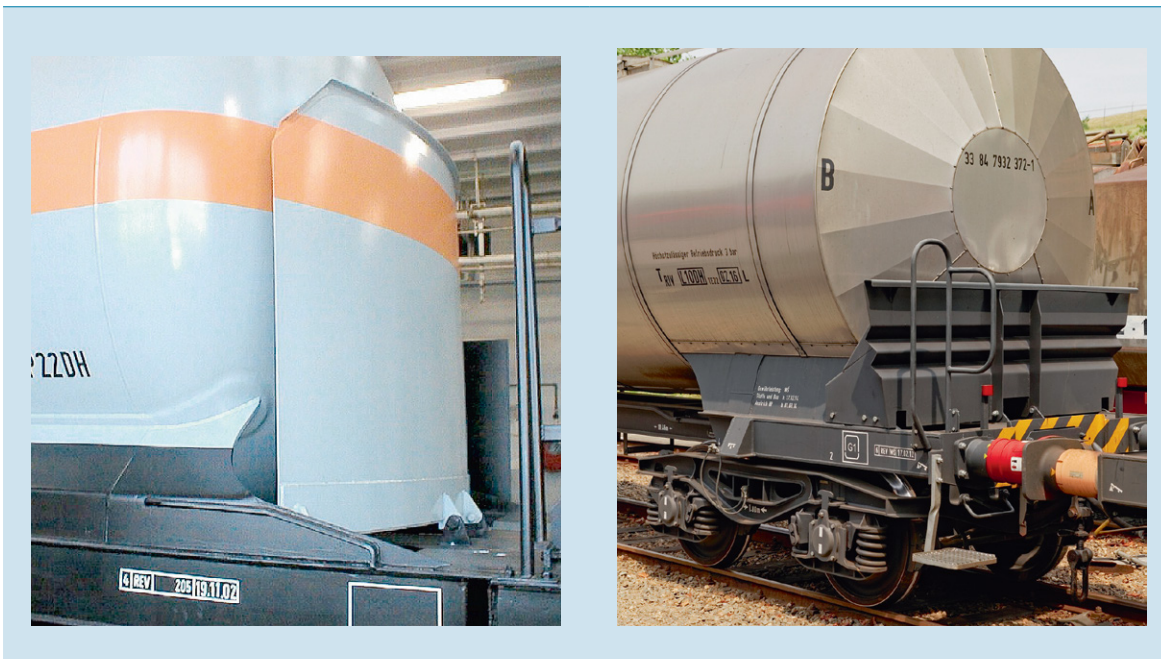
Protective shields/strengthened end walls are structures intended to prevent leaks in a tank as a consequence of a sharp part of the colliding vehicle (or its cargo) penetrating the wall of the tank. Structures of this kind effectively consist of a solid steel panel that is placed vertically in front of or against the end wall of the tank (see figure 46). The construction requirements in the RID relate to the width, height and thickness of the shield, and to its attachment.

Figure 46: These photographs show two examples of protective shields. (Photos: SABIC)
