# REPORT

JB 2019/04

## REPORT ON RUNAWAY WORK MACHINE AT ENSJØ METRO STATION, 7 JUNE 2018

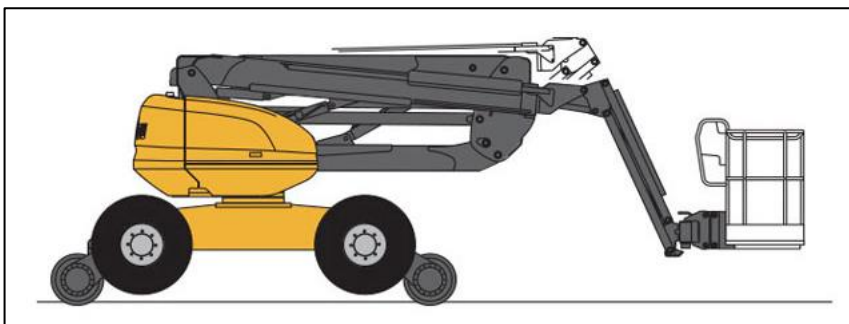
Figure 3: Schematic drawing of the machine involved. Source: Rail Products UK

The AIBN examined and tested the MEWP several times to determine how the brake system worked and whether the machine was defective. The machine was first tested at Hesselberg in Oslo on 13 June, and subsequently on 21 June and 6 July. A closer examination of the oil leakage from the machine revealed that it came from the slewing rim and not from the brake system.
