# REPORT RAIL 2022/08

***Faulty interlocking system at Jar metro station on the Kolsås line, 27 November 2021***

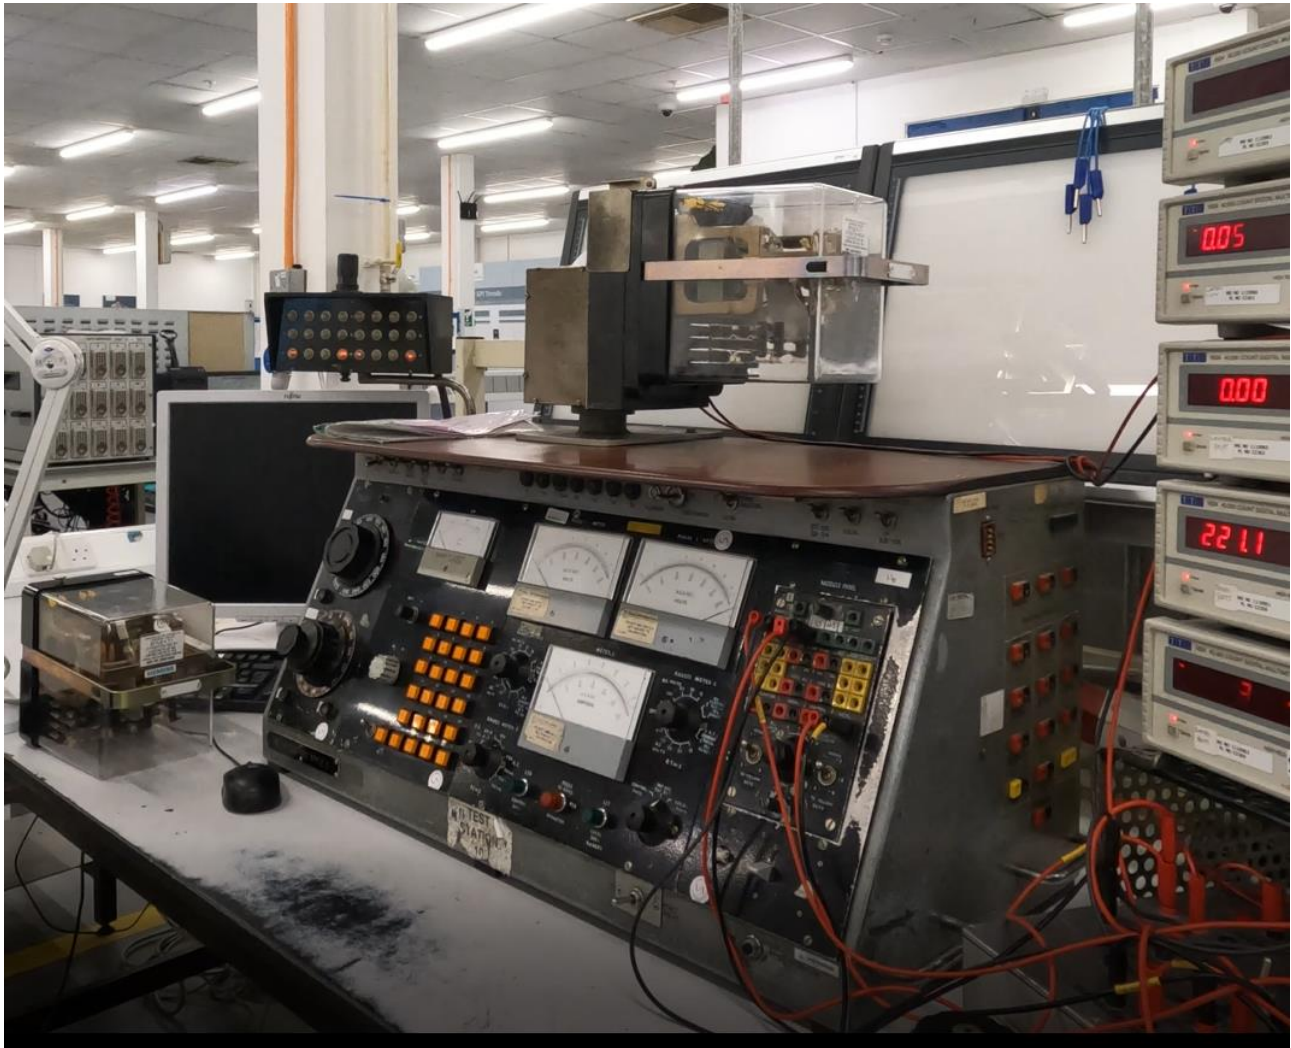
Figure 4: Comparable relay mounted on top of test bench. The relay involved in the incident can be seen on the left-hand side of the worktop. Photo: NSIA
