**Goods train derailment
Amsterdam-Muiderpoort,
22 November 2008**

The Hague, March 2010 (project number M2008RV1122-01)

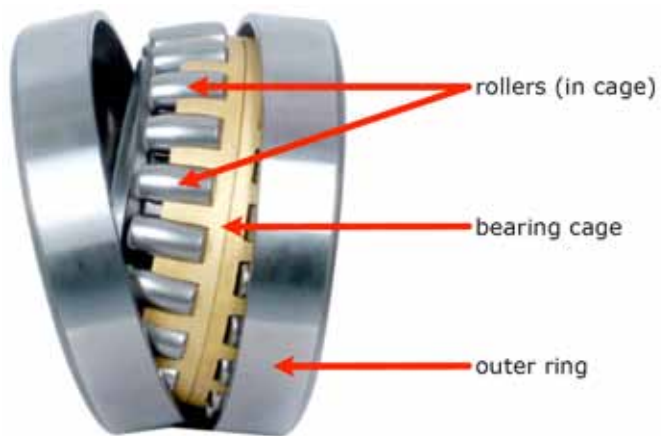
Figure 10: Example of a bearing. This outer ring has been opened to show the rollers and the bearing cage. The bearing shown in this photo (of the same as the bearing involved in the Muiderpoort derailment) is a double-row barrel bearing with a comb-shaped bearing cage.

The breakage of a cage lip will result in friction between the rollers that are no longer held in place and can seize. If the wagon continues to move then the seized rollers begin to rub against the inner and/or outer ring. The resultant friction heats the axle box and axle journal (overheating) to an extent that the axle journal can break off or melt (as was the case in the Muiderpoort derailment).

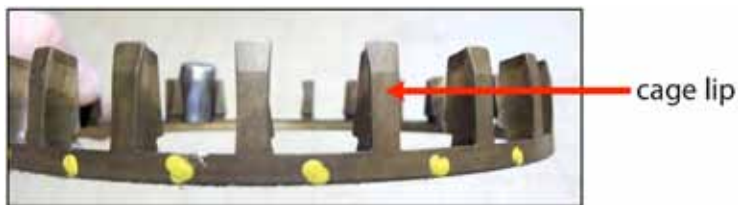
Figure 11: This photo shows a comb-shaped bearing cage as used in the bearings in question.
