STATE COMMISSION ON RAILWAY ACCIDENTS INVESTIGATION
Ministry of Interior and Administration

REPORT No PKBWK 05/ 2021

on the investigation of a serious train accident that occurred on
26 January 2021 at 07:39
on route between Zbąszynek and Lutol Suchy, track no 1,
level crossing category D
at km 10.196 of railway line no 367 Zbąszynek - Gorzów Wielkopolski

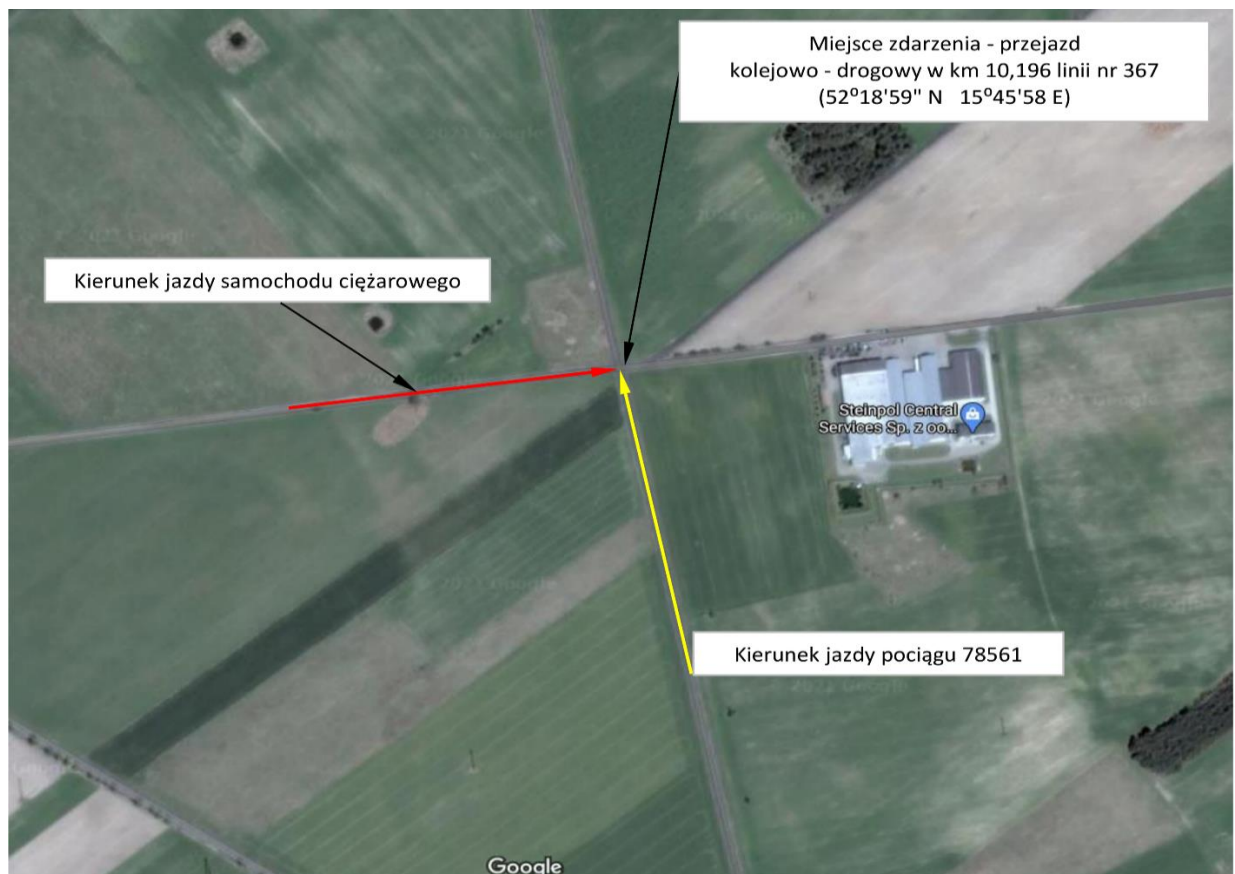
Photo 4- General view of the incident site (source: Google maps)

The D-category crossing where the accident happened is located on a communal dirt road No. 006323F Chociszewo - Mago, made partly of 3 m wide concrete road plates with dirt roadside. The crossing location coordinates are 52°18'59 "N 15°45'58 "E. The maximum speed of road vehicles on the road in the area of the crossing is 30 km/h, according to the road sign. The road is crossing the railway track at an angle of 90 °. The area of the railway line and road crossing is flat, undeveloped, and in fields area. Visibility of the crossing measured along the road axis is normal (higher than the required 60m). Visibility of train head from the road for the required triangles of 5 m, 10 m and 20 m preserved. In the field of visibility triangles there are no bushes and trees and no other obstacles limiting the field of vision. On the day of the incident, that is on 26 January, no works were carried out in the area of the crossing. On that day the weather conditions were good, there was no rain or fog. It was morning, before sunrise, the sky was slightly cloudy, the temperature was approx. 1° C. Moreover, in the area of the crossing at the time of the incident there were no other road users who could absorb the attention of the driver of the road vehicle.
