STATE COMMISSION ON RAILWAY ACCIDENT INVESTIGATION
Ministry of the Interior and Administration.

REPORT No. PKBWK 06/2022

**on the procedure on a railway incident that occurred on 05 February 2021 at 09:37
in Gogolin station track no. 6, 22.400 km of railway line no. 136 Kędzierzyn Koźle – Opole
Groszowice**

WARSAW, 21 July 2022

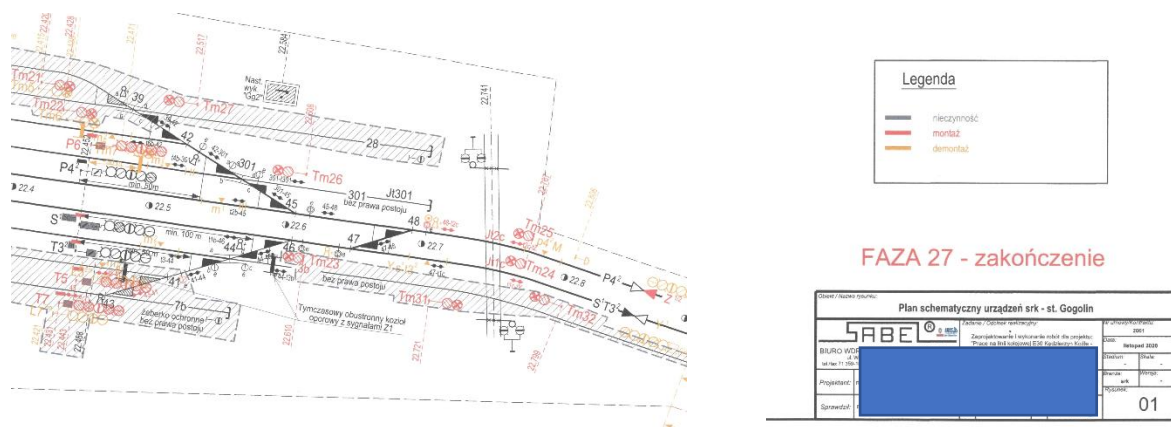
The contractor provided the aforementioned documentation for Gogolin stations. The supplied schematics of the stations – the schematic plan of the signalling equipment and the schematic plan of the Gogolin RTS station are incompatible, despite the fact they refer to the completion of the same phase of the works. Presented below is a selected excerpt from the documentation supplied to the traffic stations.
