**STATE COMMISSION ON RAILWAY ACCIDENTS INVESTIGATION**  
**Ministry of the Interior and Administration**

**REPORT No. PKBWK 02/2022 from investigation of railway accident that occurred on 26 February 2021 0532 hrs at Grodzisko Dolne station, on second railway track, at km 163.654 of railway line No. 68 Lublin - Przeworsk, railway management infrastructure of PKP PLK S.A., Rzeszów Railway Department.**

**WARSAW, 9<sup>th</sup> of March 2022**

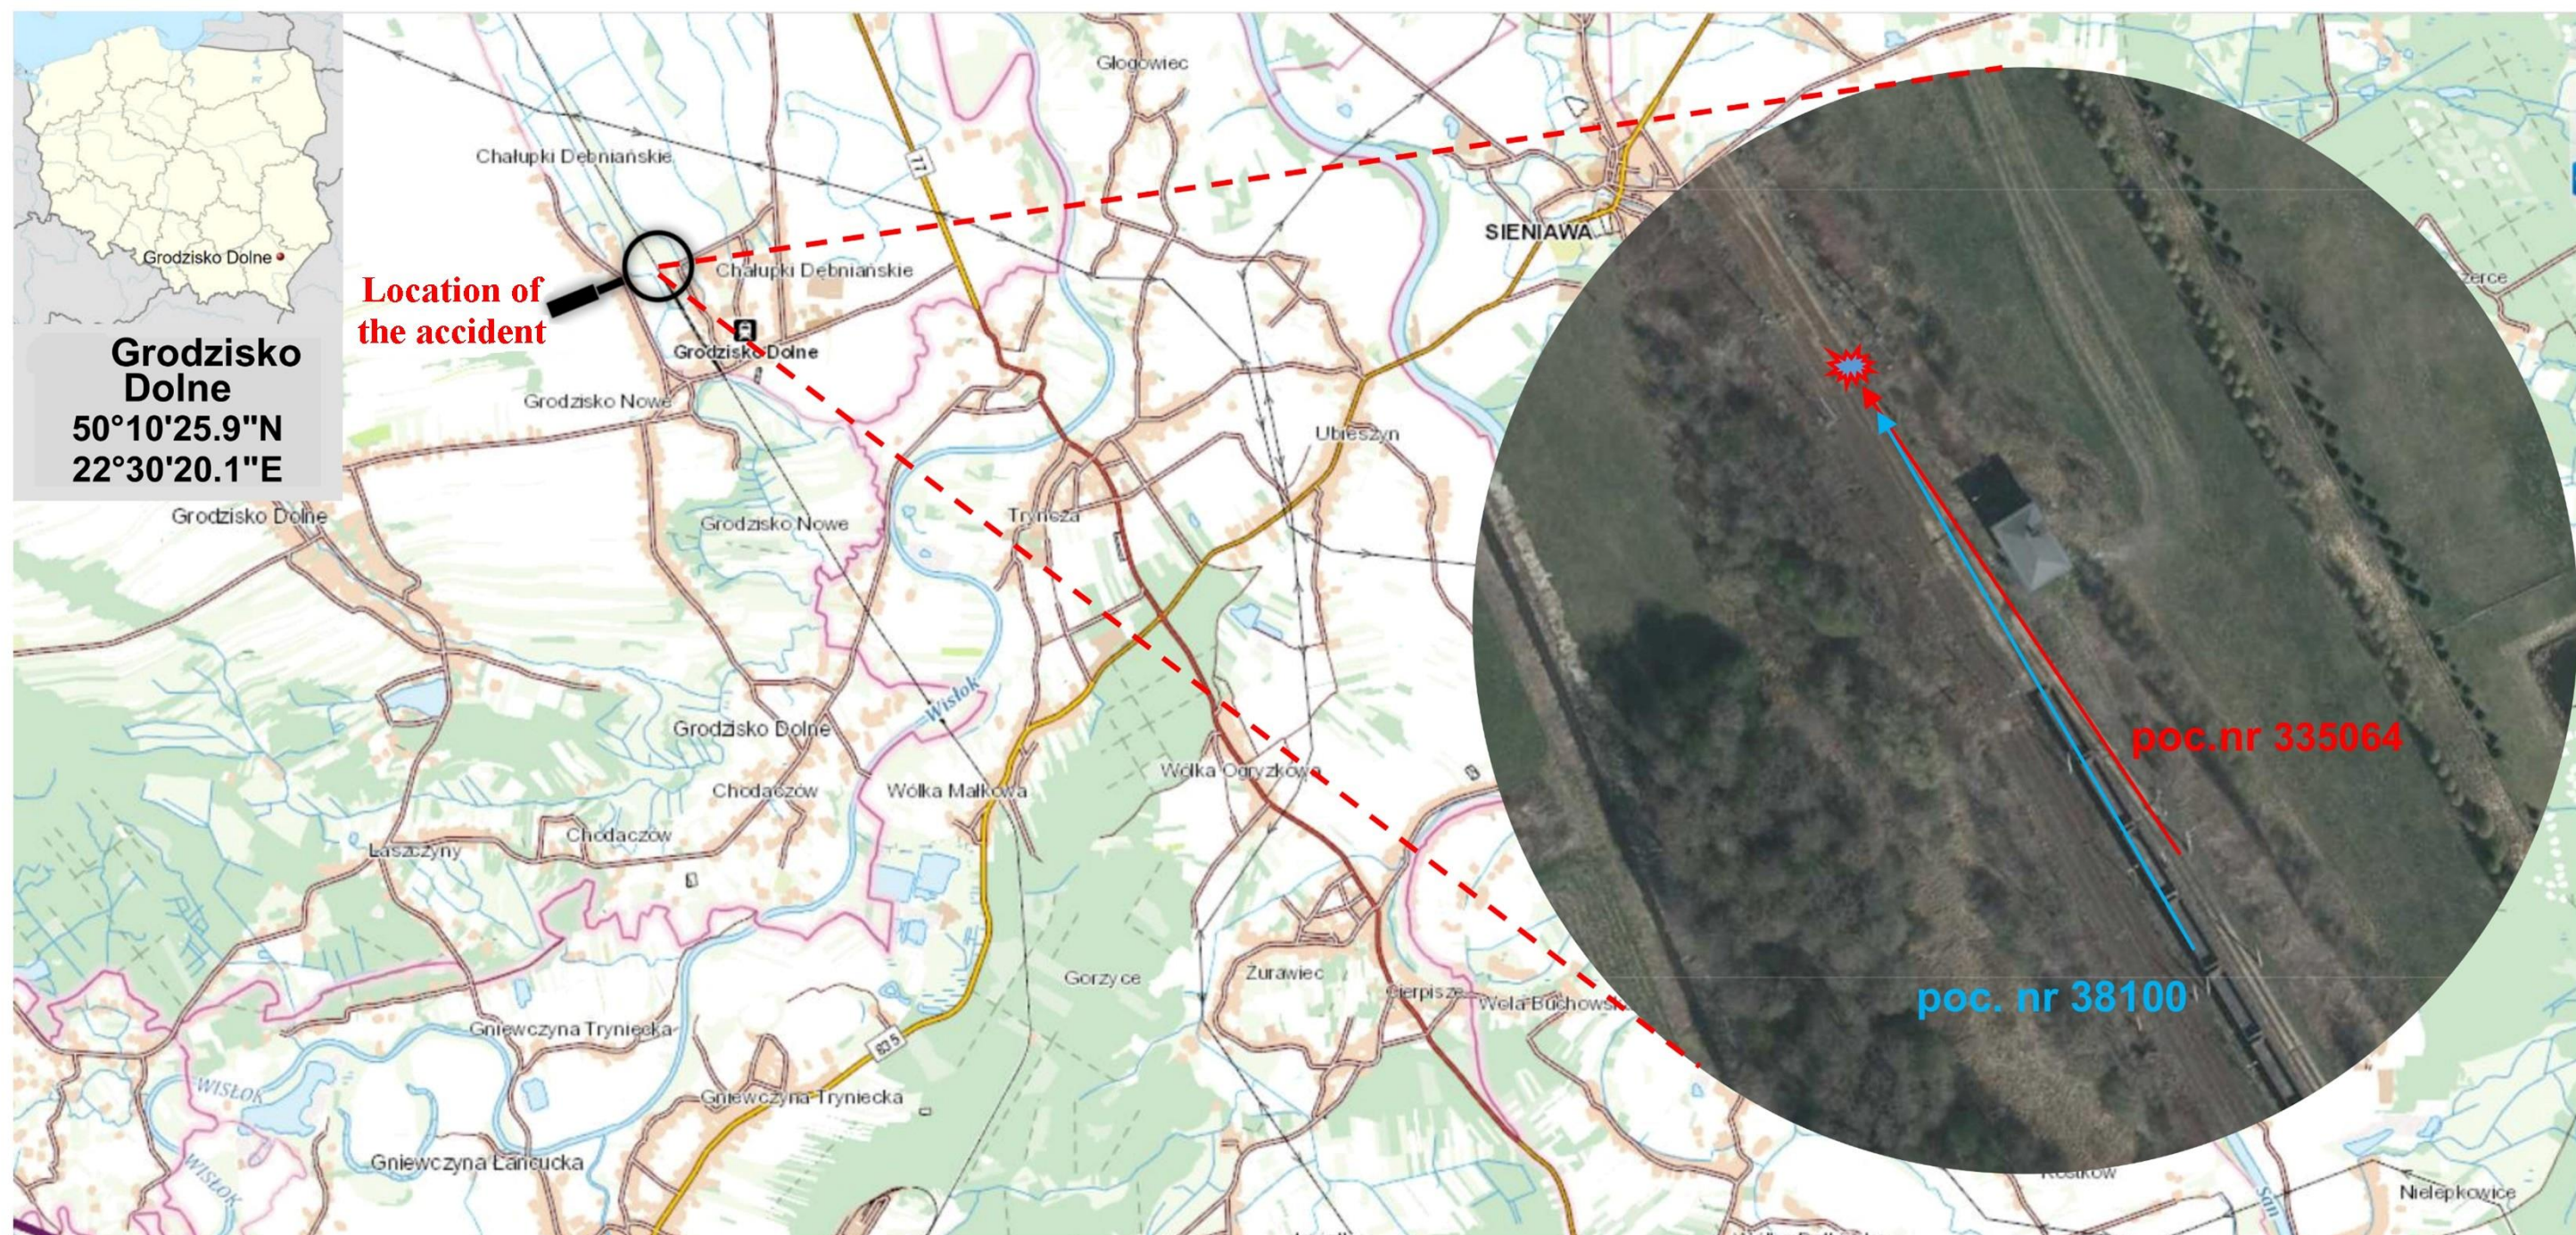
Figure 1 - General view of the site (source: Geoportal)

On the day of the accident, i.e. 26.02.2021, no works were carried out in the area of Grodzisko Dolne station and on the adjacent routes, train traffic was conducted on the basis of properly working traffic control devices at the station and the adjacent routes. The track no. 3 at the station and turnout no. 3 on the main track were closed and partially dismantled. The accident occurred during darkness before dawn, air clarity favourable, air temperature +3 °C, ground temperature about 0 °C, lingering snow, no precipitation.
