STATE COMMISSION ON RAILWAY ACCIDENT
Ministry of the Interior and Administration

REPORT No. PKBWK 01/2022

**from the procedure in case of serious train accident on 04 April 2021 at 09:10 on route from
Oborniki Wielkopolskie - Rogoźno Wielkopolskie, on track no. 1, railway-road crossing
category D at km 30.453 of railway line no. 354 Poznań Główny POD – Piła Główna**

WARSAW, 23.02.2022 r.

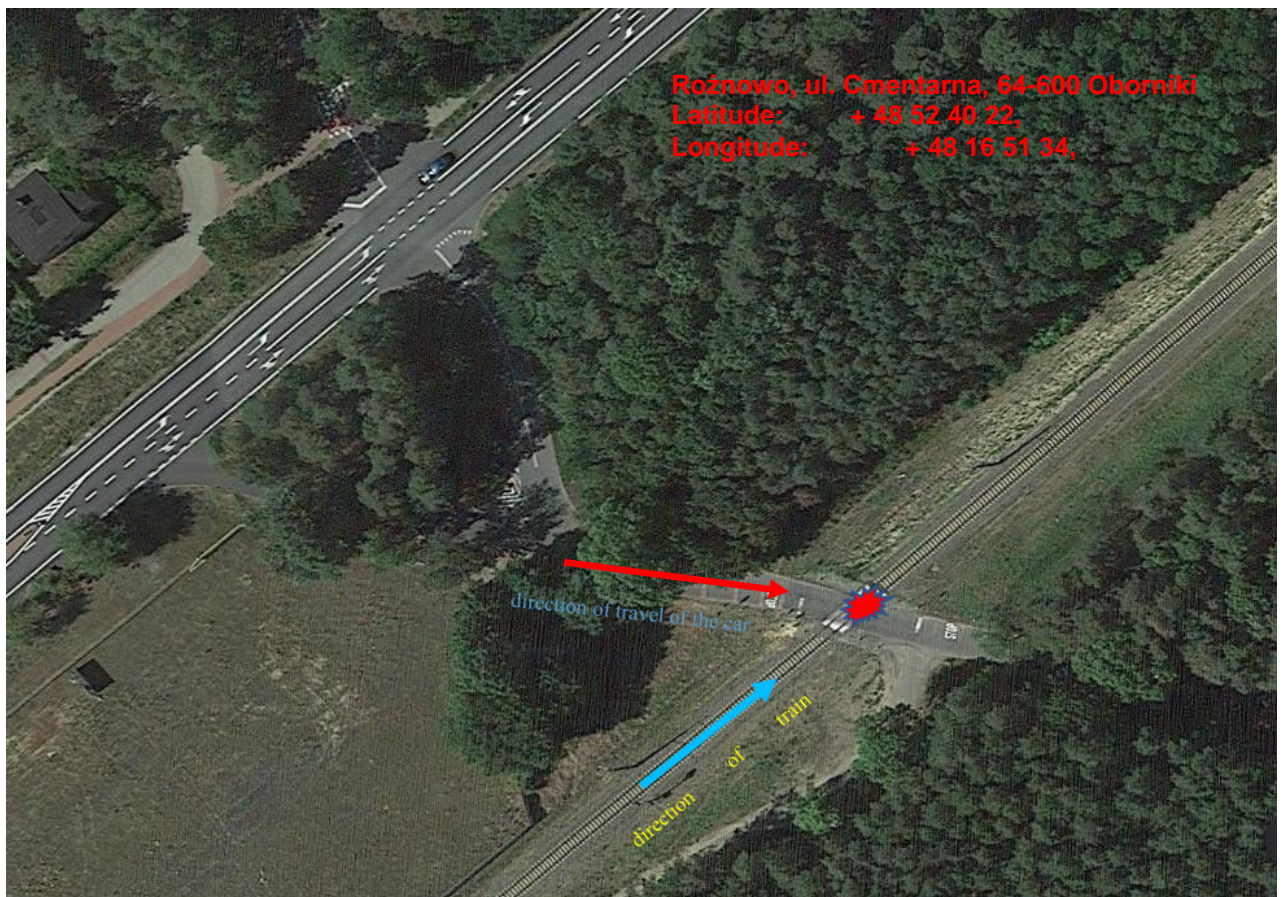
The incident occurred on 04.04.2021 at 09:10 on the Oborniki Wielkopolskie - Rogoźno Wielkopolskie track no. 1, cat. D at km 30,453 of railway line no. 354 Poznań Główny POD - Piła Główna, crossing ID 354 030 453 (yellow sticker on St. Cross). St. Andrew's Church located on the side of the track).

Photo 4. General view of the scene (source: Google maps)
