STATE COMMISSION ON RAILWAY ACCIDENT INVESTIGATION
Ministry of the Interior and Administration.

REPORT No. PKBWK 05/2022

**from the investigation regarding a serious train accident that occurred on 15 June 2021
at 10:05 at Kochanówka Pustków station
on track no 1, level crossing category C at km 313.328 of railway line no. 25 Łódź
Kaliska – Dębica
PKP PLK S.A. infrastructure manager area Zakład Linii Kolejowych [Railway Facility]
in Rzeszów**

WARSAW, 31 May 2022

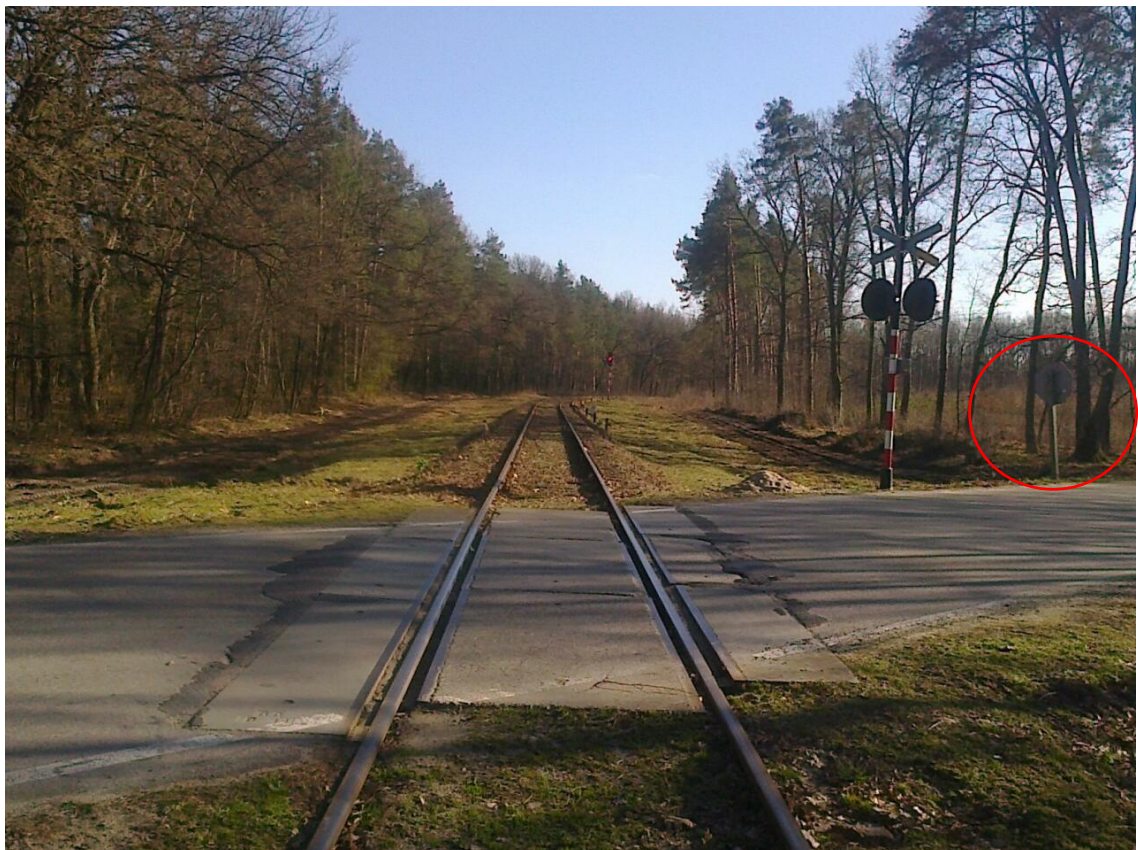
Photograph 4 – View of the crossing prior to revitalisation (27.07.2019) (source: *Ogólnopolska Baza Kolejowa* [National Railway Database])

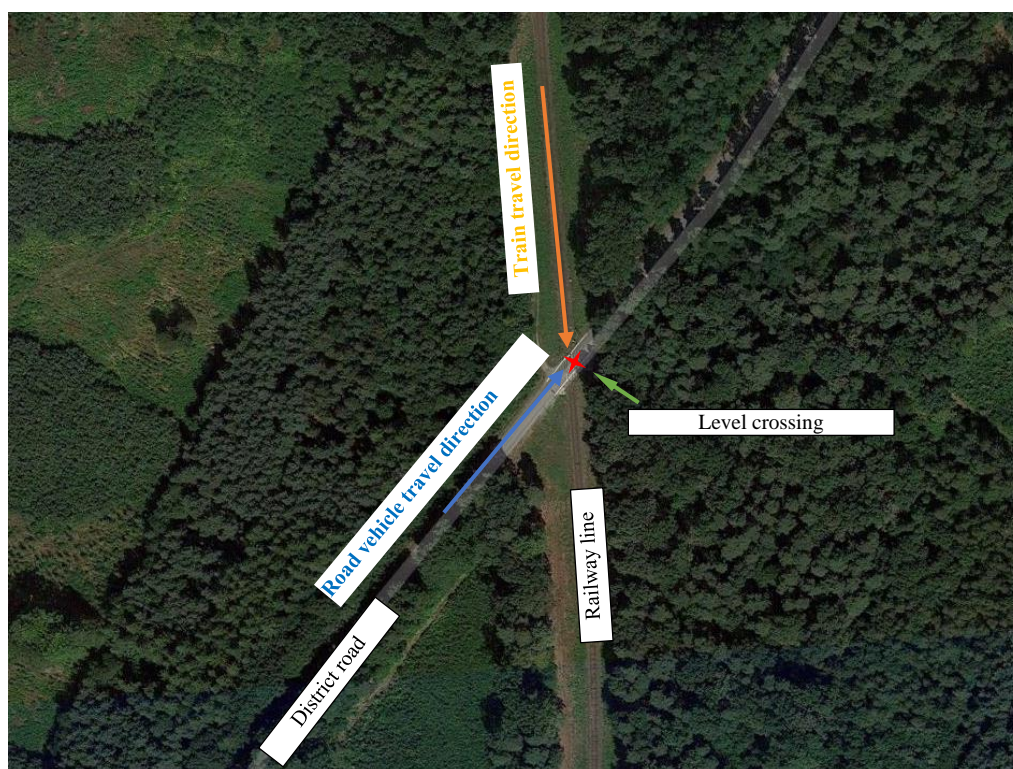
Photograph 5 – General overview of the scene (source: Google Earth)

The category C level crossing where the severe accident occurred is located on the class L district road no. 1283R Brzeźnica – Kronowice, made of a bituminous surface with a dirt shoulder. The geographical coordinates of the crossing are 50°07'14.3"N 21°29'58.6"E.

The speed limit for road vehicles on the access road and the crossing is 90 km/h. The district road crosses the railway track at an angle of 60°. The railway line crosses the road in an undeveloped area. No work was being carried out on the crossing at the time of the incident.

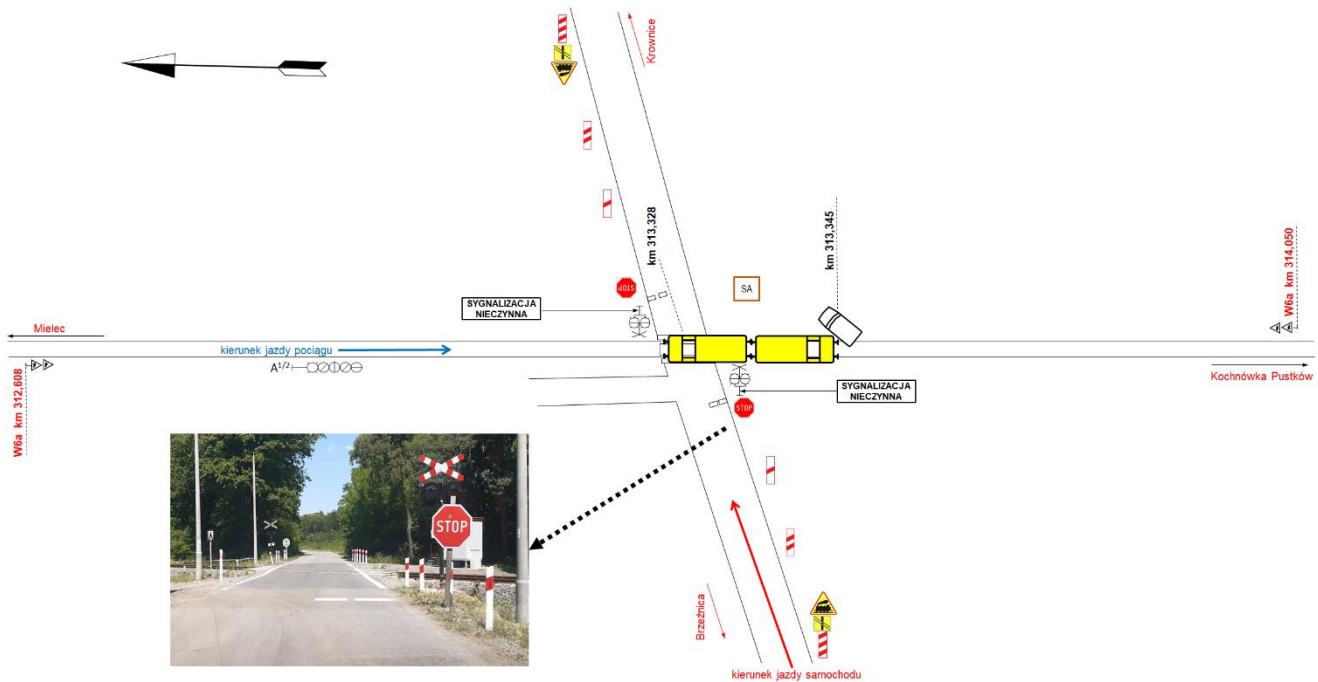
Drawing 1 – Sketch of the accident (developed by PKBWK)

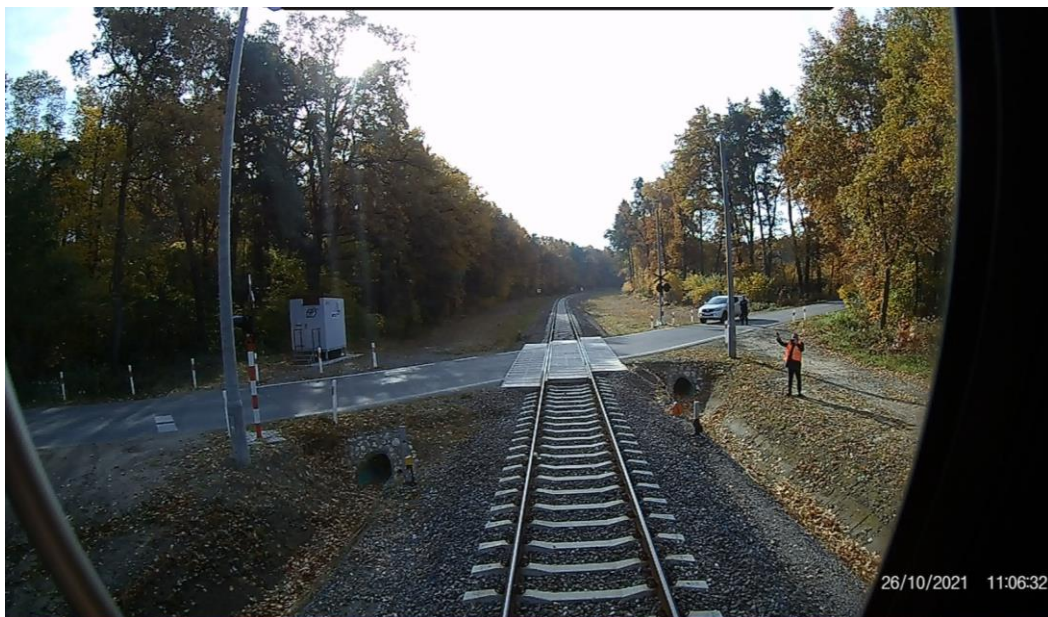
Based on the interviews, experimental runs and braking tests carried out by the Commission’s Investigation Team, the train was travelling at a speed not exceeding 20 km/h when the emergency brake was applied.

Photograph 10 – A frame from the PKBWK video recorder during the experiment – view from a distance of 20 m to the axis of the crossing (source: PKBWK)
