**STATE COMMISSION ON RAILWAY ACCIDENT INVESTIGATION**  
**Ministry of the Interior and Administration.**

**REPORT No. PKBWK 04/2022**

**from the investigation of a railway accident that occurred on 29 July 2021 at 06:15 on the track Szczecin Gumieńce – Tantow, on track no. 1, at the railway crossing category C at 7.585 km of the railway line no. 409 Szczecin Gumieńce – State Border (Tantow) PKP PLK S.A. infrastructure manager area Zakład Linii Kolejowych [Railway Facility] in Szczecin**

**Warsaw, 11 May 2022**

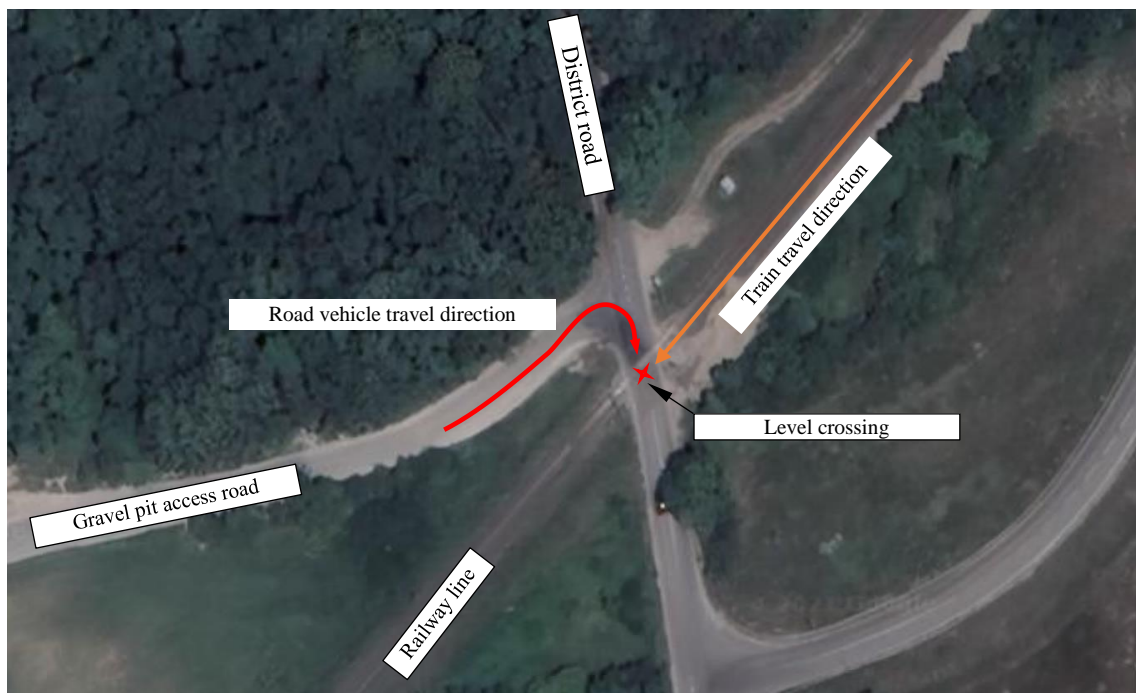
Photograph 4 – General overview of the scene (source: Google Earth)

The category C crossing where the accident occurred is located on the district road no. 3924Z Smoleńcin – Kołbaskowo, made of a bituminous surface with a dirt shoulder. The geographical coordinates of the crossing are 53°20'33"N 14°26'20"E. The speed limit for road vehicles on the road in the area of the crossing is set at 90 km/h. The district road crosses the railway track at an angle of 70°. The railway line crosses the road in an undeveloped area. The district access road to the crossing merges with access to gravel pit. The axis of the road joining the district road is situated 13 m away from the outermost rail of the track. The road to the gravel pit is only used as access to the gravel pit. The gravel pit access road contains no signage for traffic users regarding approaching the public district road nor information about approaching the crossing. 150 metres in front of the road, prior to the merging area with the district road, there is a board displaying the information "*Attention! Level crossing, take extra care.*" Traffic signal no. S3, a self-acting crossing system, faces the exit from the district road (towards the road to the gravel pit) and it is built into the road strip of the district road. The level of the road to the gravel pit is lowered by approximately 1.6 metres in relation to the level of the district road. The levelling of the road to the gravel pit and the district road takes place in the area of the junction of these roads over a length of 30 metres, forming driveway (towards the district road). Within the area of the access road, looking to the left from the road to the gravel pit towards the district road, the visibility of vehicles travelling on the district road is restricted due to the wooded and vegetated area in the road lane of the district road. A road mirror has been installed in order to improve the visibility for vehicles merging into traffic from the road to the gravel pit. In the morning in sunny weather, drivers of road vehicles travelling on the gravel pit road towards the district road are blinded by sunrays. The sun is at the height of traffic signal number S3, which makes it difficult to identify the signals it transmits (photograph 9). When joining traffic from the road to the gravel pit onto the district road the road mirror is also at the level of the sun, making it very difficult to use as intended (photograph 10).
