STATE COMMISSION ON RAILWAY ACCIDENTS INVESTIGATION
Ministry of Interior and Administration

REPORT No. PKBWK 0 1/2023

**on the investigation of the railway incident
that occurred on October 16, 2019 at 13:51
at Leszczyny station, at km 31.738
railway line no. 140 Katowice Ligota - Nędza**

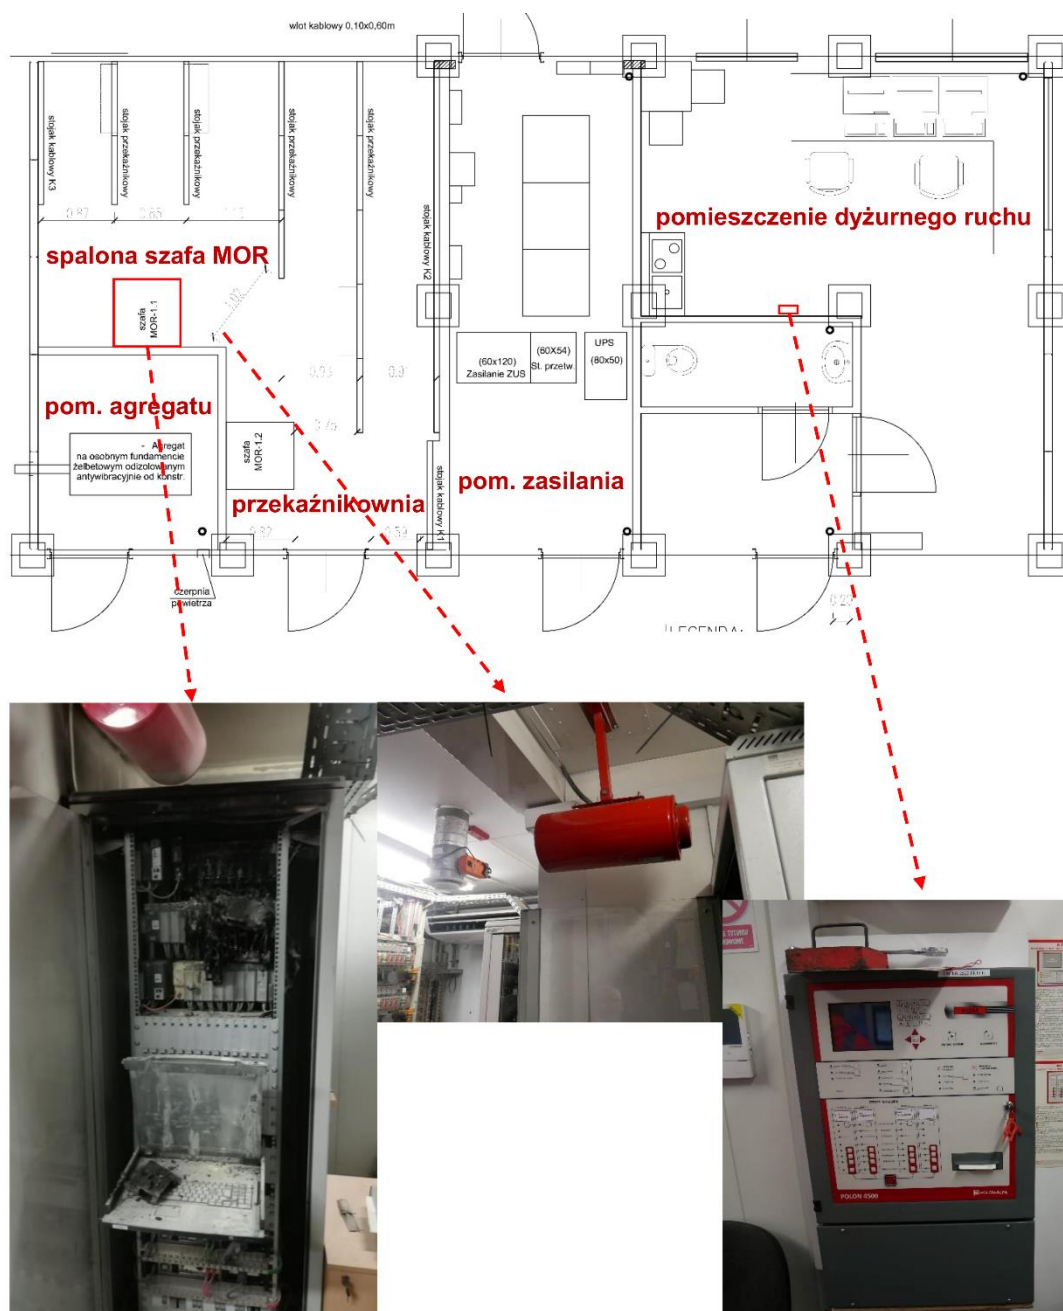
Figure 1 - Sketch of the layout of the rooms and some equipment of the Lsz control room

The container yard is located at 31.738 km of railway line No. 140 at a distance of 5.5 m from the outermost rail of switch No. 17. The layout of the yard is shown in Figure 1 below.

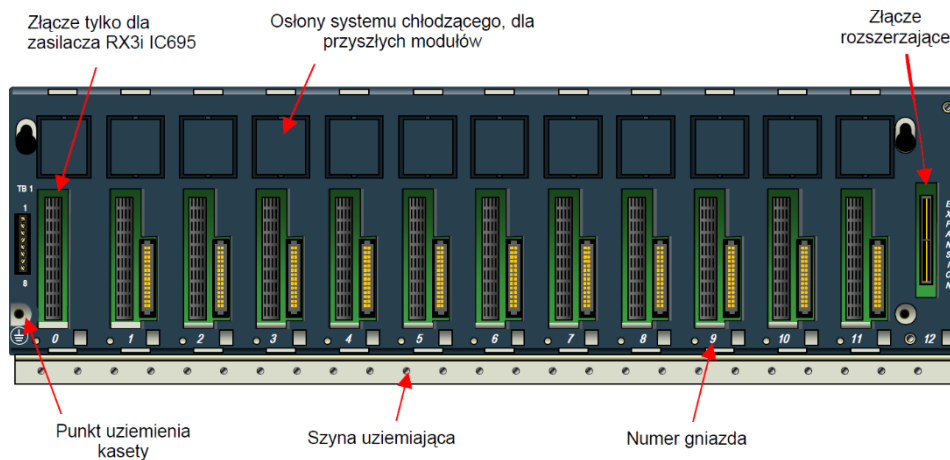
Figure 2 - An example of the RX3i series universal base cassette

In the PLC A2 expansion cassette, the I/O modules from slot 4 upwards were destroyed. There is no visible damage outside the PLC A1 and PLC A2 cassettes.

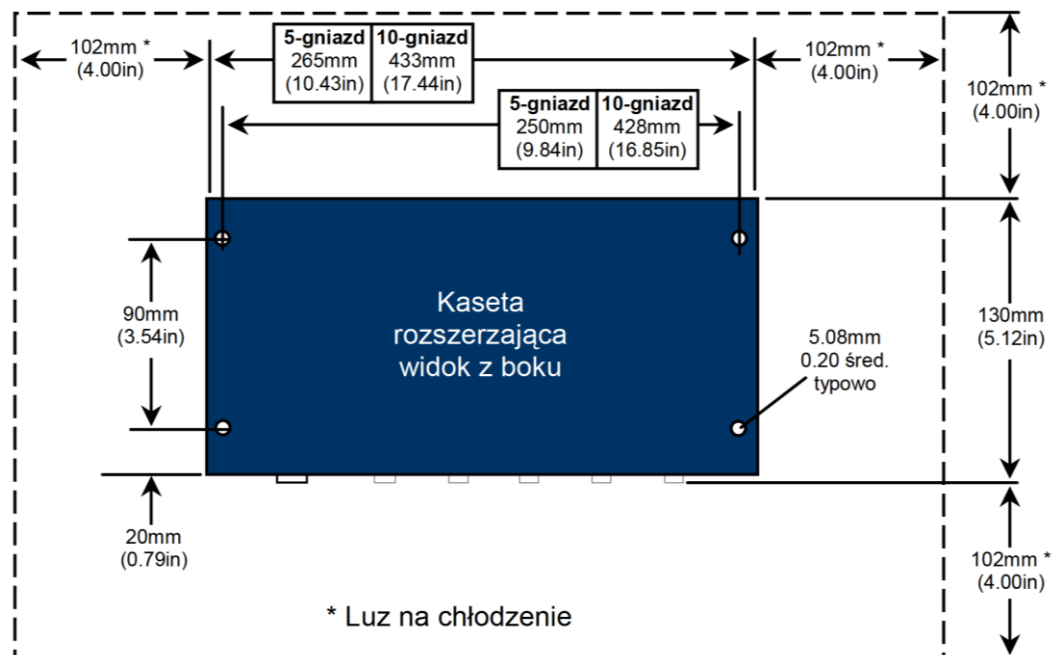
Figure 3 - Dimensions of the RX3i serial expansion cassette and layout in the enclosure

"The enclosure must be able to properly distribute the heat generated by the components inside so that none of them overheat. The amount of heat dissipated is also a factor in determining the need for cooling systems such as fans or air conditioners in the enclosure. The minimum clearance around the RX3i base cartridge for cooling purposes should be 102 mm. Additional clearance may be required depending on the amount of heat generated by the equipment during operation. Appendix C describes how to calculate power dissipation through RX3i modules and field devices mounted in the enclosure."
