**Gabinete de Investigação de Segurança e de  
Acidentes Ferroviários**

## Fatal accident at level crossing 324,964 Algarve line, Estômbar, on 28-01-2015

### **INVESTIGATION REPORT** *- English extended summary -*

Report nr. 2016/02en

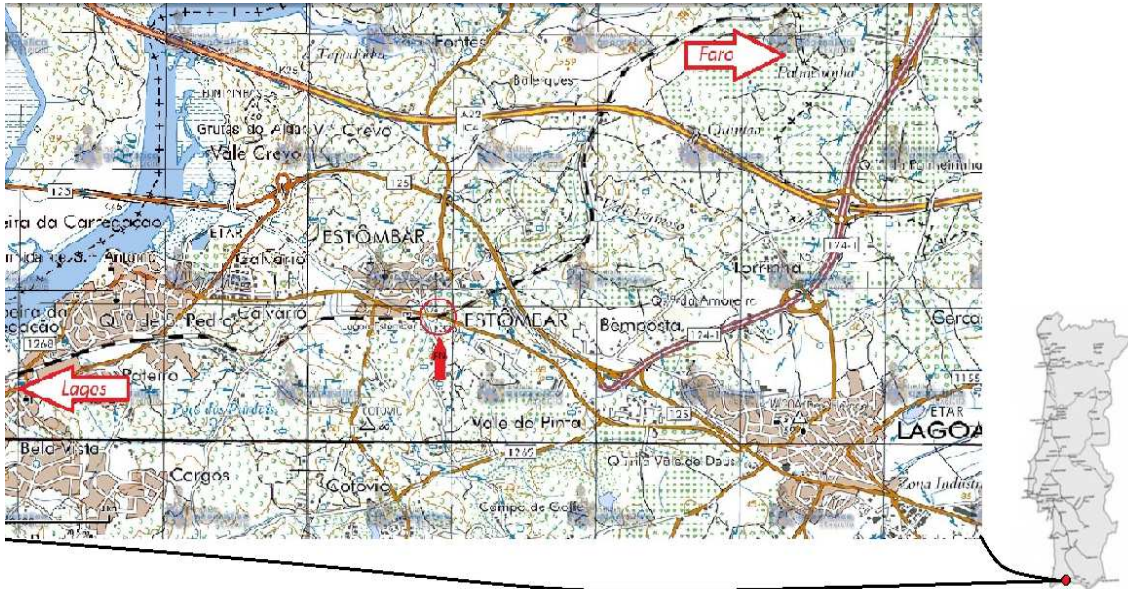
Figure 1: Accident location

On the 28<sup>th</sup> of January 2015, around 08:28h, a moped and its driver travelling on municipal road 25 (EM-25), at Estômbar village (Lagoa municipality, Faro district), collided with the lowered half-barrier of public level crossing 324,964 where the Algarve line crosses that road.
