# Rail Accident Report

## **Serious operational irregularity at Balham 20 April 2019**

Report 01/2020  
February 2020

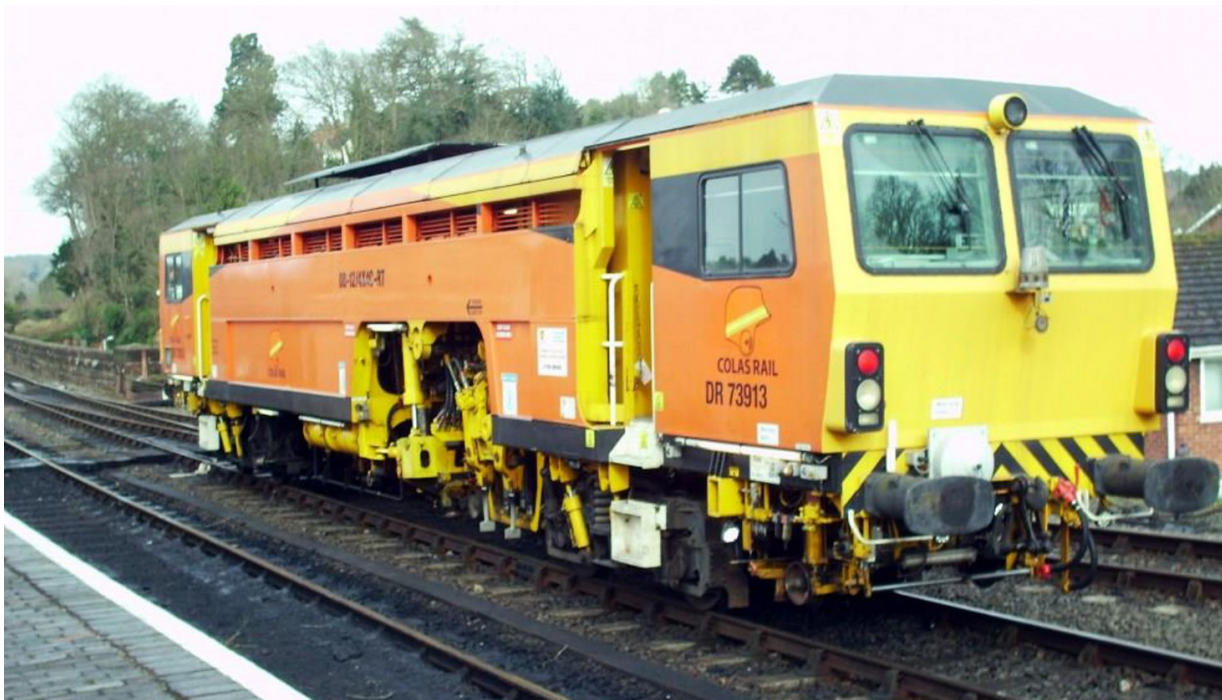
Figure 4: The tamper involved in the incident (courtesy of Colas Rail)

- 10 Network Rail owns, operates and maintains the railway infrastructure. At the time of the incident, Network Rail's South-East route had several contracts with labour suppliers to provide staff to the company and its contractors for planning and undertaking some maintenance work. In relation to this incident, Network Rail employed the planners, delivery managers, one of the possession support assistants, and the signallers at Victoria ASC, Three Bridges ROC and Three Bridges ASC.
- 11 Colas Rail is an infrastructure renewal company which also owns and operates a mixed fleet of on-track plant for maintenance and renewal operations. Colas operated the tamper (figure 4) and employed the driver and conductor driver of the tamper.
