Rail Accident Report

Runaway locomotive at Beddgelert, North Wales 16 April 2019

Report 02/2020
February 2020

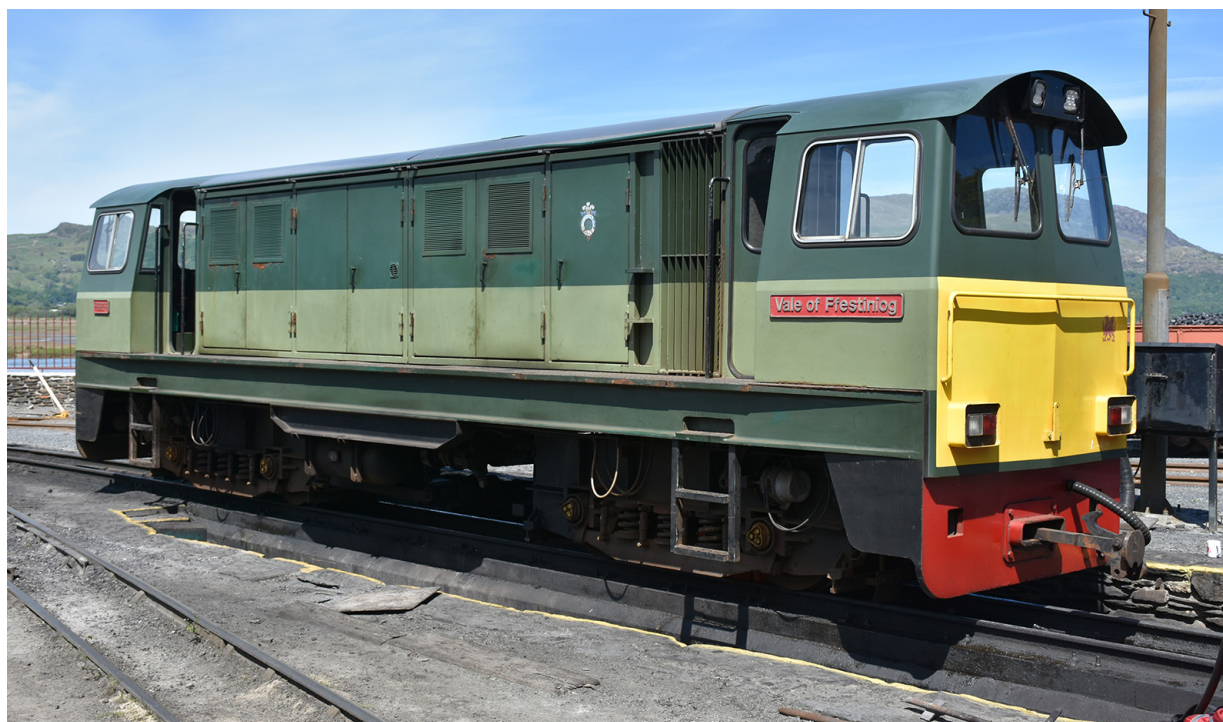
Figure 4: Locomotive 'Vale of Ffestiniog'

- 14 To operate within the loading gauge² of the FfR, 'Vale of Ffestiniog' had a new body shell fitted which included a second cab. The electrical control systems were also replaced by a pneumatic system. This work was almost entirely undertaken by one FRC engineer who has since died.
