Rail Accident Report

**Train collision with material washed out from a cutting slope at Corby, Northamptonshire
13 June 2019**

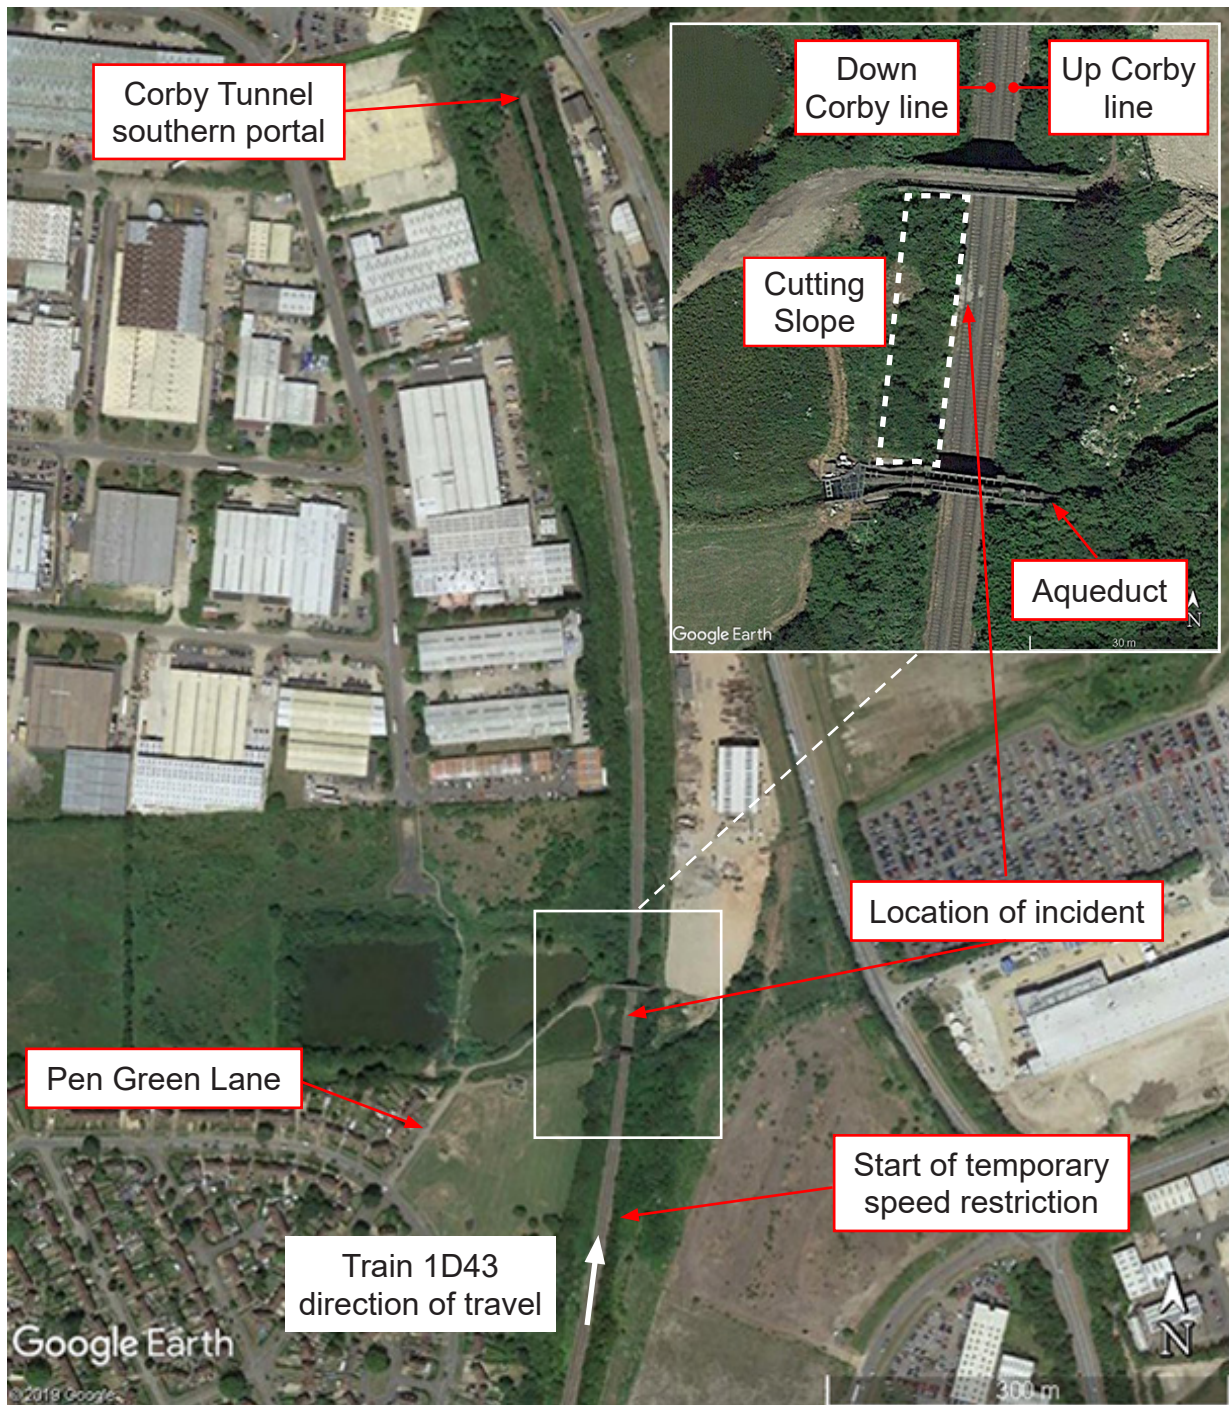
Figure 2: Google Earth image showing overview of incident site

- 4 At about 15:53 hrs on Thursday 13 June 2019, a northbound passenger train, travelling at 40 mph (64 km/h), collided with debris around one mile (1.6 km) north of Corby station (figure 1). The debris comprised sandy gravel and soil which had been washed onto the track from the adjacent cutting slope (figure 2) by flood water. The train did not derail. The driver brought the train to a stand and contacted the signaller to report the landslip and flooding.

- 7 The collision happened on the down Corby line (figure 2) at 80 miles 39 chains¹ (from a zero reference at London St Pancras), between Corby and Manton Junction, which is part of Network Rail's East Midlands Route² within its Eastern Region.³ Here the railway passes through a cutting, on a left-hand curve (in the northbound direction of travel) with a radius of about 2000 metres (figure 2).

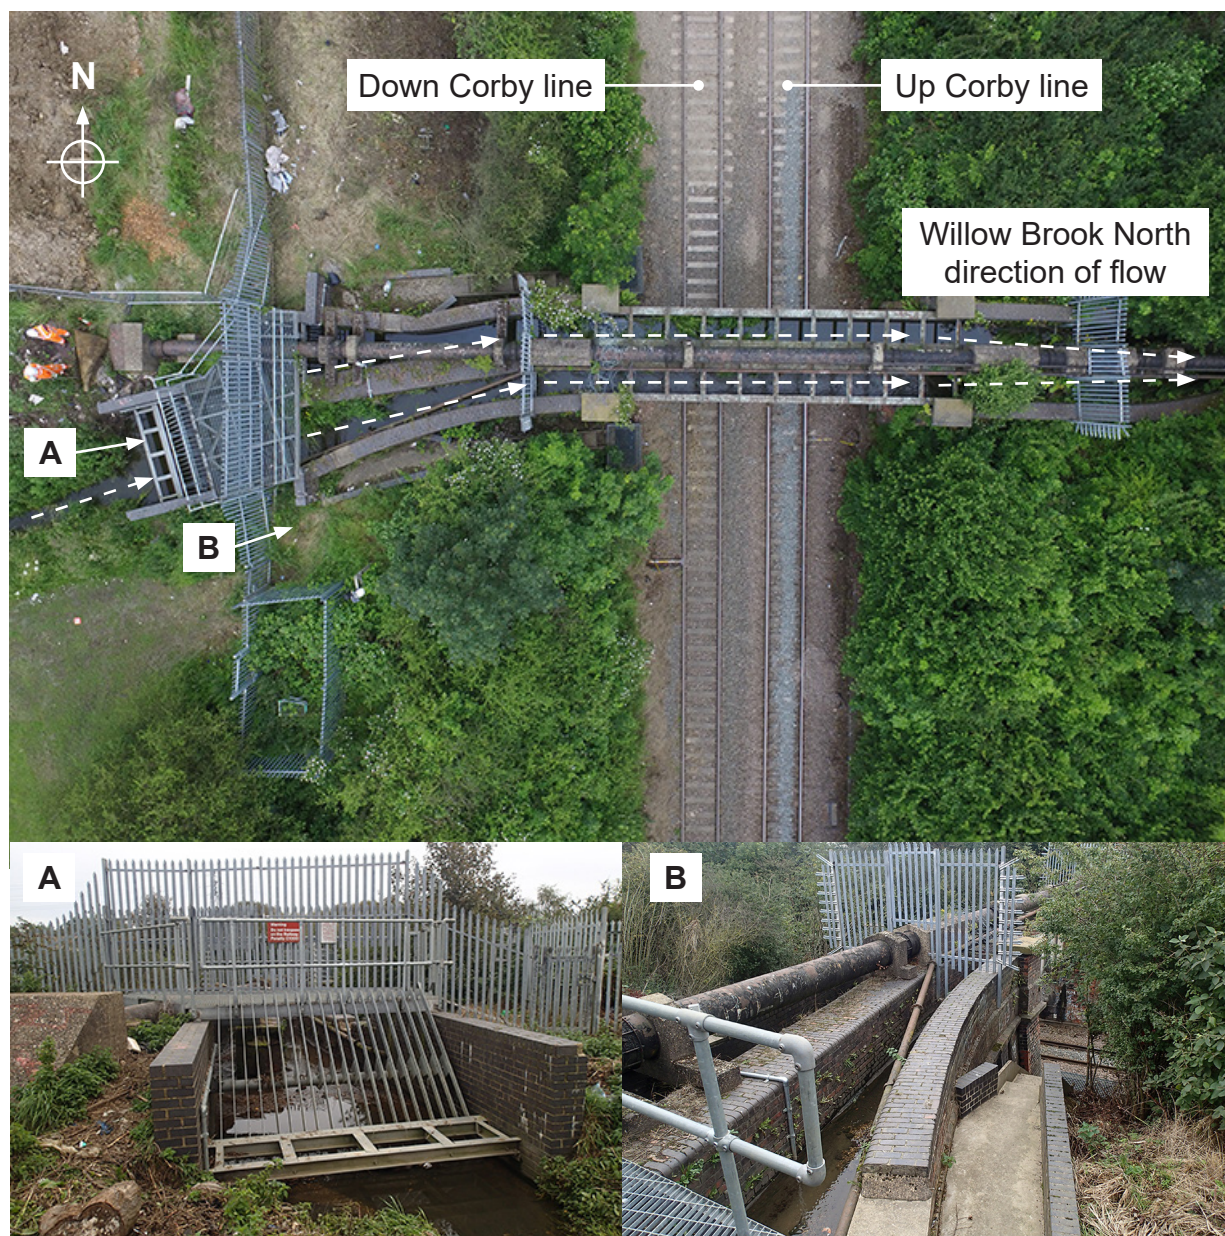
Figure 4: The aqueduct over the railway

- 8 At this location, known as the Pen Green Lane area, the two-track railway comprises the up Corby and down Corby lines. The permitted speed for trains on both lines is 60 mph (97 km/h). However, northbound trains were travelling slower than this as a temporary speed restriction of 40 mph (64 km/h) was in place on the down Corby line, starting 9 chains (181 metres) to the south. This speed restriction was due to the condition of the track in Corby Tunnel. Just south of the incident location, at 80 miles 38 chains, an aqueduct carries a watercourse called Willow Brook North, over the railway (figures 2 and 4).

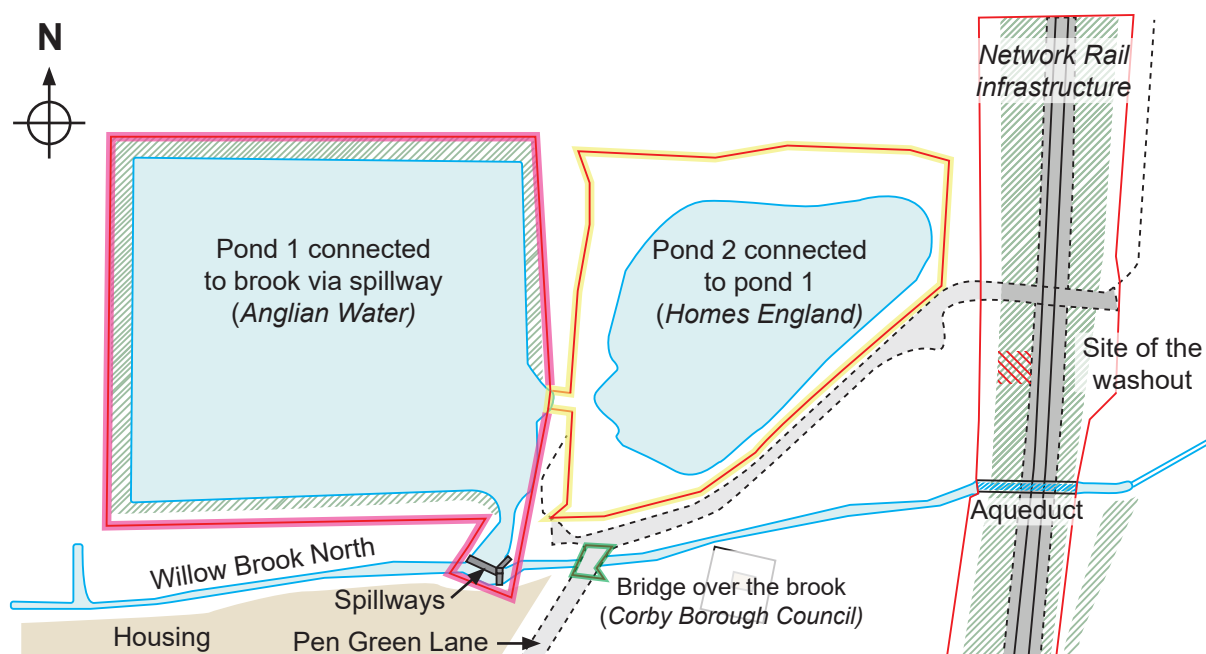
Figure 5: The assets relevant to the flooding in the Pen Green Lane area

- 12 Figure 5 shows the assets relevant to flooding in the Pen Green Lane area and the organisations responsible for them. The watercourse, Willow Brook North, is designated as a main river.⁵ This means the Environment Agency has permissive powers under the Flood and Water Management Act 2010 to maintain the watercourse as necessary for flood risk management purposes. Network Rail is responsible for the aqueduct that carries Willow Brook North over the railway, and the trash screen at its entrance. Anglian Water is the owner of the Pen Green Lane flood storage reservoir (from now on referred to as pond 1) and is responsible for the structure and trash screens that connect it to Willow Brook North. Homes England is the owner of the Pen Green Lane balancing pond (from now on referred to as pond 2) and is responsible for the culvert and trash screens that connect it to pond 1. Corby Borough Council is responsible for the bridge that carries Pen Green Lane over Willow Brook North. Northamptonshire County Council is the Lead Local Flood Authority, and is responsible for preparing and maintaining a strategy for managing the risk of flooding in the Corby area.

60 The water flowing in Willow Brook North was restricted by debris that had collected at the entrance to the bridge carrying Pen Green Lane over it (figure 5). This caused water in the brook to back up to the spillways located about 25 metres upstream of the bridge (figure 5). The spillways control the flow of water between Willow Brook North and the flood storage ponds as described in figure 10. When the water backed up, it raised the water level in the brook, which in turn diverted more water over the service spillway and into the ponds.

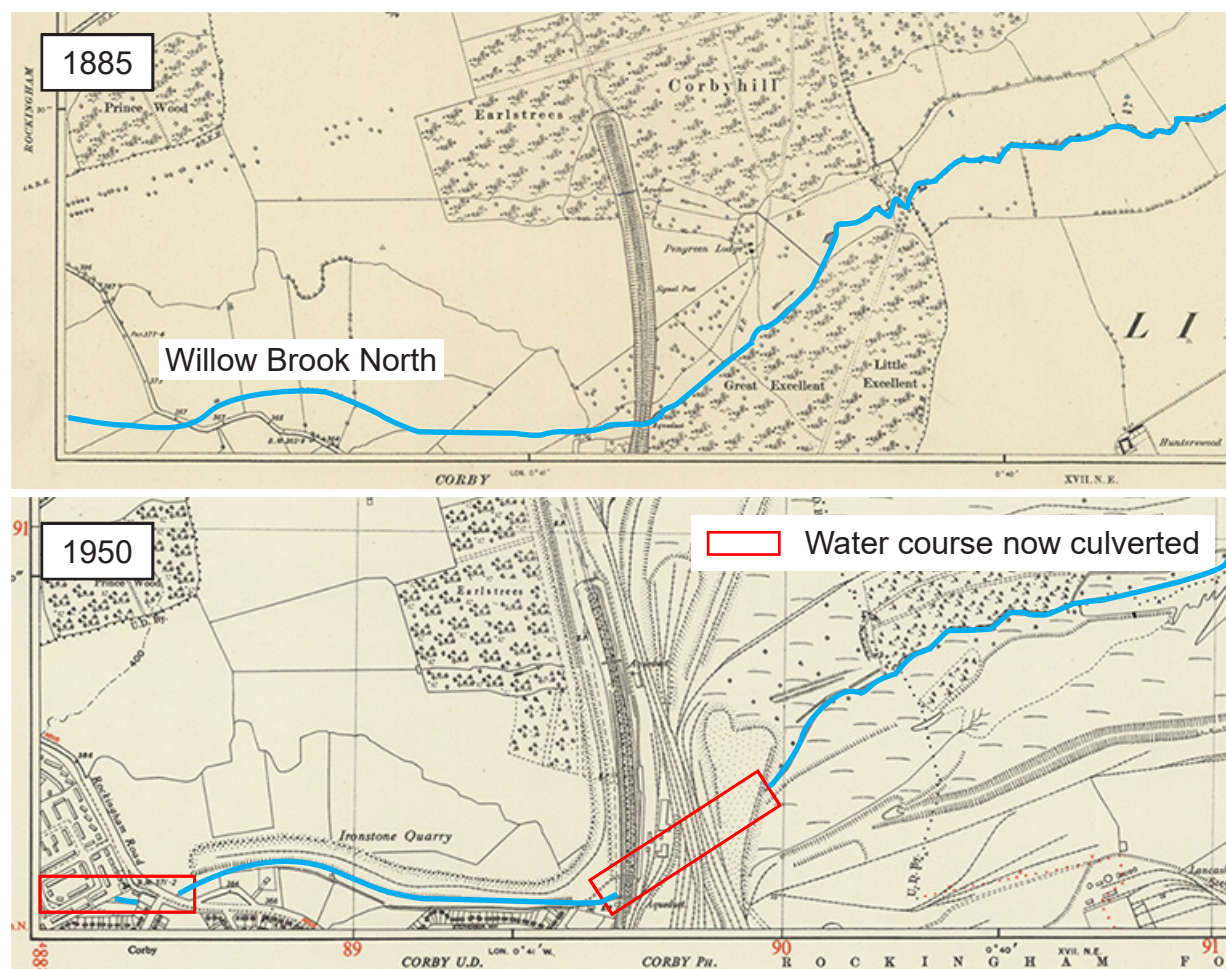
Figure 8: Map dated 1885 showing the brook passing through a rural area and a map dated 1950 showing the significant changes to the area due to industrialisation (extracts taken from the National Library of Scotland on Wikimedia Commons. Used under Creative Commons licence.)

- 34 The aqueduct at Pen Green Lane was built by the Midland Railway in 1878 to carry Willow Brook North over the then new railway line it was constructing to provide an alternative route from Kettering to Nottingham. A map dated 1885 shows the brook was an open watercourse, running through a rural area each side of the aqueduct (figure 8).

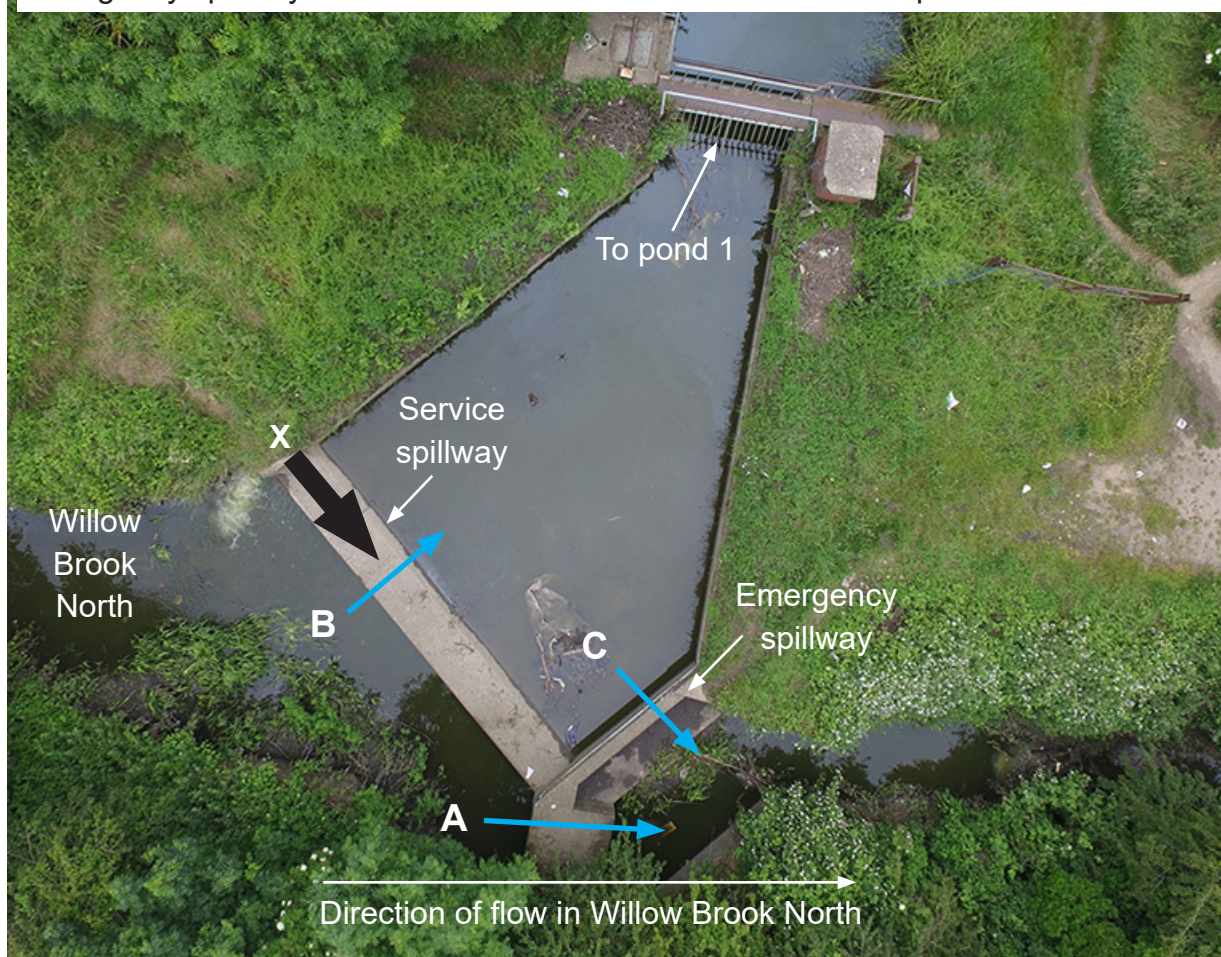
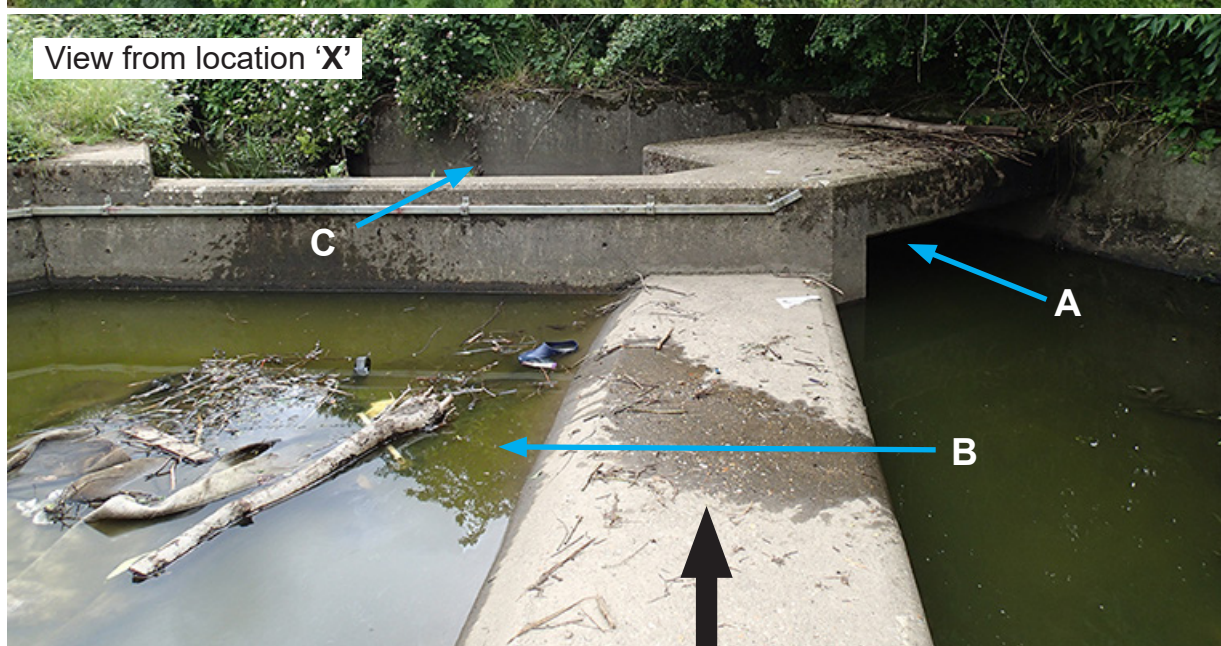
Figure 10: The spillways connecting the brook and pond 1

B – With a raised water level in the brook, water flows over the top of the service spillway and into pond 1 and the connected pond 2.

C – Once the water level in the ponds reaches this height, water flows over the emergency spillway and back into the brook instead of into the ponds.

- 67 The emergency spillway (figure 10), which should control the maximum water level in the ponds by allowing water back into the brook, was recorded by the level survey, measurements and drawings as having a level of 104.63 metres AOD. This is 0.14 to 0.23 metres higher than the 40 metre-long section of pond 2's eastern bank. This resulted in water flowing from the brook and into the ponds until it over-topped the eastern bank of pond 2, instead of flowing back into the brook via the emergency spillway.

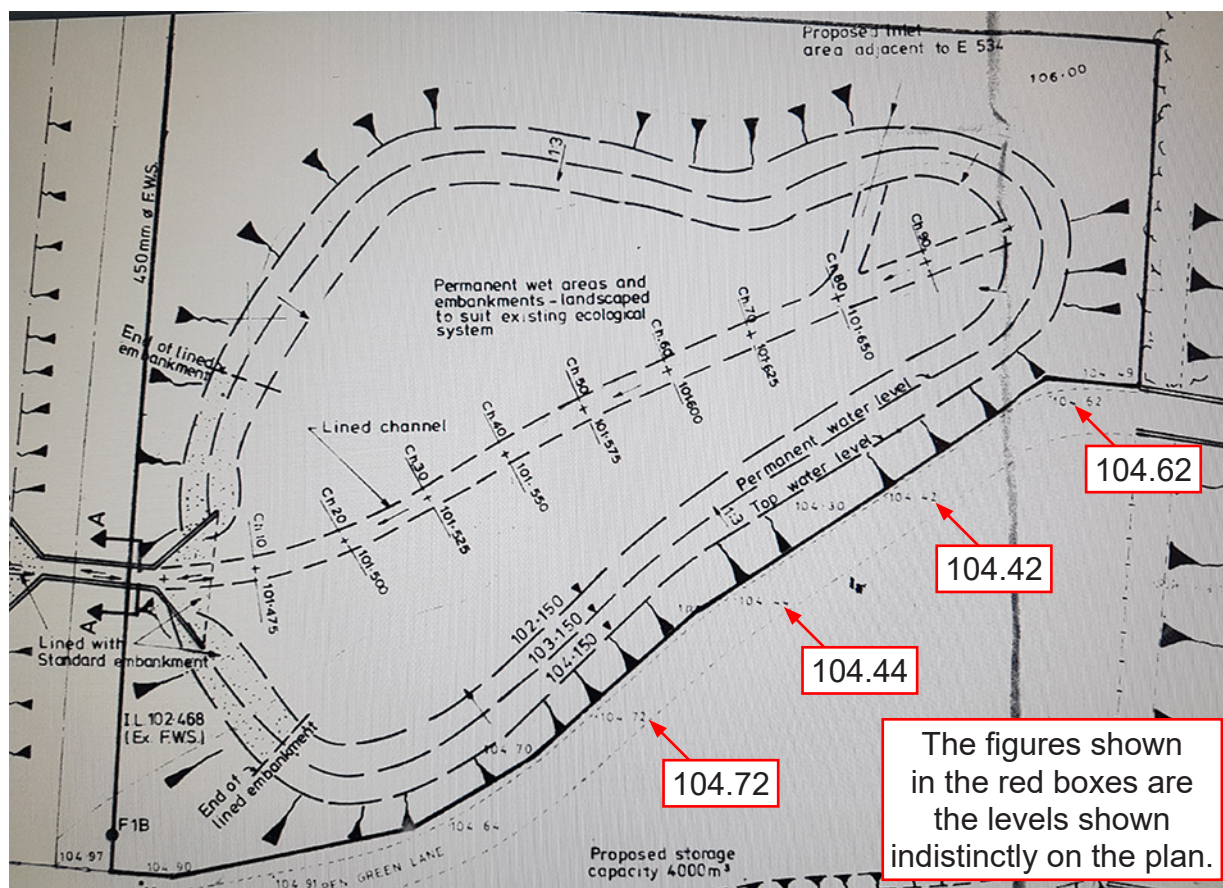
Figure 15: The plan from the planning application for pond 2

- 68 RAIB obtained copies of the planning application submitted to Corby Borough Council in 1989 to gain permission for the construction of pond 2. The application included a plan which showed the maximum water level for pond 2 was expected to be 104.15 metres AOD (figure 15) which is about the same level as the service spillway.

69 The plan also showed levels of 104.42 and 104.44 metres AOD recorded for the eastern bank of pond 2, indicating this bank was designed to be lower than the level of the emergency spillway. This made the emergency spillway ineffective in controlling the maximum water level in the ponds. Instead, the maximum water level in the ponds was controlled by water over-topping the eastern bank and flowing into the adjacent field at the crest of the cutting slope. Anglian Water staff with over 15 years' experience of this location reported to RAIB that they had never seen the water level in the ponds reach the point where water had passed over the emergency spillway.

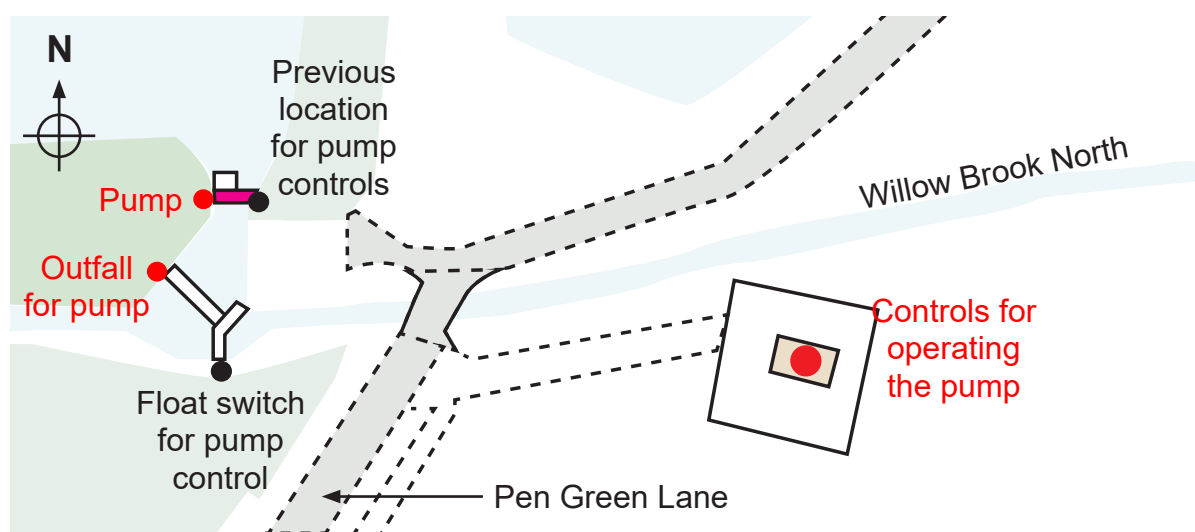
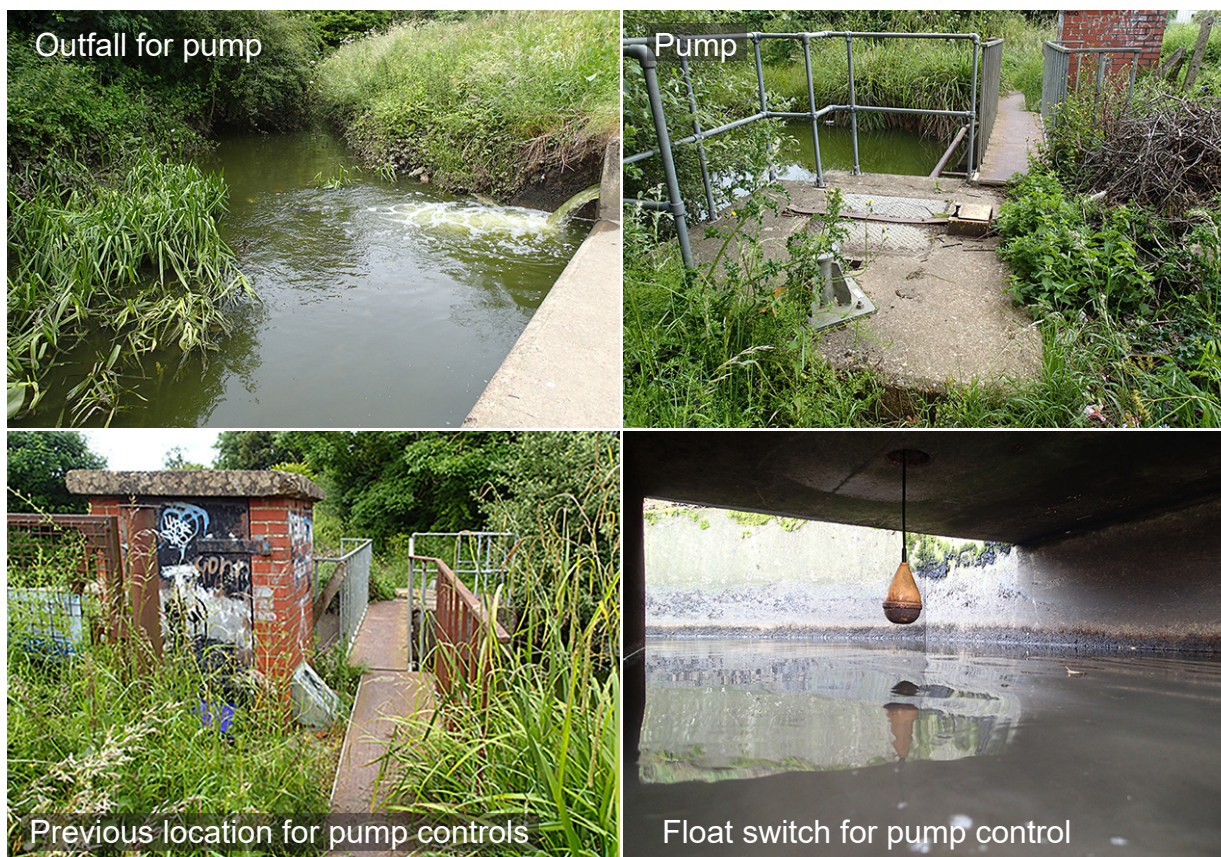
Figure 16: The pumping system at the spillways

- 71 The pump is installed next to the trash screen by the entrance to pond 1, with its outlet into the brook located just before the service spillway (figure 16). Anglian Water is responsible for the pump and its operation. When pond 1 was constructed a pump system was installed and its operation was automated, with sensors that measured the water levels in the brook and pond 1 to determine when the pump should run. However, the system was frequently vandalised and so Anglian Water moved the controls for the pump to its nearby sewage pumping station (figure 16). This change resulted in the pump becoming manually controlled. RAIB has not been able to establish the exact date of this change. However, documentation related to flood management in the area that was issued in 2006, refers to the pump being manually controlled.

- 72 Anglian Water has reported to RAIB that it does not have any formal arrangements in place for the manual operation of the pump, such as when it should be used or what the water level in the ponds should be reduced to. Instead, the pump is manually operated by a field maintenance technician employed by Anglian Water who uses his experience to decide when to run the pump.

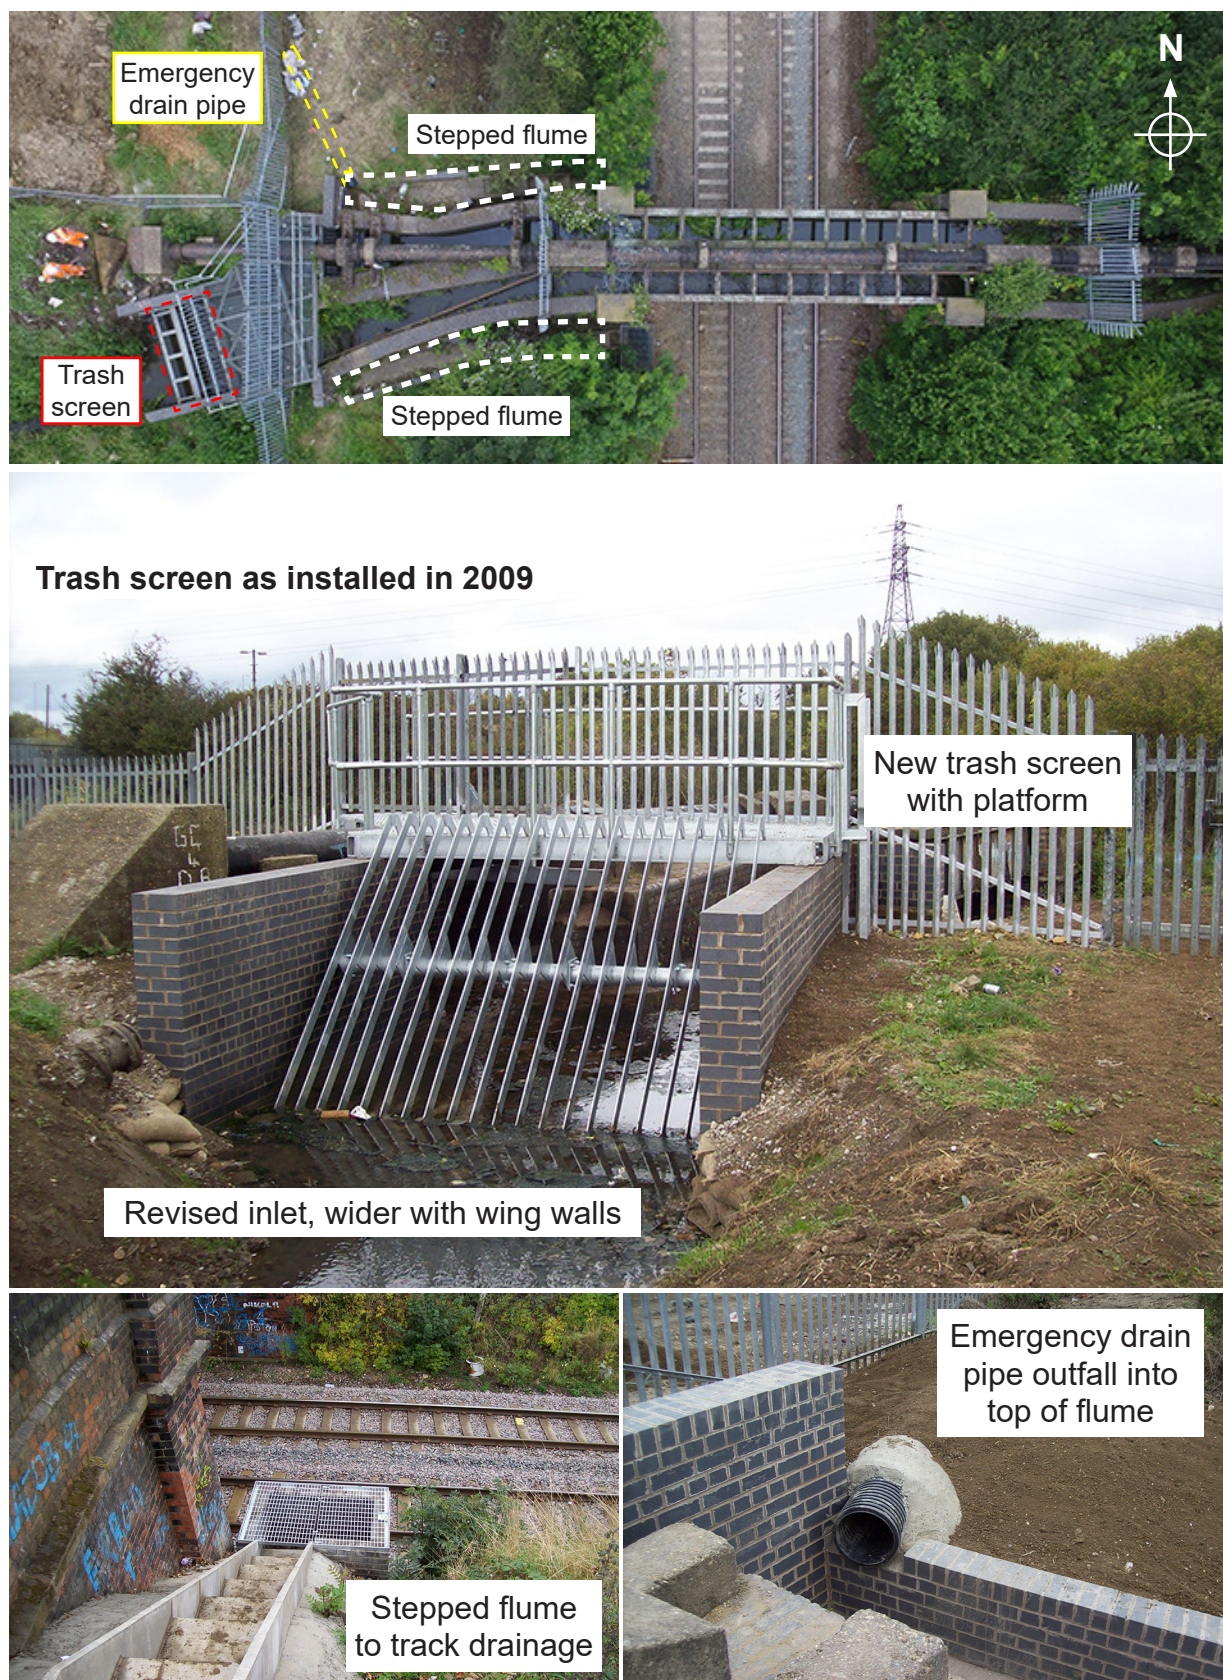
Figure 18: The changes made at the aqueduct's entrance, 2007-2009 (images courtesy of Network Rail)

- 83 The 2006 site visit report had also identified the source of the water for the washout failure as coming from the entrance to the aqueduct when it became blocked. Water from the brook then flooded the land surrounding the entrance and flowed to a low spot at the top of the cutting slope, where the washout in 1999 had occurred. To better manage flooding at the entrance to the aqueduct, Network Rail scoped, designed, obtained planning permission and made changes at the aqueduct's entrance between 2007 and 2009. This included modifications to the inlet of the aqueduct, installation of a new trash screen with a platform for clearing debris, replacement of the flumes either side of the aqueduct with stepped flumes to better manage any overflow, and modifications to the cess drain chambers to receive the overflow water (figure 18). Network Rail also installed an emergency drain pipe, with its inlet at the boundary fence line of the adjacent field. Its outlet discharged into the flume on the northern side of the aqueduct.

- 84 Network Rail completed these changes to the aqueduct's entrance in 2009, at the same time that the earthwork was repaired. It believed that these changes would protect the adjacent cutting slope from flood water, so the repair to the cutting slope did not include any specific measures to deal with a large volume of water at the crest. This meant that when water from pond 2 flooded the field at the crest of the cutting slope prior to this incident, the cutting suffered a washout failure.

107 The next significant flood event occurred in 2016. Network Rail staff and an earthwork examiner attended a reported landslide. They found a washout had occurred with water ponding in the field above the cutting slope. They reported that the water had come from the flood storage pond which had overtopped, as well as from the entrance to the aqueduct. They also noted that the emergency drain pipe that should allow water to drain from the field at the cutting slope's crest was blocked (figure 18).

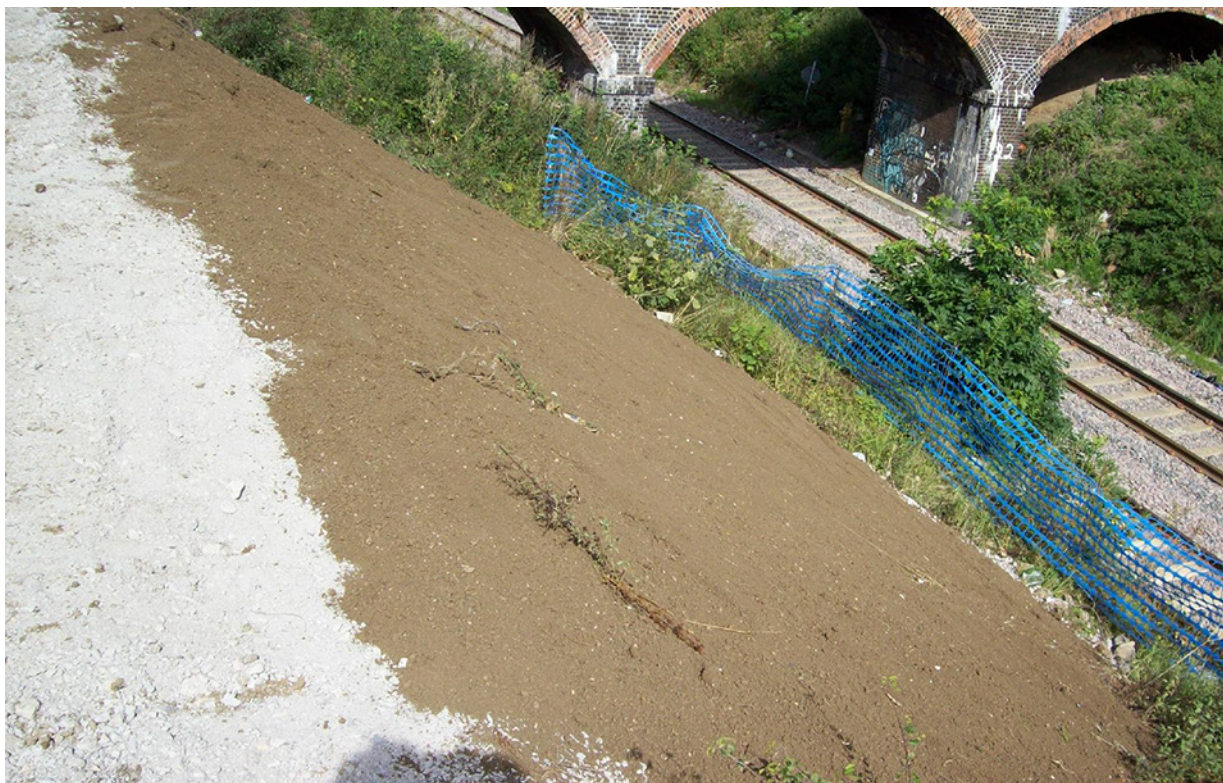
Figure 19: The repaired cutting slope in 2009 (image courtesy of Network Rail)

- 85 The as-built drawings for the repair to the cutting slope show that a series of steps, called benched excavations, were cut into the cutting slope. The void was then filled using 'MOT class 1 granular fill' and covered with a layer of soil (figure 19). This fill material was a sandy gravel and was very susceptible to washout if significant amounts of water seeped through it from the pond that formed in the adjacent field at the cutting slope's crest.

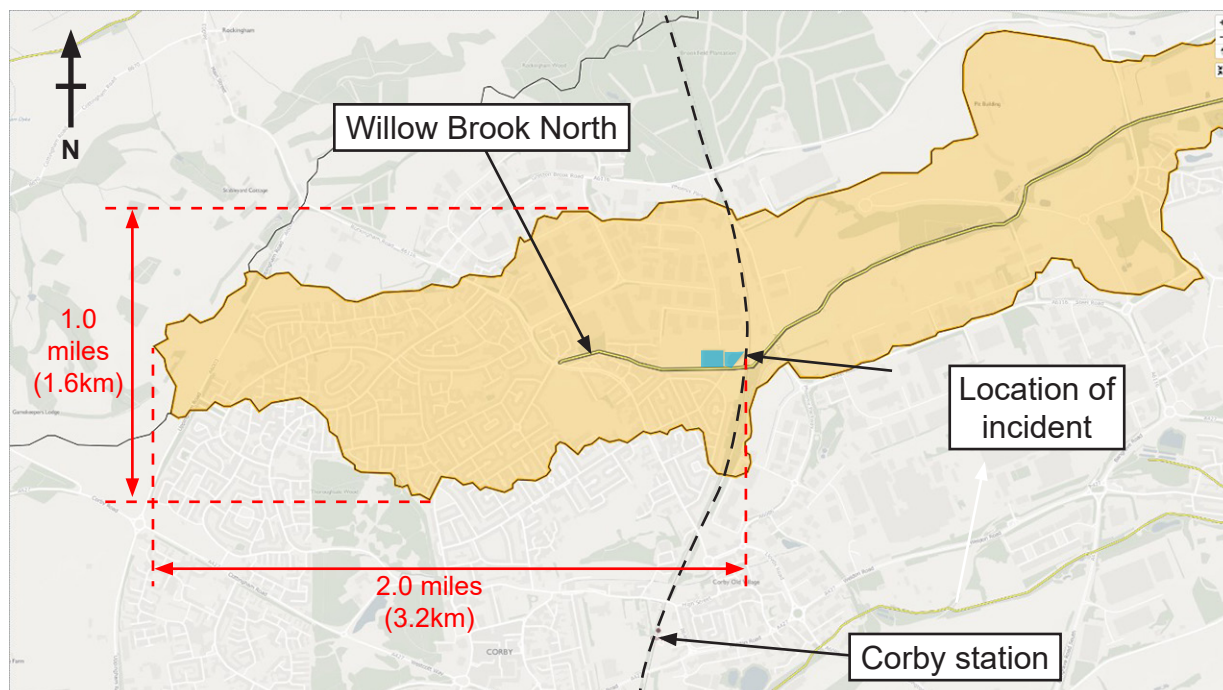
Figure 21: The catchment area for Willow Brook North as defined by the Environment Agency (image courtesy of the Environment Agency, see <https://environment.data.gov.uk/catchment-planning/WaterBody/GB105032045590>)

- 96 Flooding has been happening on the railway at Pen Green Lane for a long time (paragraphs 36 to 49). Rainfall radar data for the Willow Brook North surface water catchment area (figure 21) recorded between 9 June and 13 June 2019 indicated the rainfall was not exceptional. It was less than a 1 in 1 year¹² rainfall event over the five-day period, in terms of both intensity and volume. Figure 21 also shows that the size of the water catchment area is not large, covering about two square miles (five square kilometres). However, the flood management system at this location could not cope with the volume of surface water that was discharged into the brook during that period. This was primarily due to three factors:

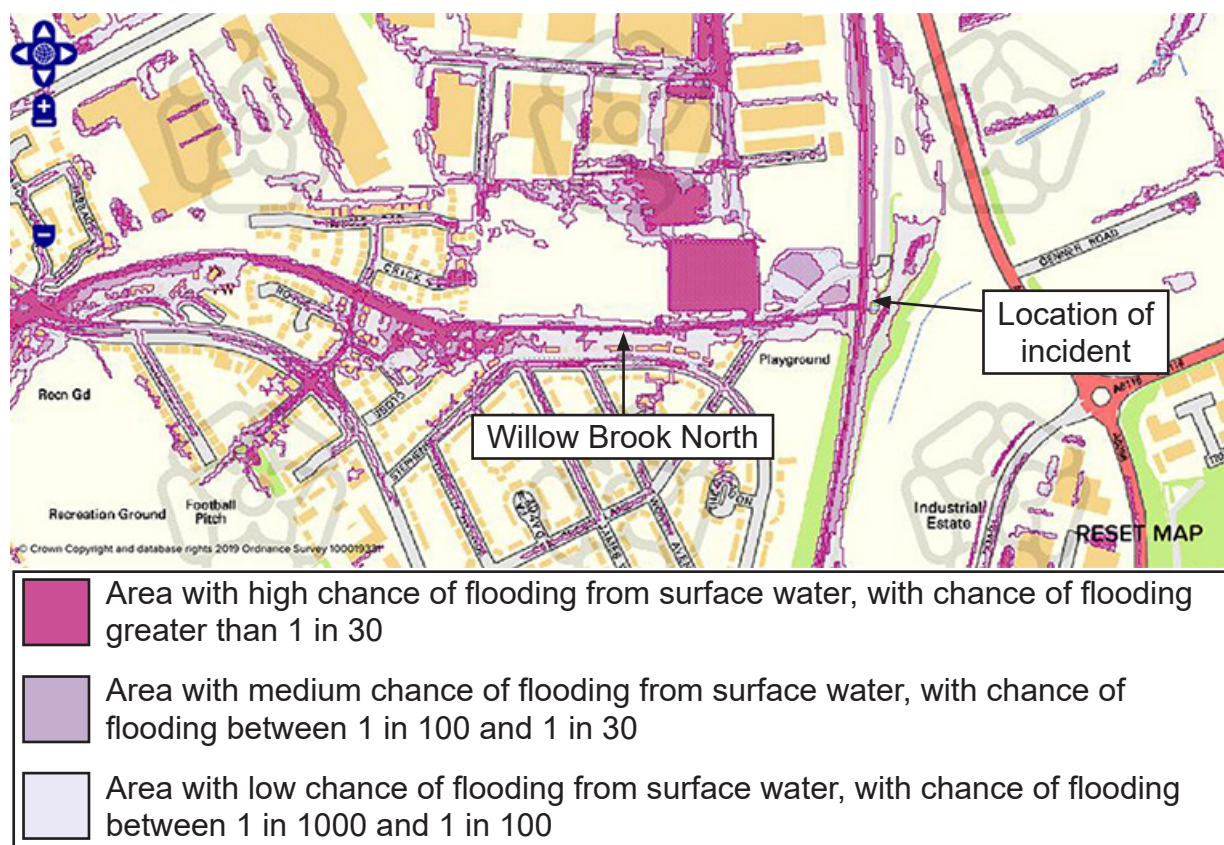
Figure 22: Northamptonshire County Council flood risk toolkit results for risk of surface water flooding in the Pen Green Lane area

- 98 As the Lead Local Flood Authority, Northamptonshire County Council also provided a publicly available web-based toolkit to understand the risk of flooding at locations within its area of responsibility. The toolkit showed the Pen Green Lane area as being at risk from surface water flooding (figure 22). Northamptonshire County Council had no plans to carry out any flood mitigation work at this location as it considered fluvial flooding¹³ to be the greatest risk at Pen Green Lane, so under the Flood and Water Management Act 2010, it believed that management of this risk rested with the Environment Agency.
