Rail Accident Report

Collision between a train and utility vehicle at Dollands Moor freight yard, Kent 4 September 2018

Report 05/2019
June 2019

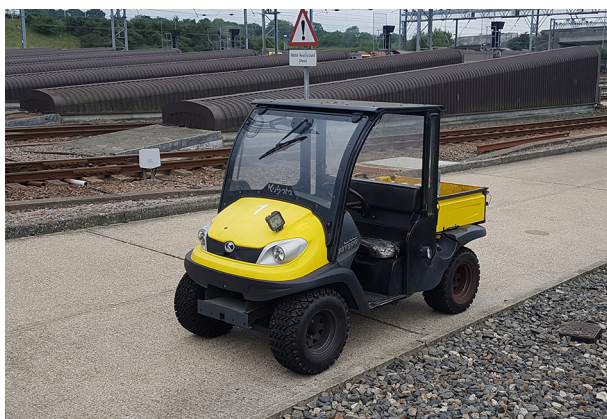
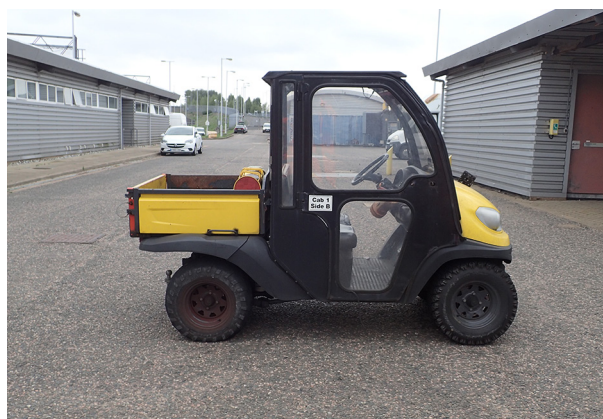
20 Both buggies had been equipped with inspection lights on the left-hand side (figure 7a) to assist with train checking duties, controlled by a switch in the cab. The buggies are left-hand drive and the shunters had removed the left-hand doors to make it easier to get in and out of the vehicles.

Figures 7a and 7b: views of the undamaged Kubota RTV 500 buggy at Dollands Moor yard

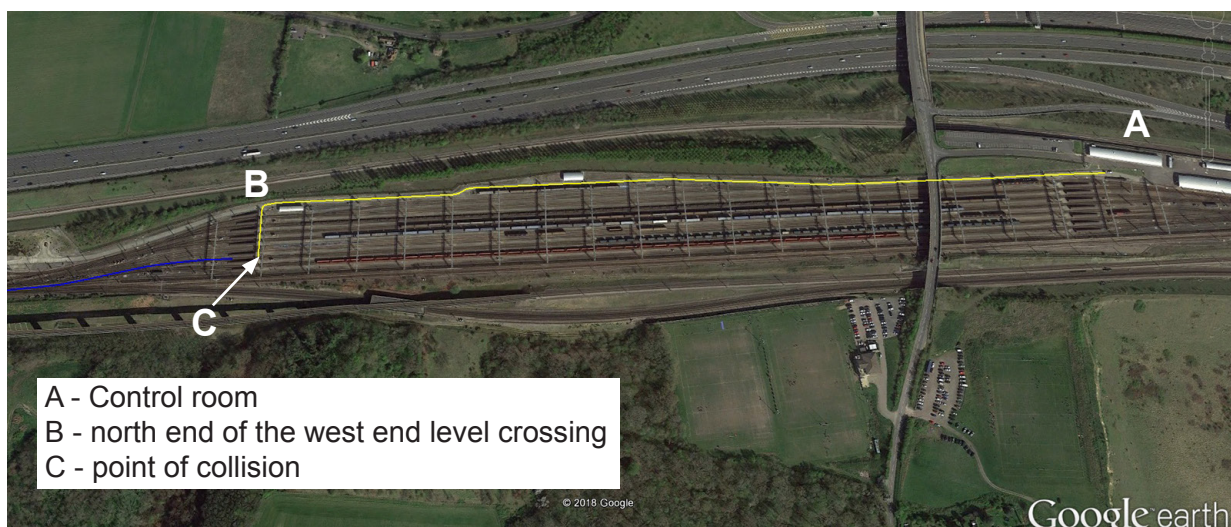
- 37 At 03:36 hrs, the shunter drove up the main access road in a buggy to the west end level crossing, a distance of about 830 metres (figure 8 and figure 9). The other shunter, as was normal practice, made his way to the opposite end of the yard and stopped on the concrete walkway on the north side of siding 2.

Figure 8: Google Earth image looking north, showing route of buggy from control room to siding 2.

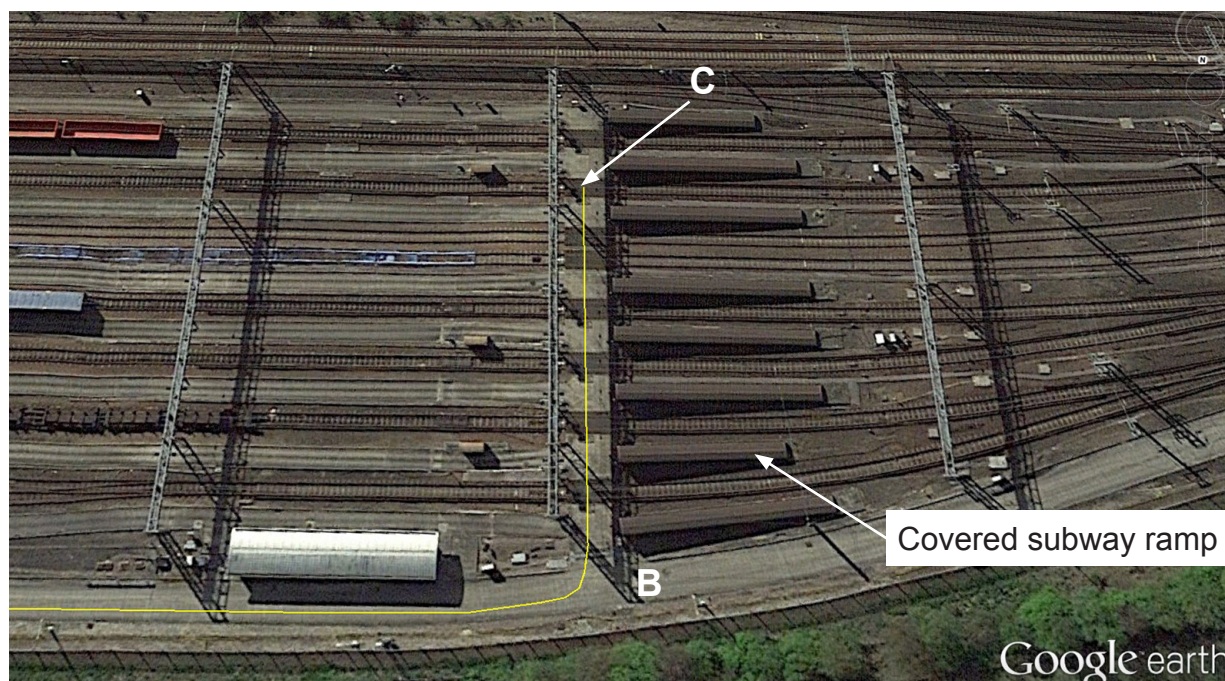
Figure 9: Google Earth image looking south, showing west end level crossing. Locations B (north end of crossing) and C (point of collision) are as marked on figure 8.
