Rail Accident Report

**Signal passed at stop and near miss,
Deansgate-Castlefield tram stop, Manchester
17 May 2019**

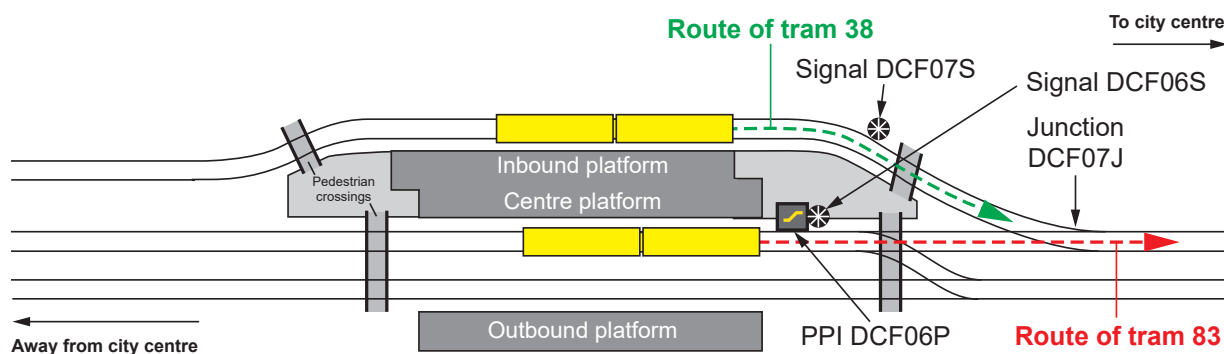
Figure 4: Layout of Deansgate-Castlefield tram stop (note some details have been removed for clarity)

- 6 The tram stop has three platforms, each of which can accommodate two trams. The inbound platform is used by trams travelling towards Manchester city centre from Cornbrook and the outbound platform by trams travelling away from the city. The centre platform was added in 2017 as part of the Deansgate-Castlefield remodelling programme. In normal service this platform is used by inbound trams, although it can be used by outbound trams during engineering work or degraded operations. The tram stop includes a pedestrian walkway at each end. This crosses the tram lines and allows pedestrian access to and from the platforms.

- 7 The lines from the inbound and centre platforms converge at junction DCF07J. This is made up of a set of trailing points¹ located approximately 35 metres from the end of the centre platform. Trams leaving the centre platform must also pass over a set of facing points at junction DCF06J. This junction allows trams to pass between the inbound and outbound lines outside normal service patterns.

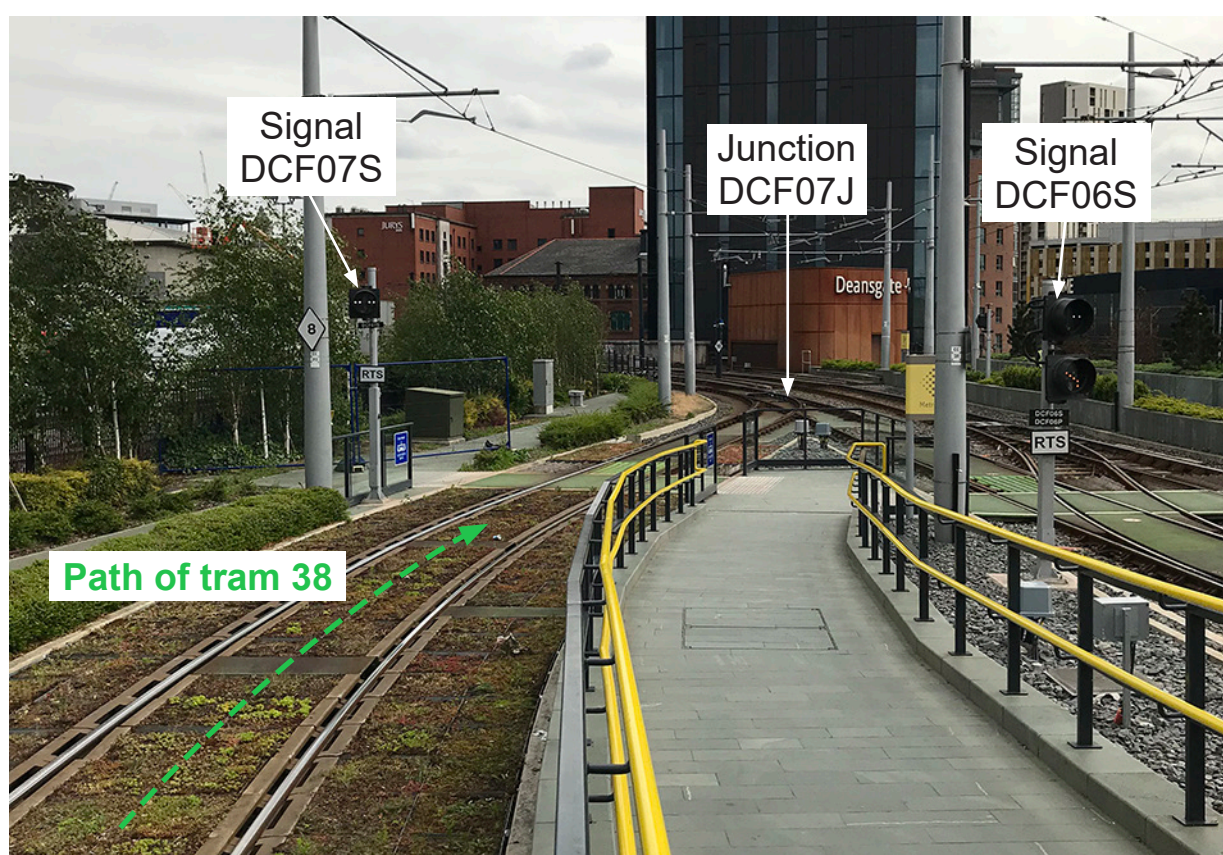
Figure 5: Signal DCF07S located beyond the inbound platform

- 11 TMS will normally route inbound trams approaching from Cornbrook into the inbound platform via a set of motorised points. A tram driver should not allow their tram to depart from the inbound platform until they receive a proceed aspect on DCF07S signal (figure 5). If the inbound platform is already occupied by two trams, TMS will route the next inbound tram into the centre platform instead. A tram should not depart from the centre platform until a proceed aspect is displayed on DCF06S signal and the PPI for junction DCF06J shows a left indication to indicate that it is set for trams to continue straight ahead on the inbound line (figure 6).

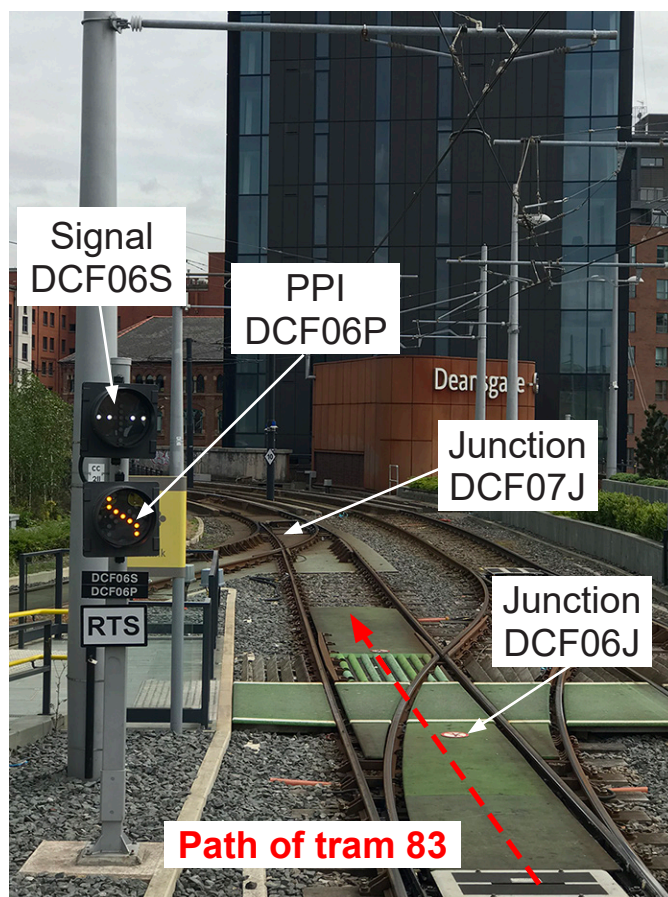
Figure 6: Signal DCF06S, PPI DCF06P and the junctions located beyond the centre platform

- 41 For similar reasons, he is unlikely to have passed the platform and signal DCF06S due to any confusion between the left indication on PPI DCF06P and a proceed signal. It is of note that PPIs on the Metrolink system use orange LEDs as opposed to the white LEDs found in tram signals, further reducing the likelihood of this error being made.

- 46 The driver of tram 83 stated that he had no clear recollection of failing to call at Deansgate-Castlefield tram stop or of passing signal DCF06S at stop (paragraph 38). OTDR and CCTV evidence show that he also did not operate the tram's controls in reaction to these events (paragraphs 29 to 33). This indicates that the driver was affected by a temporary loss of awareness as tram 83 passed through Deansgate-Castlefield.
