Rail Accident Report

Freight train derailment at Willesden High Level Junction, north-west London 6 May 2019

Report 07/2020
August 2020

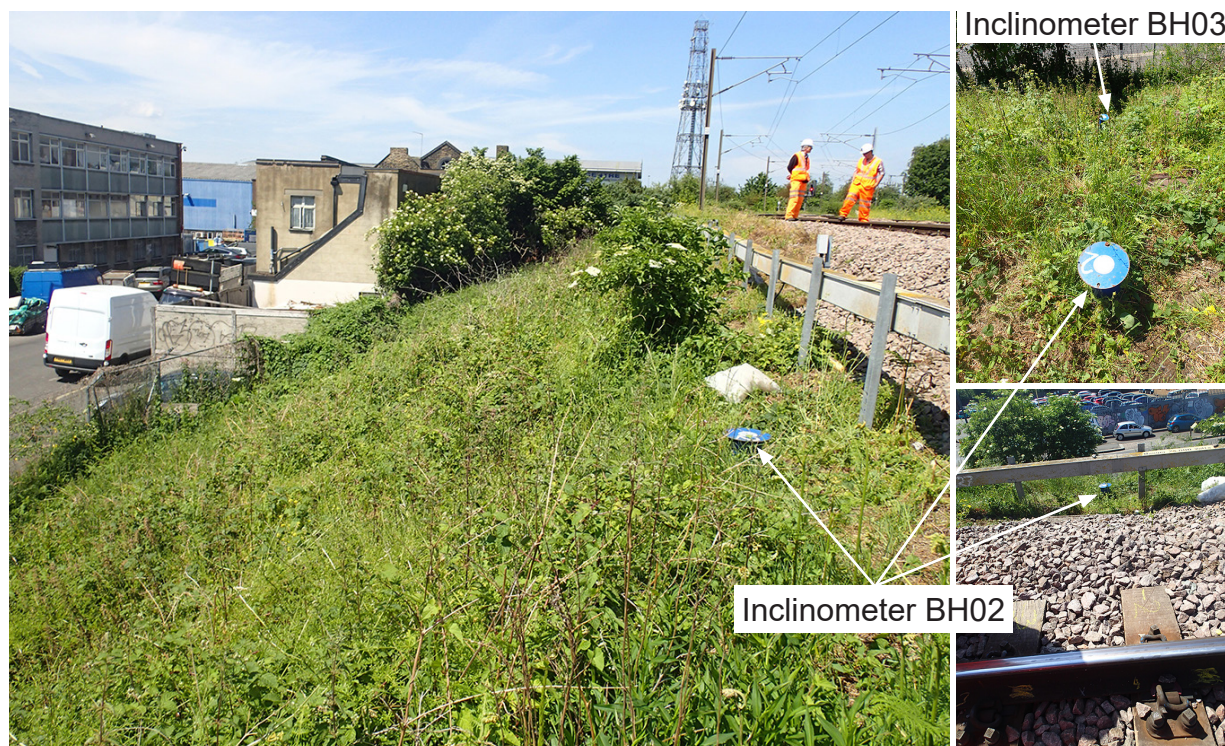
Figure 5: The inclinometer locations on the up-side slope of Mitre Bridge Curve embankment

- 22 The Anglia SAE(G) decided to monitor the embankment movement using inclinometer⁸ measurement devices. Holes for two inclinometers (BH02⁹ and BH03) were bored in the slope adjacent to the up High Level line (up-side slope), see figure 5. A hole for a third inclinometer (BH01) was bored in the slope adjacent to the down High Level line (down-side slope). The monitoring of the embankment was ongoing at the time of the derailment. A pattern of progressive seasonal movement had been identified and the Anglia SAE(G) was overseeing the development of options for works designed to stabilise this.

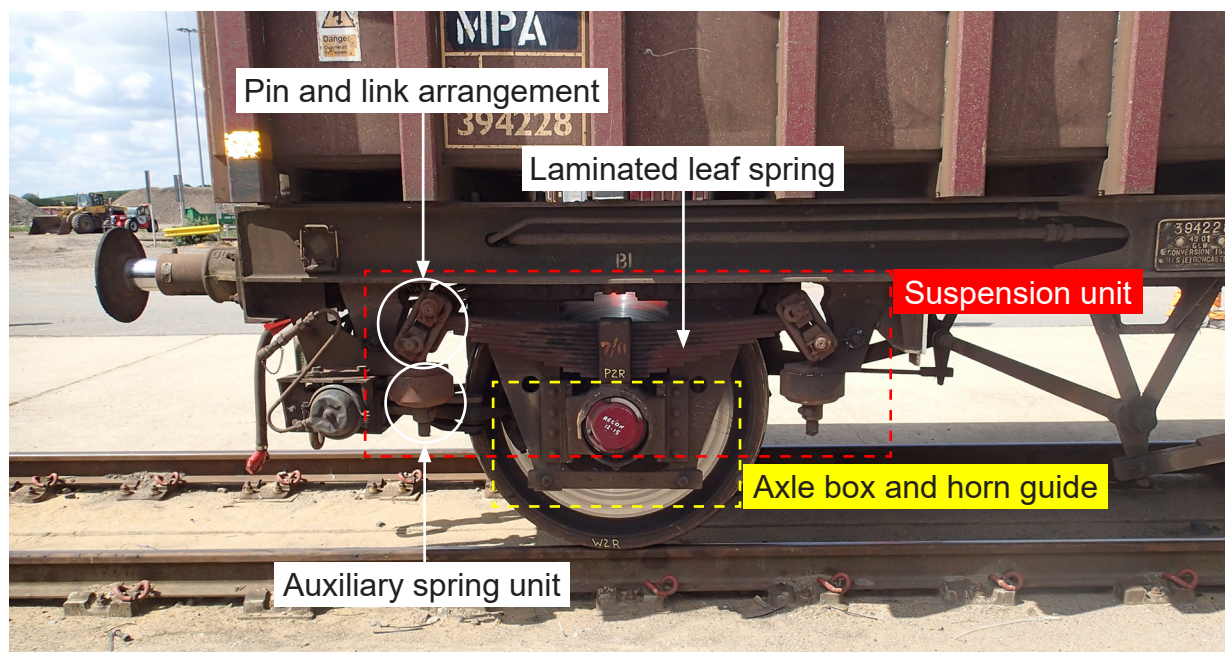
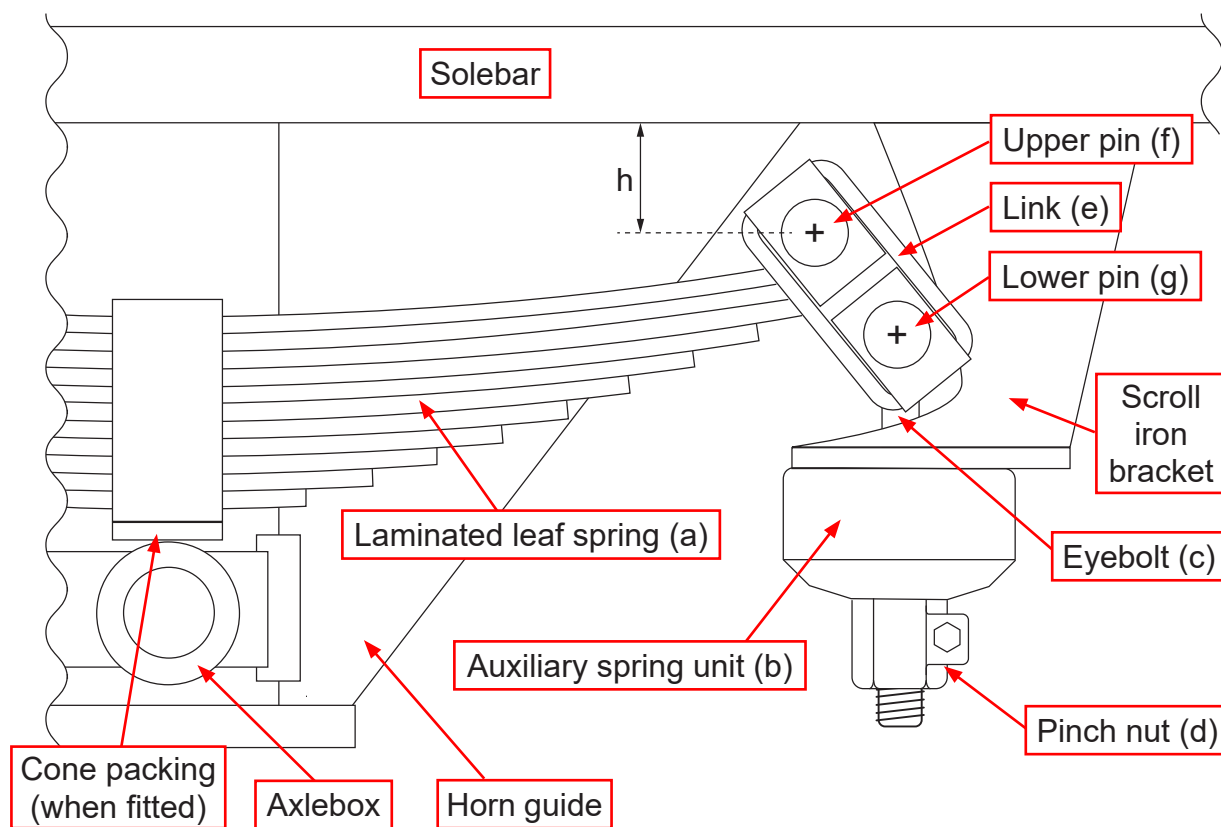
Figure 9: Suspension unit arrangement

- 67 Figure 9 shows the arrangement of the main components comprising each suspension unit:
- laminated leaf spring, which is supported by the axlebox
 - pair of auxiliary spring units: each abuts the underside face of one of the underframe scroll iron brackets. Flexibility is provided by a pair of internal rubber elements that are sandwiched between three plates: upper, mid and lower

- 68 Preload is introduced and increased within each suspension unit by tightening the pinch nuts. This compresses the springs and draws the upper pins lower, increasing the distance between the underside of the solebar and the centre of the upper pin (dimension 'h' on figure 9). By increasing the preload within an individual suspension unit the wheel load at that wheel increases, as does the wheel load at the diagonally-opposite wheel. The wheel loads at the other diagonal pair of wheels reduce correspondingly.

- variation in horizontal curve radius
 - variation in track gauge
 - the degree of diagonal wheel load imbalance
 - wagon suspension condition: horn guide gaps, and friction and unintended additional (parasitic) stiffness effects in the laminated leaf spring and pin and link arrangement (figure 9).
