Rail Accident Report

Collision at Stainforth Road level crossing, 11 January 2018

Report 08/2018
July 2018

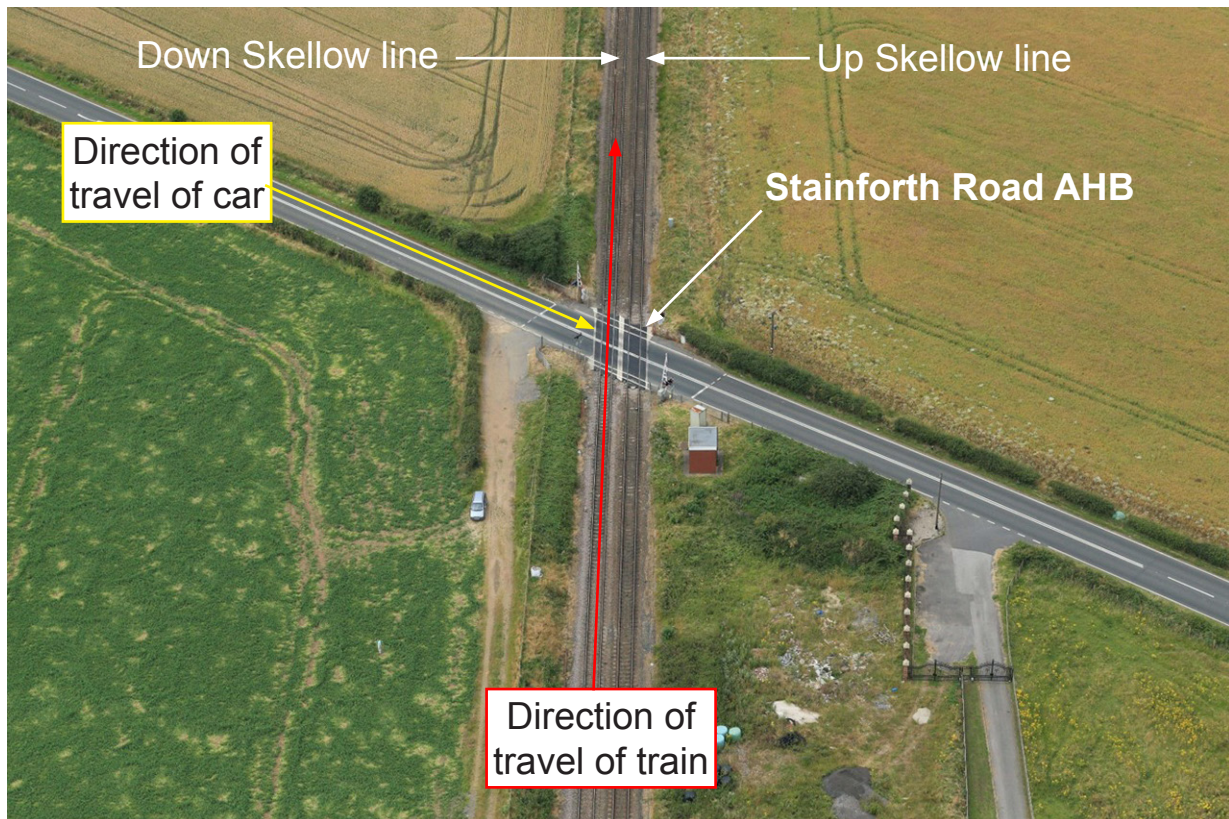
- 5 Stainforth Road AHB level crossing is located where Stainforth Road passes over the Up and Down Skellow lines, which run between Stainforth and Applehurst junctions. The railway at this location is on an east to west axis. Stainforth Road is a single carriageway road, subject to the national speed limit (60 mph (97 km/h) for cars). The road traverses the crossing from the south-west to the north-east, on a skew (figure 2).

Figure 2: Stainforth Road AHB level crossing (image courtesy of Network Rail)

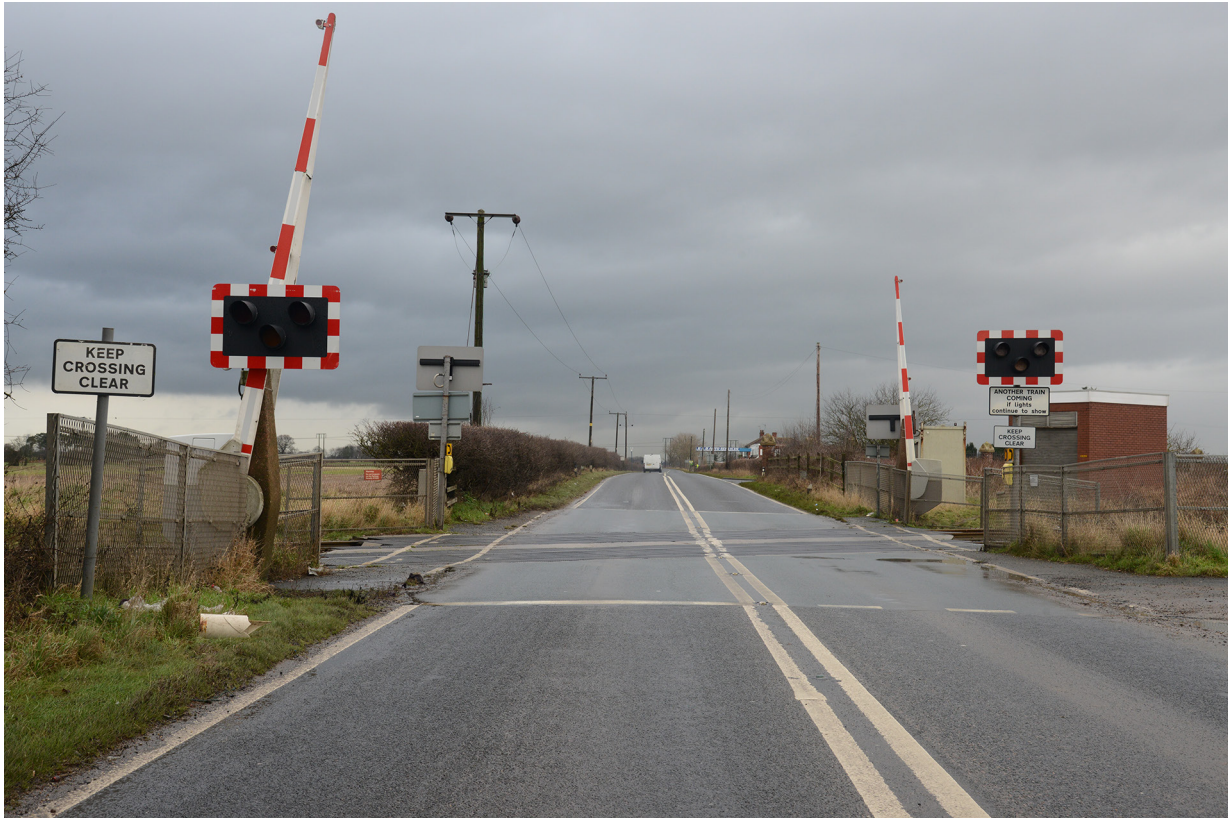
- 7 The road surface of the crossing measures just over 11 metres wide. It includes a central two-lane carriageway which is around 8.5 metres wide, flanked on each side by a marked footpath (figure 3). The crossing is in a rural location and there are no ambient light sources which illuminate the crossing surface at the time of day that the accident occurred. There is vegetation growing to the side of the crossing. This blocks the view of car drivers along the railway in the western direction as they enter the crossing from the south-west (termed as 'northbound' road users in this report).

- 8 The approach to the crossing for northbound road users is straight and level, with a small dip in the road around 50 metres on the approach to the crossing. The presence of the crossing is indicated to road users by a series of statutory road-side signs and road markings. The carriageway on the immediate approach to the crossing and on the crossing surface itself is marked with solid double white lines in the centre of the road (figure 3).

Figure 3: Stainforth Road AHB level crossing, facing north on the approach from Barnby Dun (image courtesy of the British Transport Police)

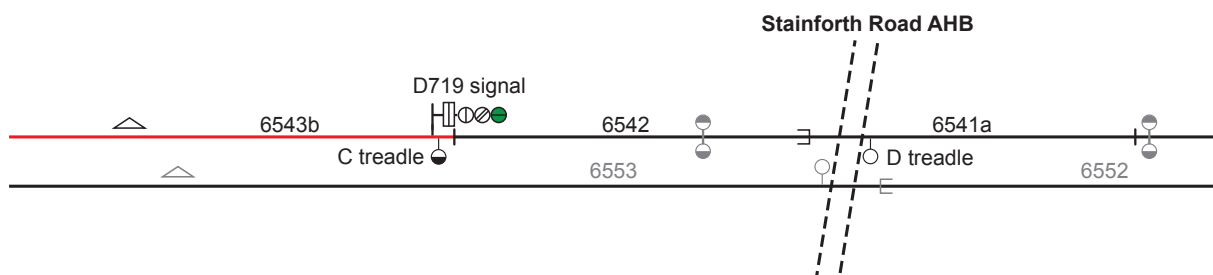
- 27 With D719 signal showing a green (proceed) or yellow (caution) aspect, trains approaching Stainforth Road AHB on the Down Skellow line will 'strike-in'⁴ when they occupy track circuit⁵ 6543b, which is located on approach to the signal (figure 8). 'Striking-in' will cause the crossing's control circuits to initiate the road closure sequence. This means that the road traffic lights and audible alarms will activate and the half-barriers will drop (paragraph 9). Just beyond D719 signal, the wheels of an approaching train will operate treadle⁶ 'C' (figure 9). This will register the presence of the train at this location within the level crossing's controls.

Figure 8: A train approaching on the Down Skellow line occupies track circuit 6543b

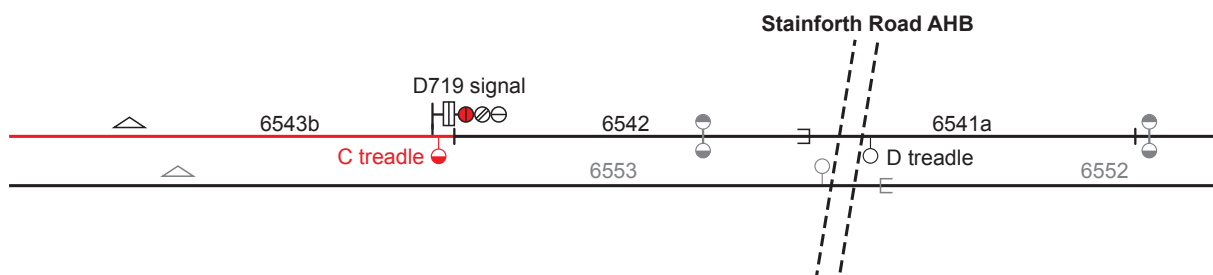
Figure 9: A train approaching on the Down Skellow line operates Treadle C

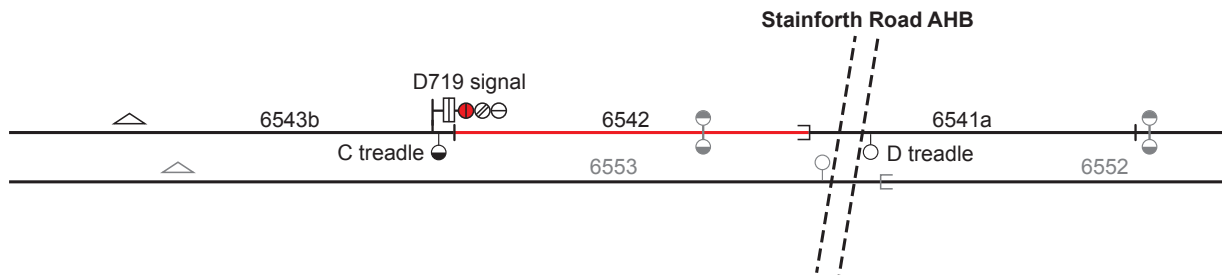
- 28 As the train continues to approach the crossing, track circuit 6542 will become occupied and track circuit 6543b will clear (figure 10). Occupying track circuit 6542 or operating treadle 'C' will also activate the road closure sequence if track circuit 6543b has not already done so (this would be the case if D719 signal is passed while showing a red (danger) aspect).

Figure 10: A train approaching on the Down Skellow line clears track circuit 6543b and occupies track circuit 6542

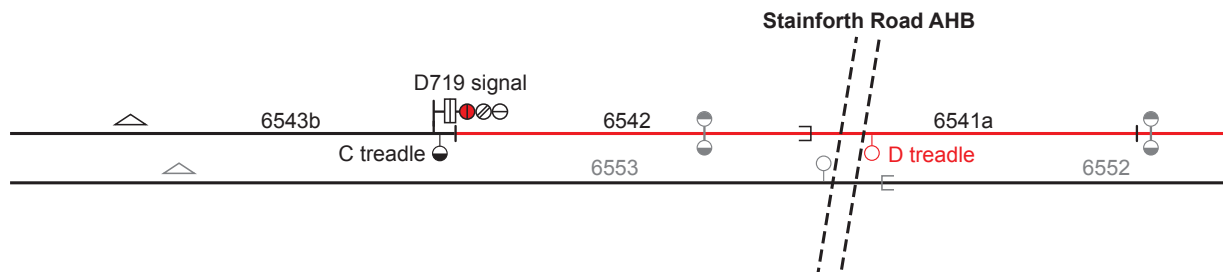
- 31 Having entered track circuit 6541a, the front of the train passes over and leaves the crossing surface. About 4 metres beyond the crossing, the train's wheels will operate treadle 'D' (figure 12). Providing the control circuitry of the crossing has previously stored the operation of treadle C and can confirm that the road closure has been called and that the barriers remain down, the operation of treadle 'D' signifies to the controls that the crossing function and direction of the train has been proved. This information will again be stored by the control circuits.

Figure 12: A train on the Down Skellow line operates Treadle D as it exits the crossing
