Rail Accident Report

Freight train derailment at Ely West Junction 14 August 2017

Report 09/2018
August 2018

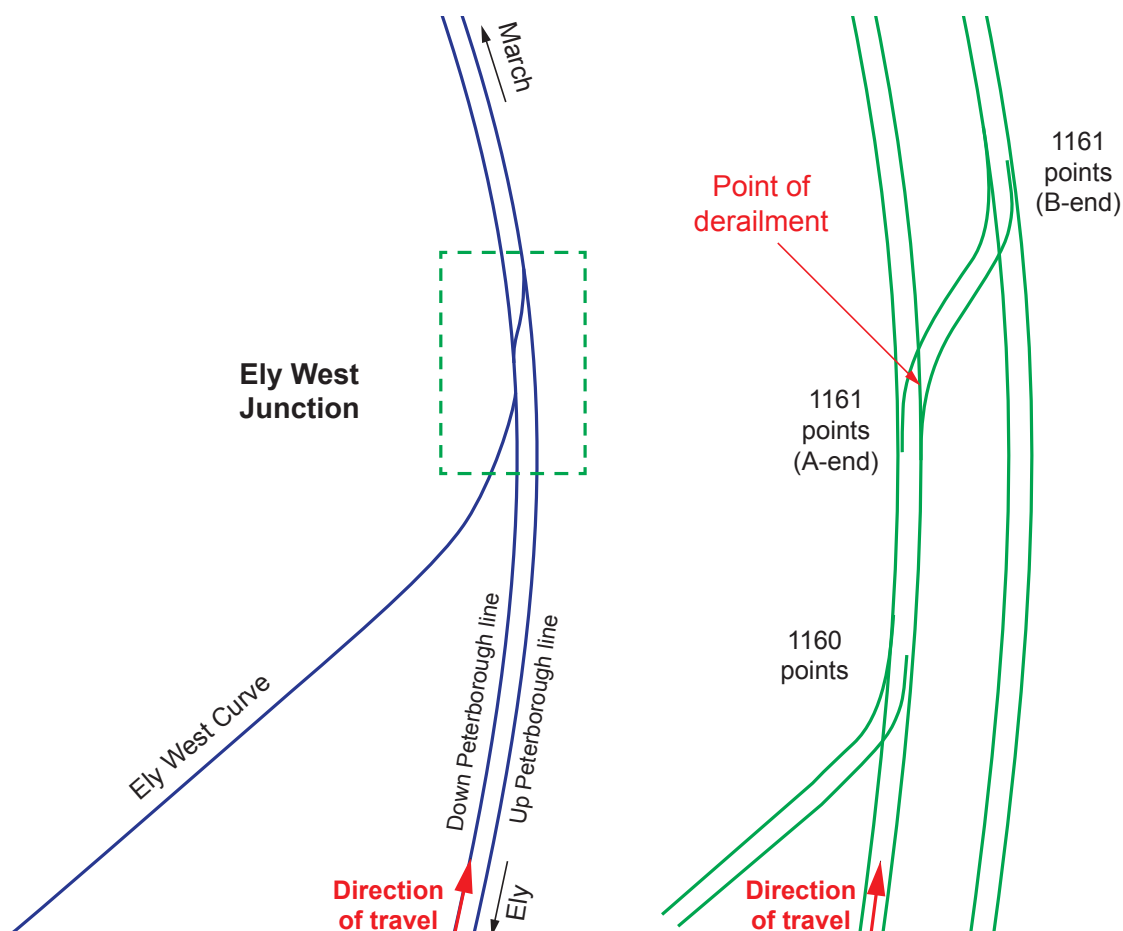
Figure 3: Track layout at Ely West Junction

- 7 The derailment took place on the plain line between the toe of 1161A points and its crossing nose (located 43 metres beyond the toe). The first visible derailment marks on the railhead were approximately 24 metres after the toe (figure 3).

- 24 At 14:21 hrs, locomotive 66713 passed over 1161A points at Ely West Junction. Shortly afterwards, when the leading right-hand wheel of wagon 630034 was 24 metres beyond the toe of 1161A points, it climbed onto the railhead and travelled along it for about 12 metres before dropping into the six-foot⁴ (figure 3).

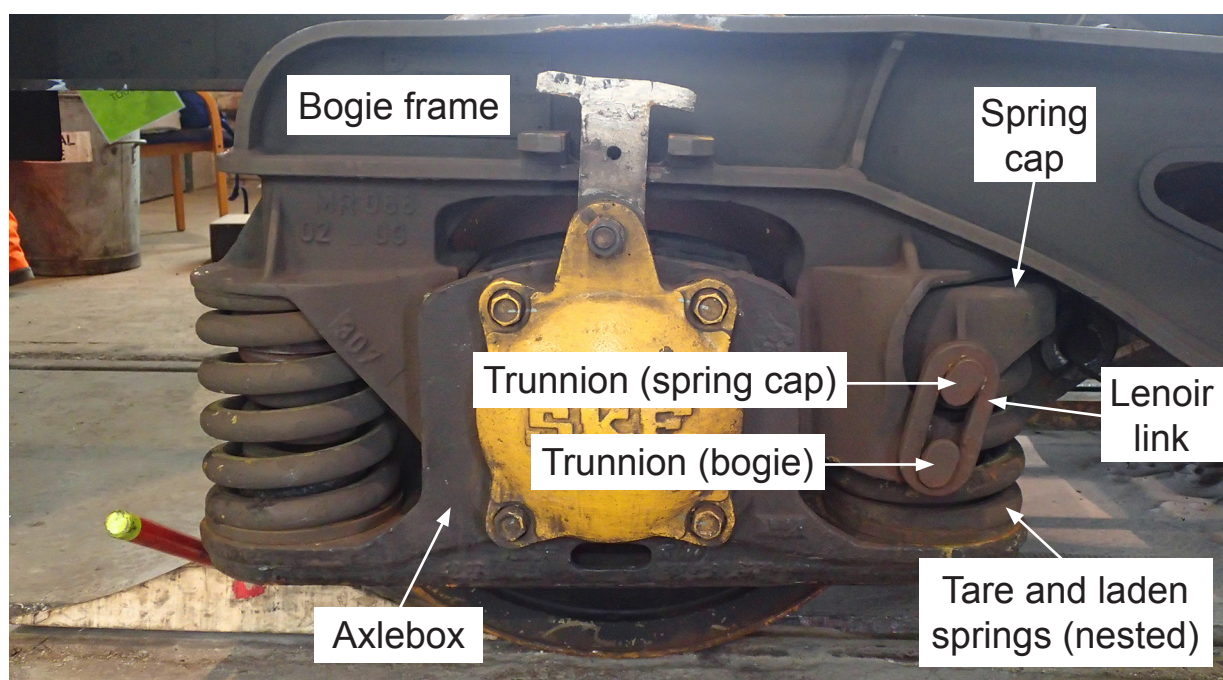
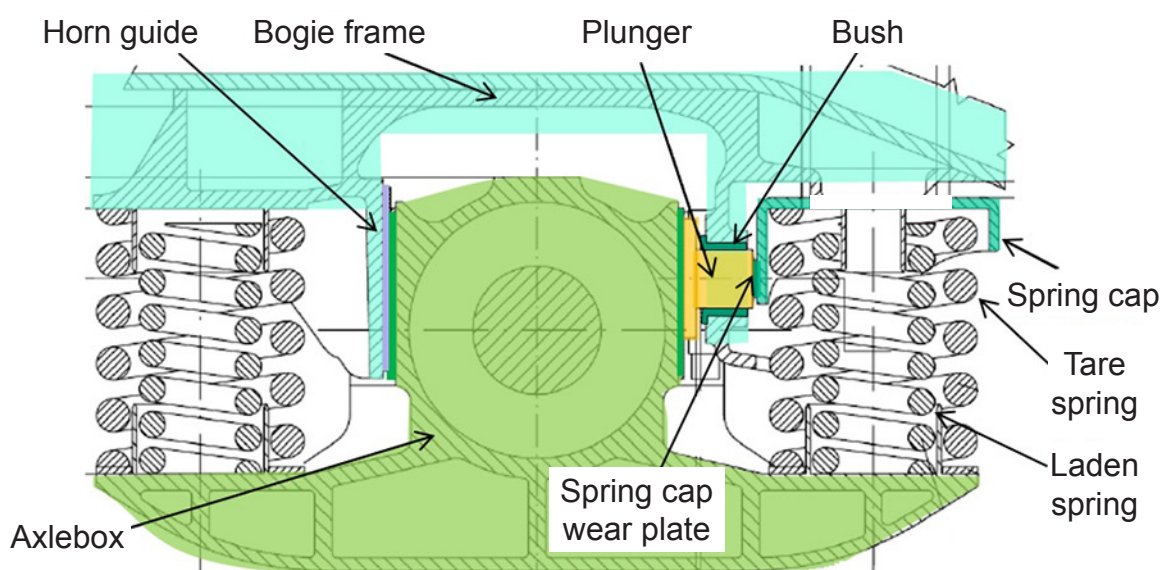
Figure 7: Components of damping system on Y33 bogies

- 28 Almost all road and rail vehicles incorporate some damping to minimise the amount of bouncing they experience following external inputs, eg unevenness in the road or track. Y33 bogies use a friction-damping arrangement where the vertical movement of the axlebox within the bogie frame horn guides is damped by friction. The key components of the damping arrangements are the Lenoir links, the spring cap and its wear plate, the plunger and the axlebox. Figures 7 and 8 show how these individual components are arranged.

- 30 Under the horizontal component of the load in the links, the spring cap wear plate pushes against the plunger which is free to move inside a bush (figure 8). The plunger pushes against the axlebox which in turn pushes against the bogie frame horn guide wear plate. If the axlebox slides up or down inside the horn guides, the axlebox has to overcome the frictional force provided by the horizontal load which pushes the components against one another, hence the name 'friction-damping'.

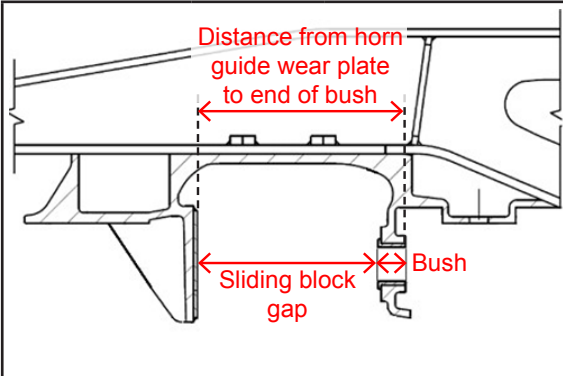
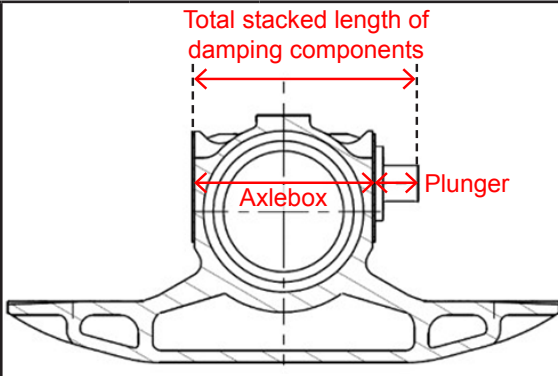
Table 3: Comparison of bogie dimensions and damping stack length using VPI values

- 69 The RAIB ascertained the relative vertical position of the bush and spring cap wear plate centrelines using the dimensions contained in the VPI maintenance guidelines and standard bogie components drawings. As new, the centreline of the spring cap wear plate (diameter 36 mm) is aligned with the centreline of the bush (diameter 55 mm). As the damping components including the Lenoir links and trunnions wear, the spring cap moves up in relation to the bush position. The RAIB calculated that at the extreme of wear of the components¹⁵, the top of the spring cap wear plate may sit higher than the top of the bush. The physical evidence showed this was 4 mm in the incident axlebox (figure 9).

¹⁵ As the spring cap wear plate wears, the weld connecting the spring cap wear plate to the spring cap also wears which increases the effective diameter of the spring cap wear plate (the diameter on the incident wagon was approximately 44 mm).

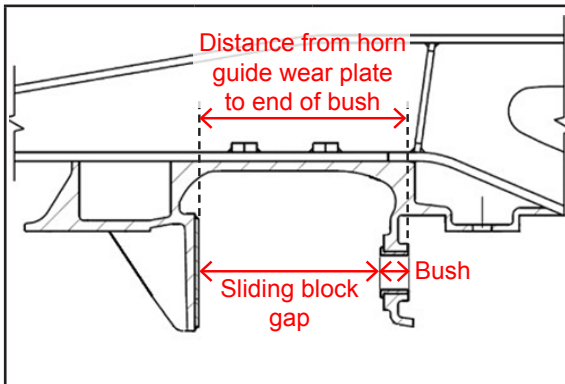
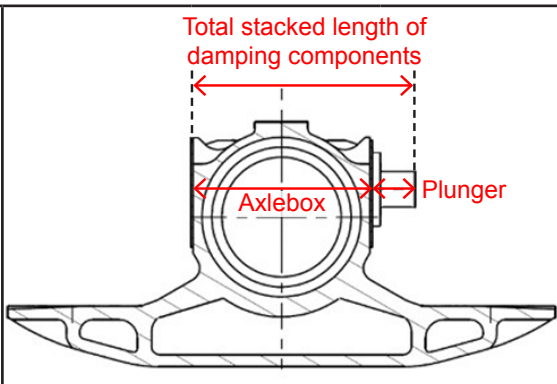
Table 4: Comparison of bogie dimensions and damping stack length using 2016 General Repair specification

- 87 The reduction in allowable wear on the Lenoir links and trunnions equate to a reduction in maximum vertical movement of the spring cap in relation to the bush of up to 3.5 mm.

- 88 Table 4 shows the effect of the changes introduced in the 2016 General Repair specification on the stack length. By changing the thickness of the horn guide wear plate from 7 mm to 5 mm, the nominal sliding block gap has increased from 290 mm to 292 mm. As the new 5 mm wear plate has a fully worn limit of 4 mm, the repair limit for the sliding block gap dimension becomes 293 mm.
